West Thames Navigation Projects

repairing and/or improving three locks on River Thames

by
Mark Reed

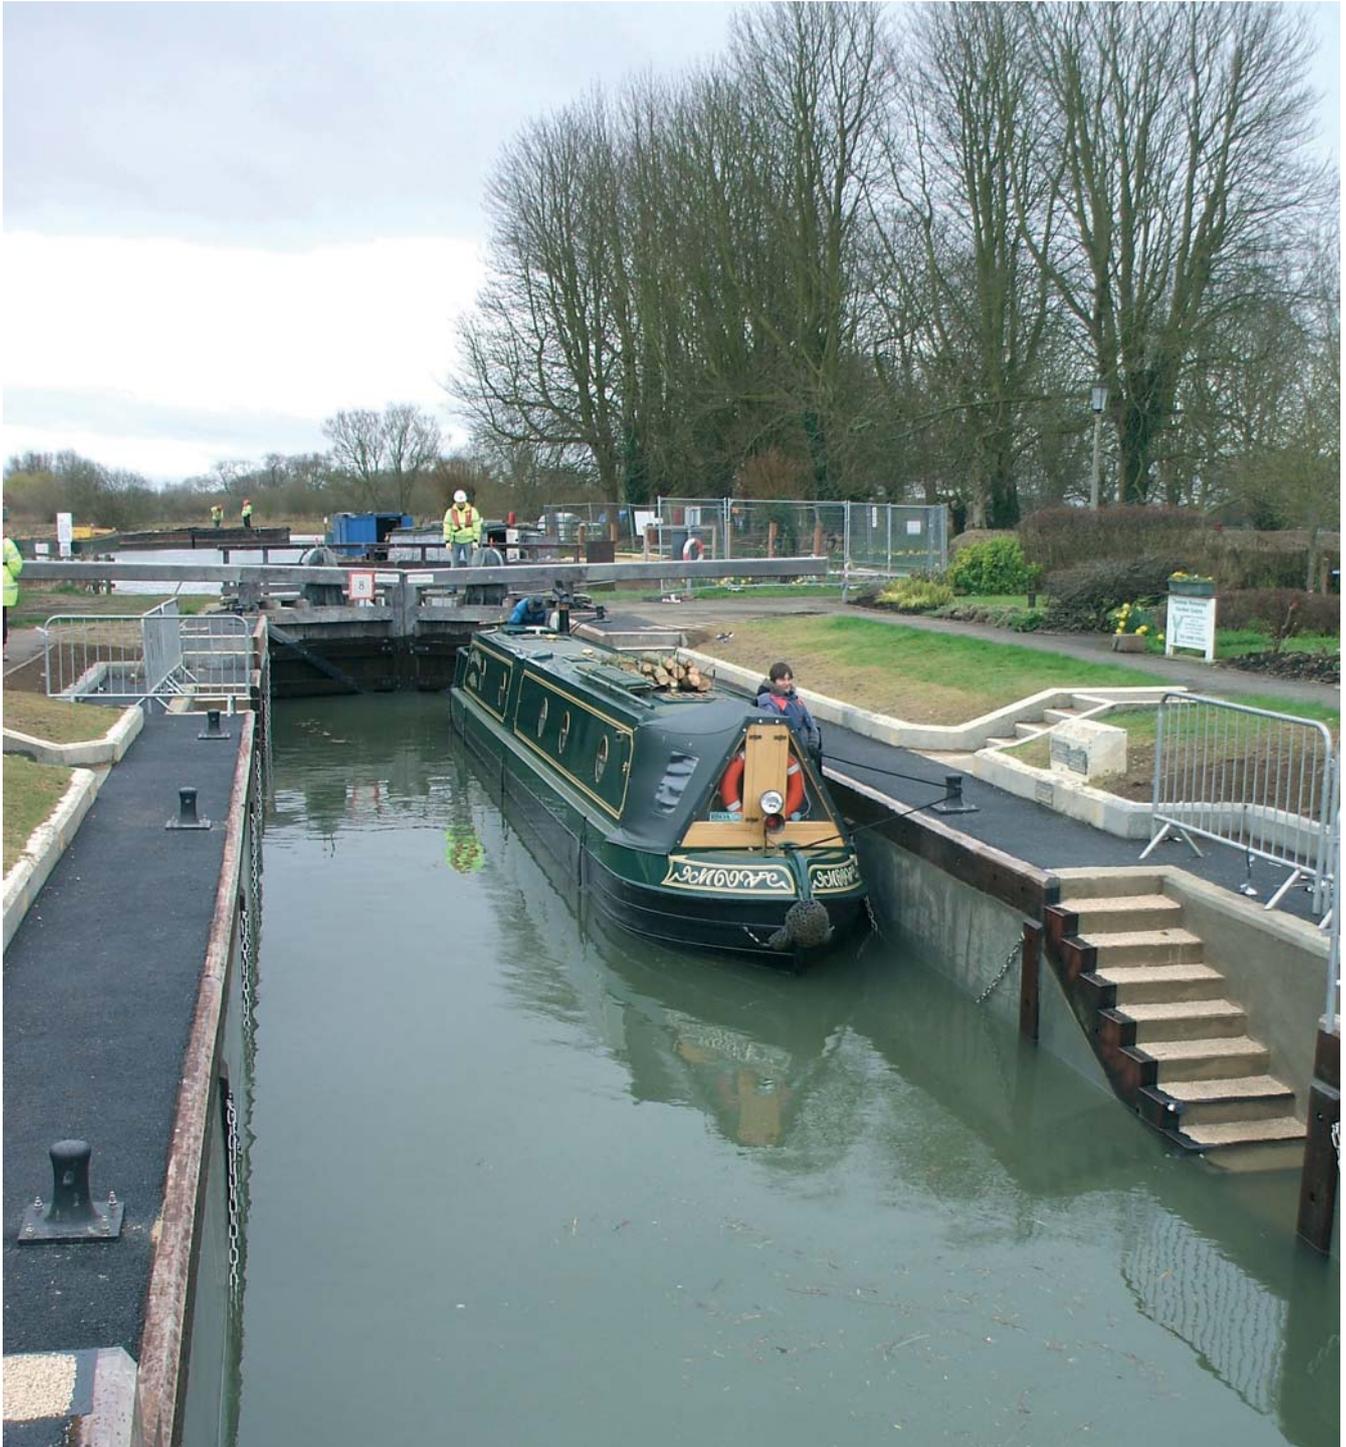
Pinkhill Lock Reopened to boaters after £690k refurbishment

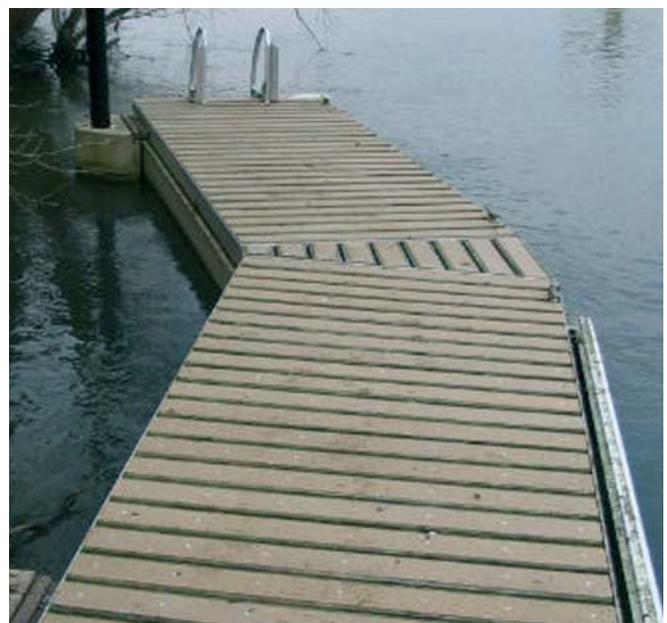
St John's Lock - revenue moorings, new anchorage piles, non slip surface

The existing piles for the revenue moorings were replaced with new 5.8m long steel tubes driven 4.3m. New non-slip strips were fixed to the existing revenue mooring deck boards to improve underfoot grip at the walkways.

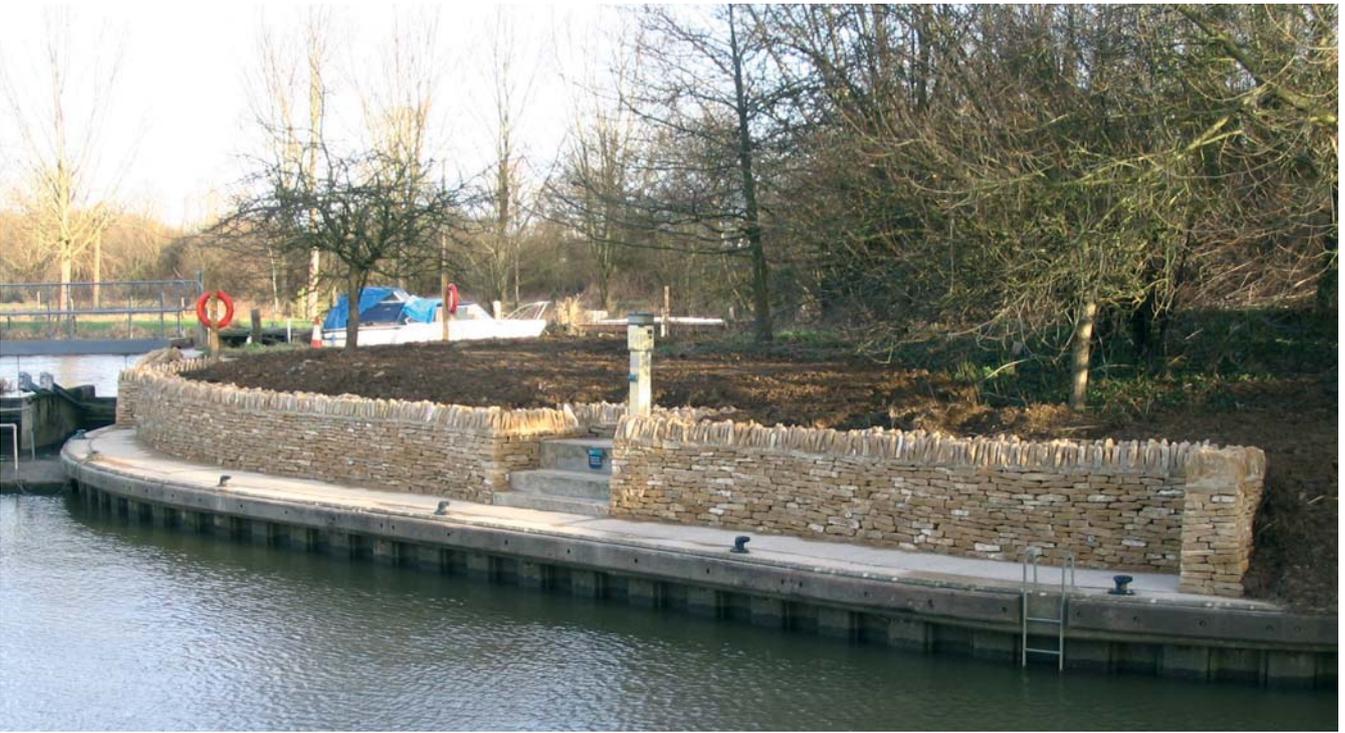
St John's New Dry Stone Wall

Following detailed design from *Halcrow Group Ltd*, the contract was awarded to **Jackson Civil Engineering**. Construction commenced early November 2007 under a planned lock closure. The existing reconstituted stone charging point wall was demolished, including the removal footpath sub-base. Piles handling holes were plate welded and new compacted sub-base with reinforced concrete footpath constructed. A new dry stone wall was constructed using locally sourced natural Cotswold stone by a specialist local dry-stone walling company, *Ernest Joynes*.

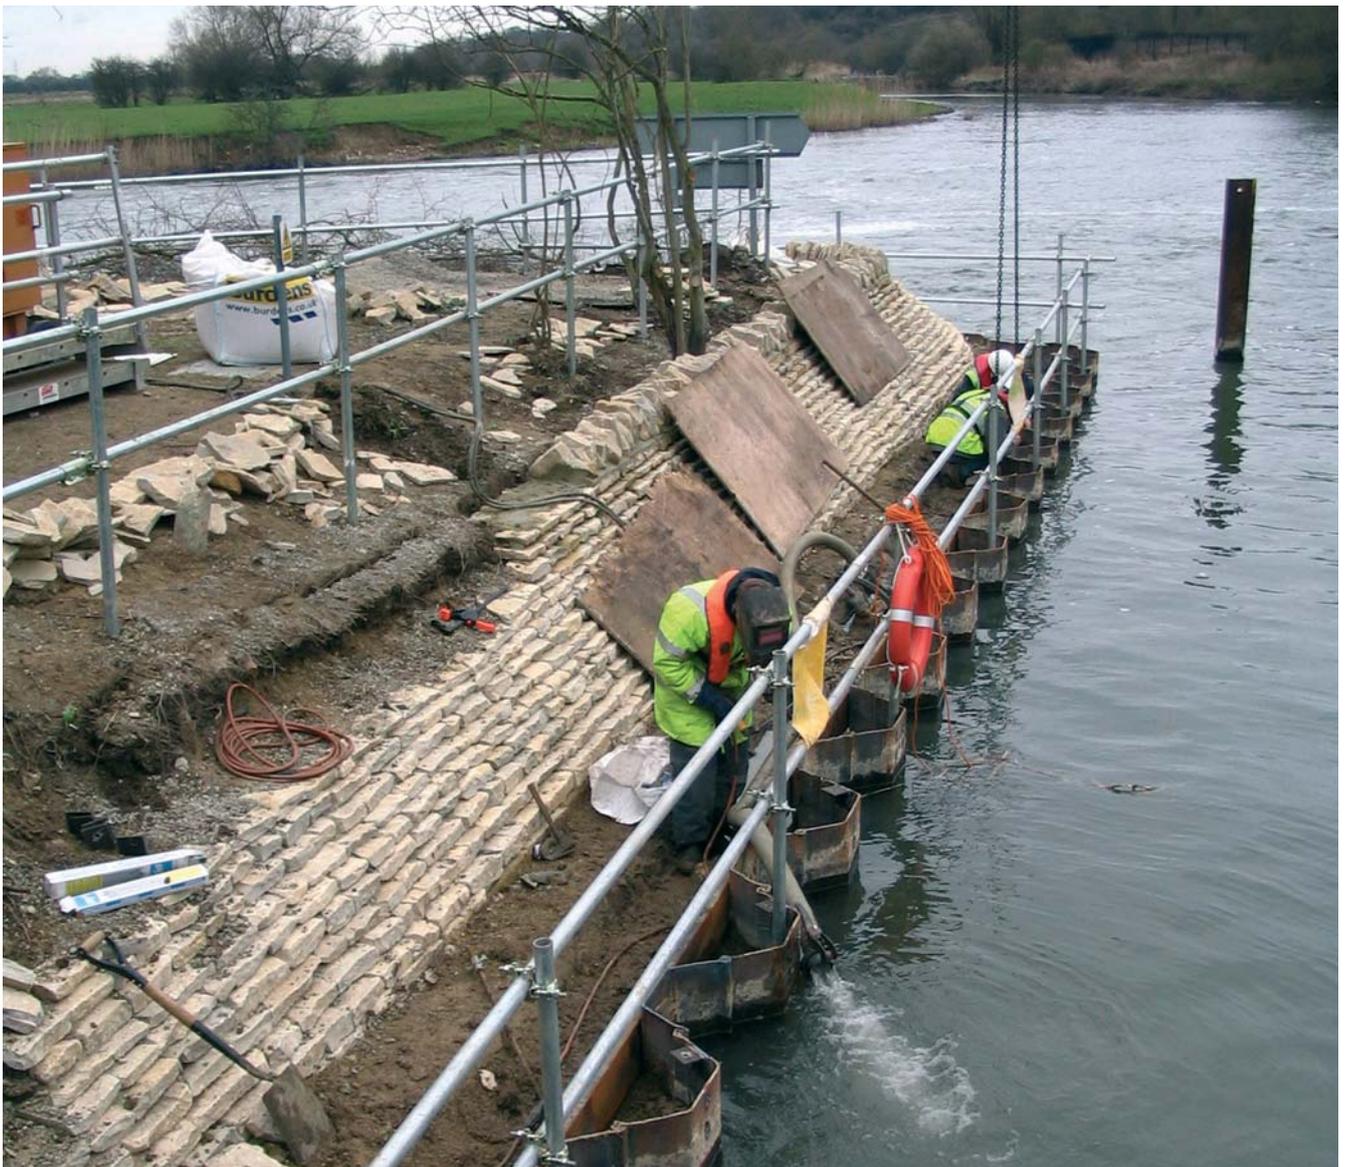
Eynsham - Piles driven and being prepared for timber capping and dry stone wall partially built

The annual waterways inspection identified that the existing left downstream bank is in poor condition with appreciable undercutting of the existing bank due to aggressive flows from the nearby Eynsham Weir. Failure of the bank put at risk the existing lock tail, nearby telemetry/weir building and existing trees.

Following detailed design from *Halcrow Group Ltd*, the contract was awarded to *Morrison Construction Ltd*. Construction commenced early November 2007 under a planned lock closure. The solution involved 28m of new PU12 steel piles, 6.5m long (locally longer to create pile bridge over existing service crossings) driven 4.8m into the existing river bed by a vibro hammer. The piling work was sub-contracted to *Commercial Marine Piling*.

The piles are clad and capped with PEFC Oak timber, new landscape planting with native species was undertaken, a new dry stone wall was constructed by Ernest Joynes dry stone wall builders and new steel guard pile replaced the existing damaged timber pile. Fish brushes were also installed within the pile in-pans. The piles and timber were purchased by Environment Agency and free-issued to *Morrison*.

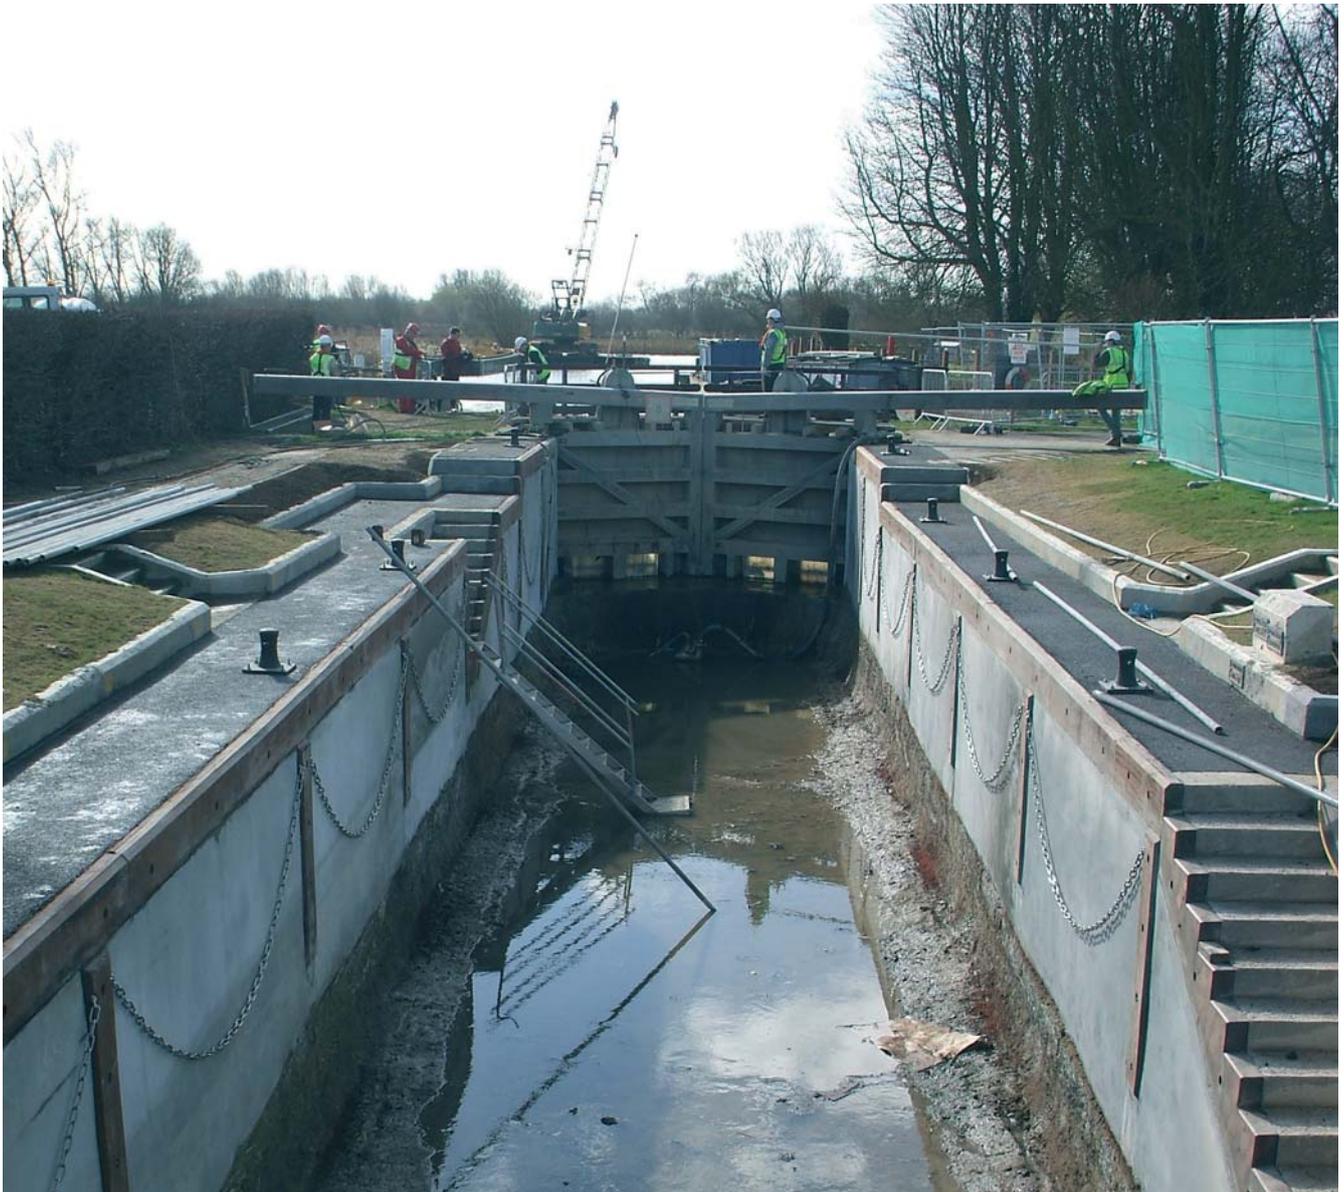
Pinkhill - this picture shows Refurb substantially complete prior to Lock opening (see photo on page 205)
