Wall De La Mare Dam (VDLM) was constructed between 1958 and 1962, and is situated in the west of the Island of Jersey, on the boundary between St Peter and St Ouen. The dam is of mass concrete construction and is 193m long and 24.3m high. It was constructed from 27 (No.) main mass concrete monoliths or 'blocks', together with a reinforced concrete draw-off tower. The reservoir holds 940,000m<sup>3</sup> of raw water. In 1971 it was first recorded that differential displacement of some of the mass concrete blocks had occurred. Upon subsequent investigation, it was apparent that the dam was suffering from Alkali Silica Reaction (ASR). Differential movement of up to 35mm has now occurred due to the characteristic swelling of the highly alkali aggregates in the presence of water. This paper describes how the rehabilitation of the dam was carried out by installing 3,200m<sup>2</sup> of a specialist geomembrane lining to the upstream face.

## Background

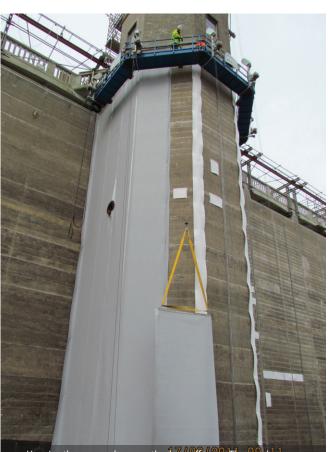
Hanging the geomembrane on the draw-off tower. The membrane was lifted upwards from the base of the tower. Note sacrificial textile was placed on the corners of the tower to protect the geomembrane. Courtesy of Jersey Water
