Gowerton WwTW Sea Outfall

Dŵr Cymru Welsh Water outfall rehabilitation to alleviate pollution in a SSSI and designated shellfish water

by Lee Galsworthy BSc (Hons) & Matt Unsworth BEng (Hons) CEng MICE

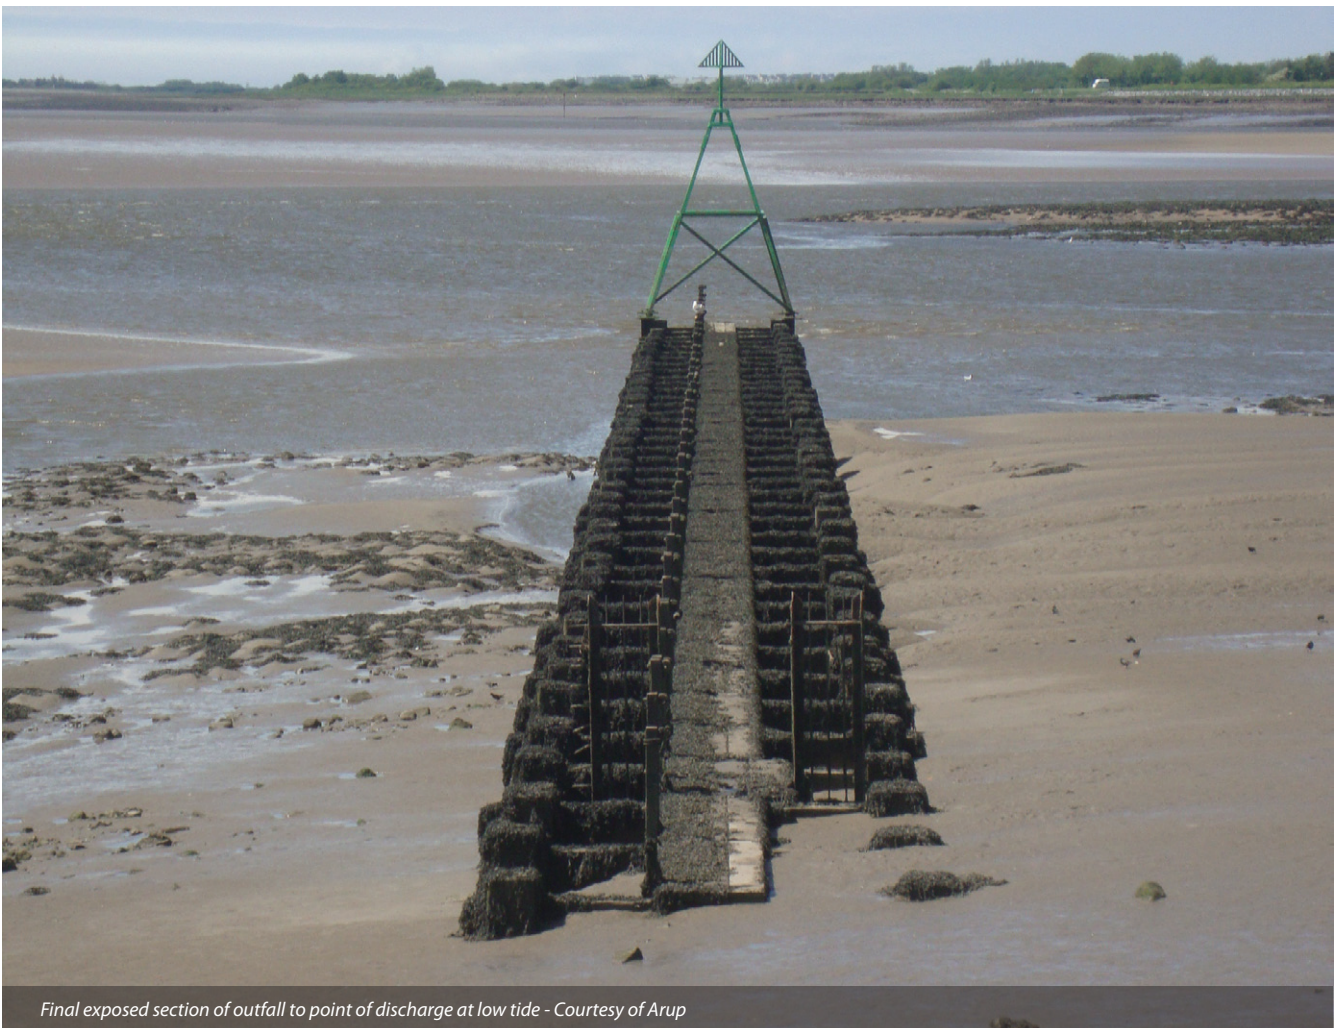
Final exposed section of outfall to point of discharge at low tide - Courtesy of Arup

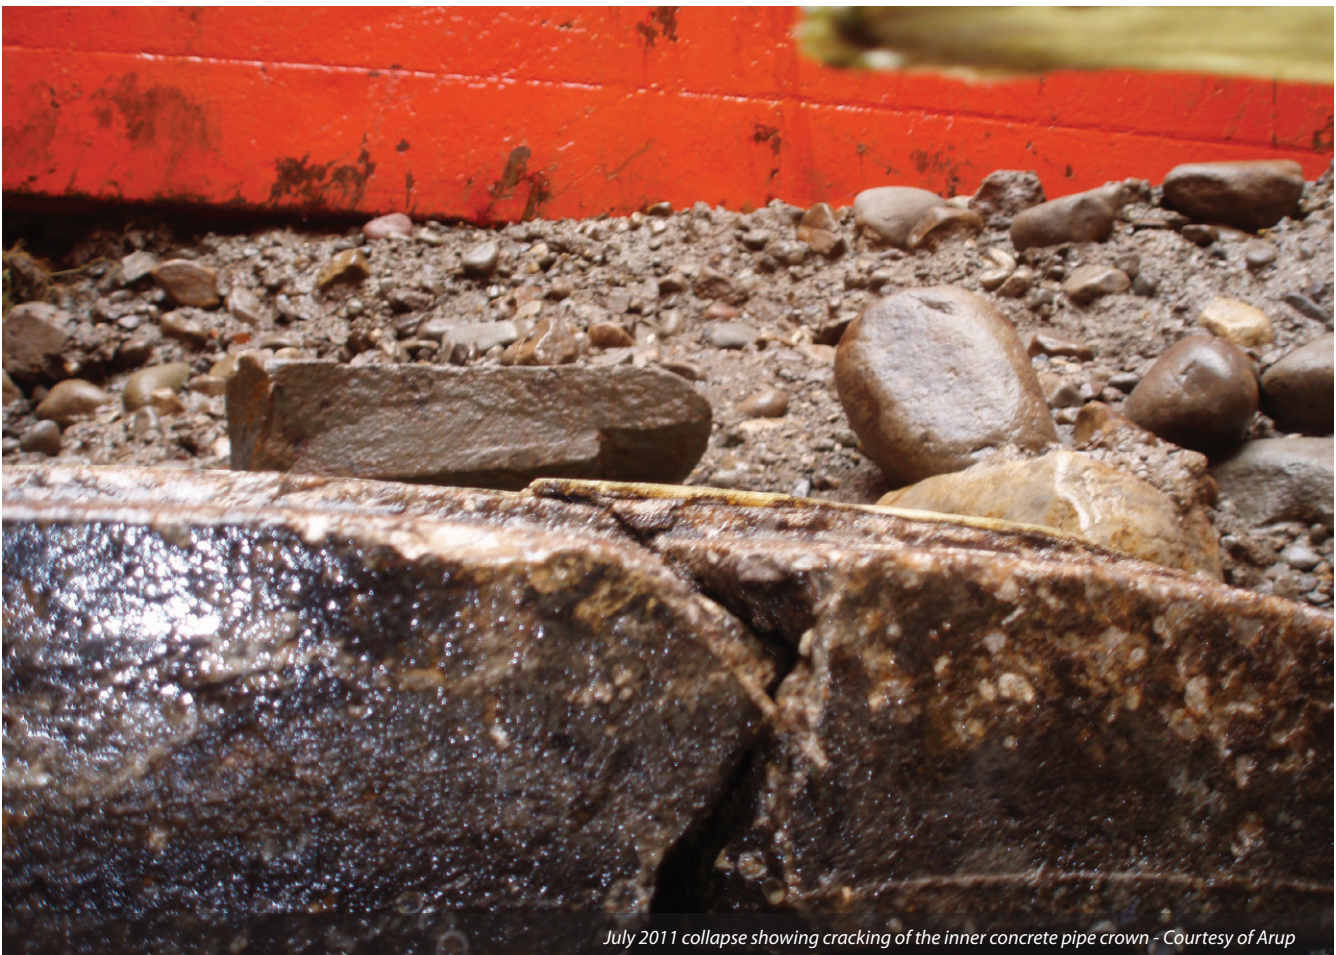
The pipe collapsed again in July 2011 within the saltmarsh, during what was by now the AMP5 feasibility stage for the project. This gave the design team an opportunity to investigate the collapse mechanism directly.

July 2011 collapse showing cracking of the inner concrete pipe crown - Courtesy of Arup

With flows being controlled within the live sewer, the isolated Dekkon pipes were cut into to enable access for the lining work. Lining of the 1,280mm diameter pipes was carried out by iLine using their EnviroCIPP high performance ultra violet cured liner in lengths up to 106m with the liner being sourced from Germany. This is the first time in the UK that a liner above 1,200mm diameter has been cured by this method.

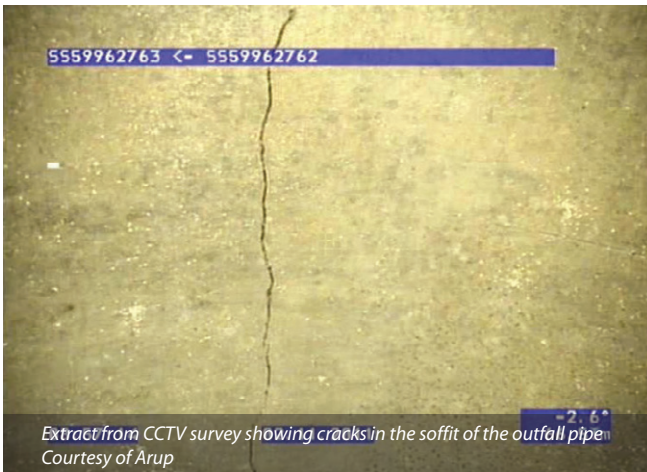
The entire length of the outfall was CCTV surveyed. The internal condition of the pipe was graded in accordance with the Manual of Sewer Condition Classification, WRC, 2004. Due to uncertainty over the structural integrity of the combined materials in the manufacture of the *Dekkon* pipe, a cautious approach was taken

with a recommendation that all structural defects graded 3 and above would require rehabilitation.

Extract from CCTV survey showing cracks in the soffit of the outfall pipe
Courtesy of Arup

The structural defects above grade 3 were fairly evenly spaced out over the sections of outfall through the saltmarsh. However, a number of them fell outside of the 1km length that was initially earmarked for off-line replacement in the PR09 submission. The proposal taken forward was to locally rehabilitate sections using structural lining as this would allow a greater extent of outfall defects to be alleviated.

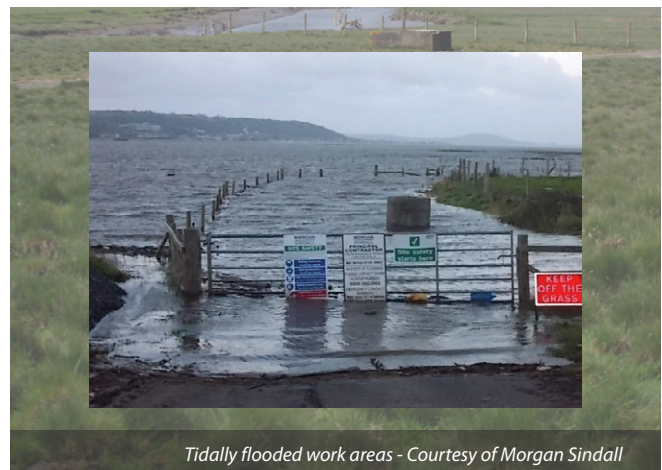
The site is subject to occasional tidal inundation when high tides flood the area. Careful planning was required to ensure the workforce was not put at risk and plant and materials were not lost or damaged.

Tidally flooded work areas - Courtesy of Morgan Sindall
