Hawkridge Dam

Concrete repairs

By Paul Godfrey BEng (Hons) CEng MICE CEnv

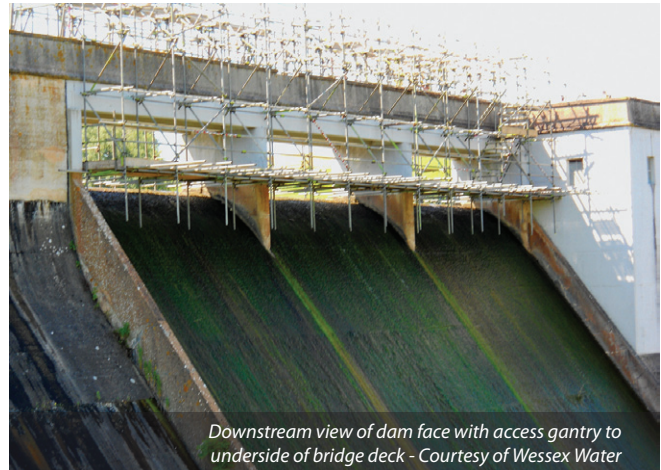
Downstream view of dam face with access gantry to underside of bridge deck - Courtesy of Wessex Water

To access the underside of the bridge-deck to carry out the repairs, a hanging cantilever platform was designed and implemented. This allowed water to spill over the spillway in times of flood, with no loadings on the spillway itself and at the same time, allow access across the dam crest and spillway bridge for Wessex Water operational staff.

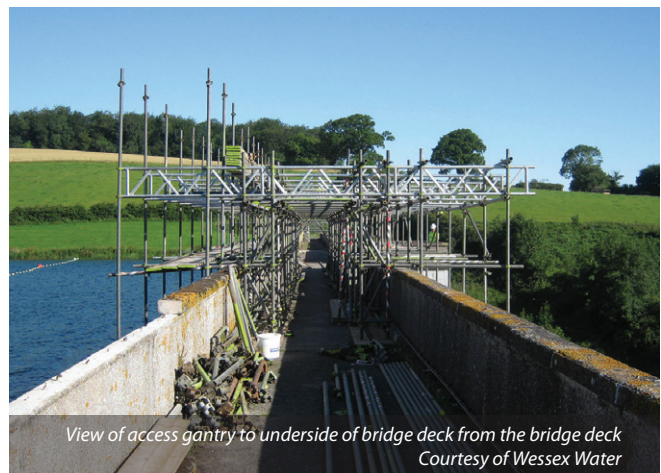
View of access gantry to underside of bridge deck from the bridge deck - Courtesy of Wessex Water

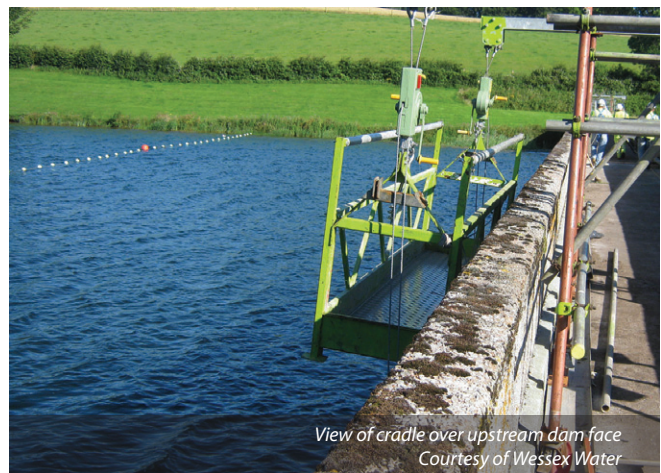
View of cradle over upstream dam face - Courtesy of Wessex Water

To access to the dam faces, discussions were held about provision of a full scaffold structure to the upstream and downstream faces. The workstream team reviewed the requirement and methodology of the concrete repairs, including evaluation of loadings and the tools required, and implemented a cradle system developed by Giraffe Access at a suitable cost.

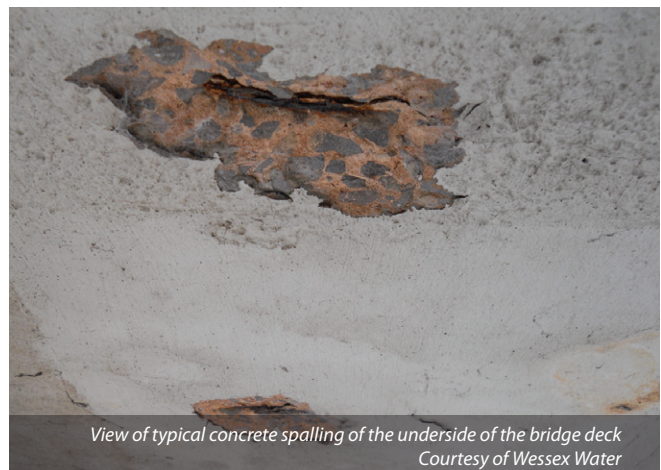
The CRL report was analysed by Atkins Structures and Reservoirs teams to review and determine the scope of works required to meet the project brief, and to also quantify the extent and type of repairs required. The damage to the concrete faces had been caused by the spalling of reinforcement in the concrete structure.

The areas of defective concrete identified in the CRL report caused by concrete spalling are typically shown by the photograph below. The defective concrete was repaired by applying a standard

View of typical concrete spalling of the underside of the bridge deck - Courtesy of Wessex Water

concrete proprietary patch repair system consisting of saw cutting all defective concrete identified to the extremities and broken out to a minimum depth of 10mm to avoid feather edging and to provide a square edge to the repair.

The repair surface was cleaned to remove any dust, unsound or contaminated material, oil, paint, grease, corrosion deposits or algae by scrubbing or the use of a proprietary degreaser. All corroded steel in the repair area was fully exposed and all loose scale and corrosion deposits removed. The reinforcing steel and repair substrate was primed prior to application of the concrete repair mortar.

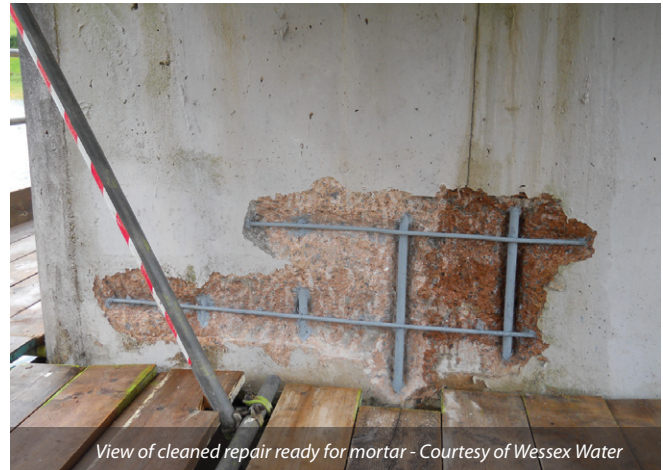
View of cleaned repair ready for mortar - Courtesy of Wessex Water

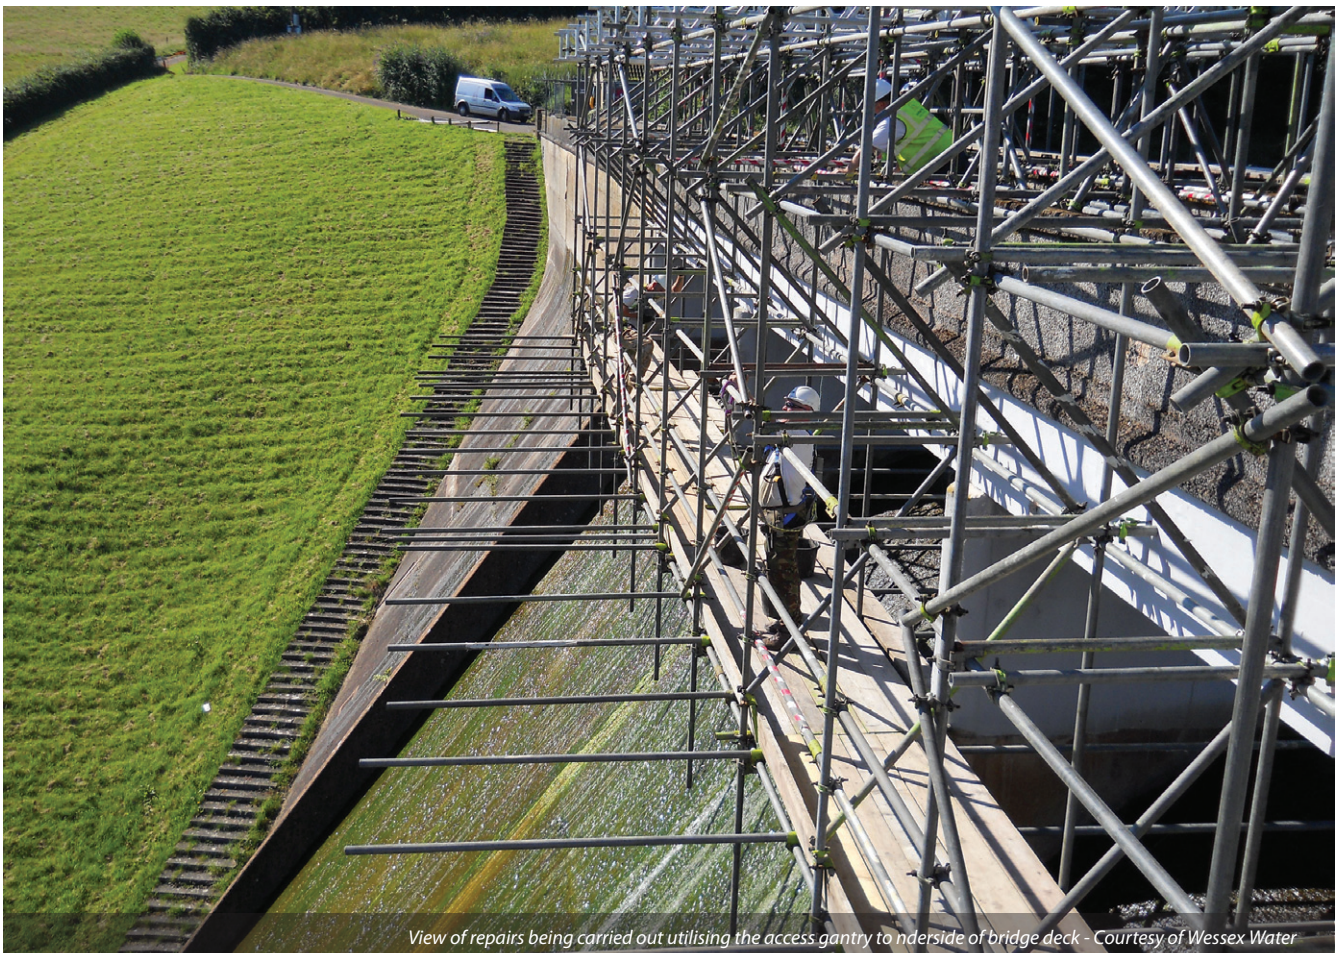
View of repairs being carried out utilising the access gantry to underside of bridge deck - Courtesy of Wessex Water
