# Katrine Aqueduct Refurbishment

## essential capital maintenance refurbishment of a strategic raw water supply

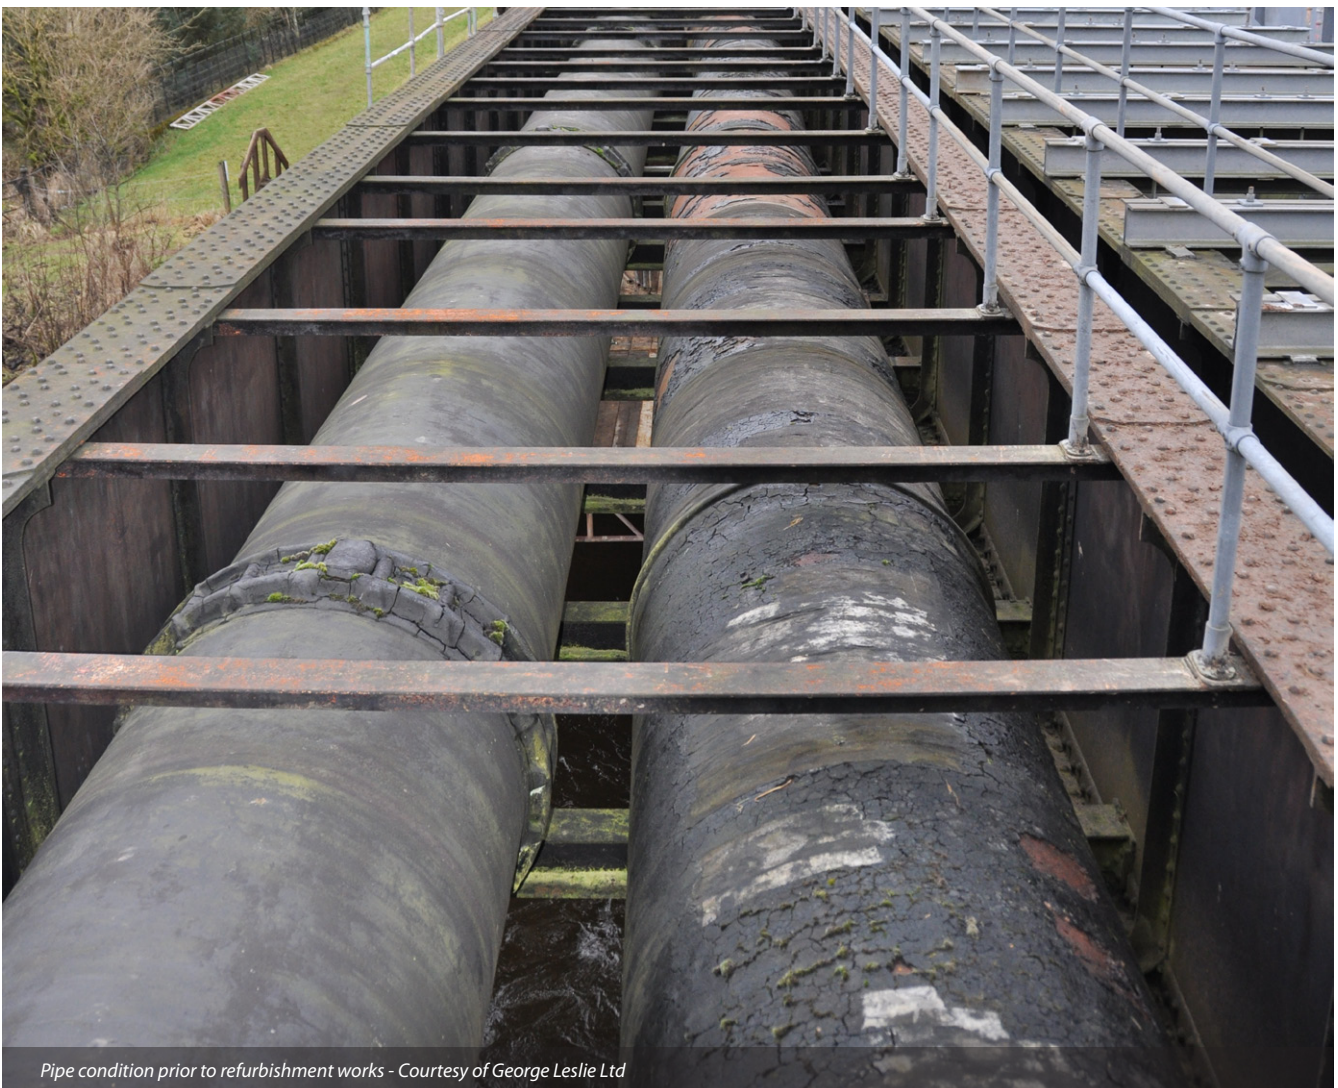
Pipe condition prior to refurbishment works - Courtesy of George Leslie Ltd

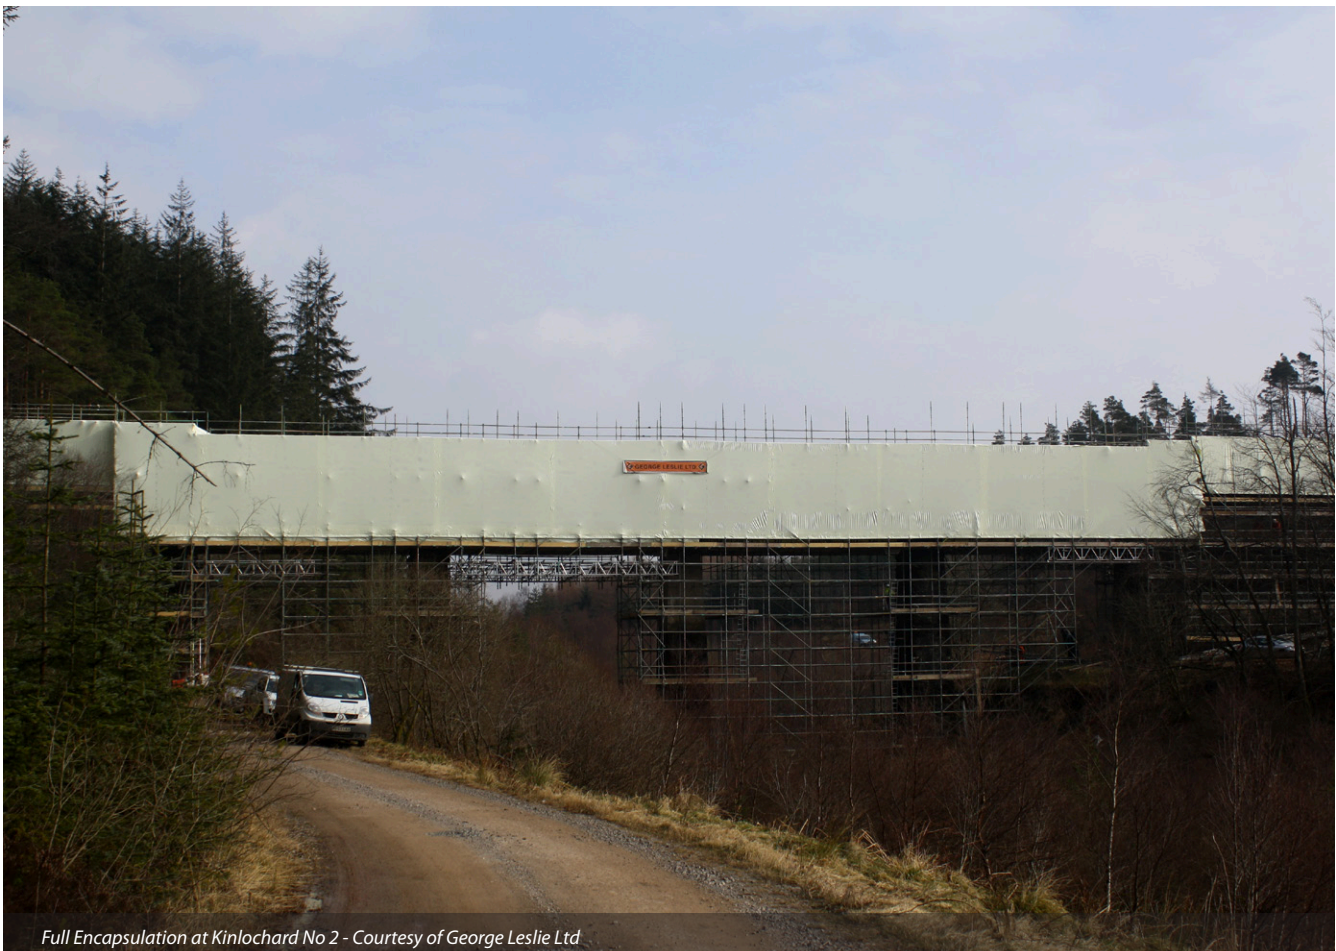
Full Encapsulation at Kinlochard No 2 - Courtesy of George Leslie Ltd

This protection work was undertaken within full 'Enviwrap' encapsulation to contain the grit and create ambient conditions for the application of a proprietary epoxy glass flake coating to provide a '25-year Life to First Major Maintenance' protection. Forced ventilation was also necessary to overcome the high humidity within the encapsulation, particularly where raw water flows were being maintained across the structures through 2.4m x 2.0m open troughs, including the 300m long Corrie 'Old' bridge.
