Talla Aqueduct overflow chamber stabilisation

by Simon Renton IEng AMICE

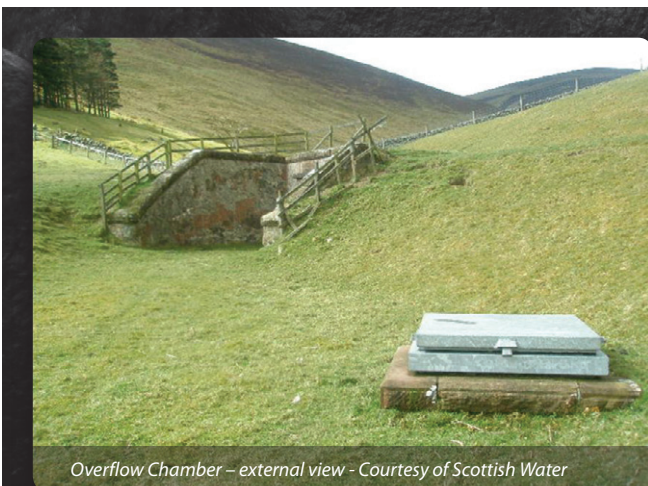
Overflow Chamber – external view - Courtesy of Scottish Water

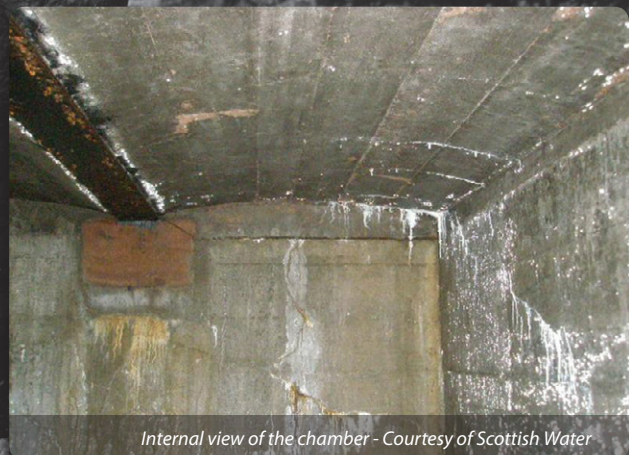
Internal view of the chamber - Courtesy of Scottish Water

Chamber repair works: Cracks in the internal structure surface of the chamber were repaired and all internal wall and roof surfaces were covered with a protective coating in order to stabilise the surface. Roof beams were cleaned to remove all rust and loose material and then painted with a protective paint system.

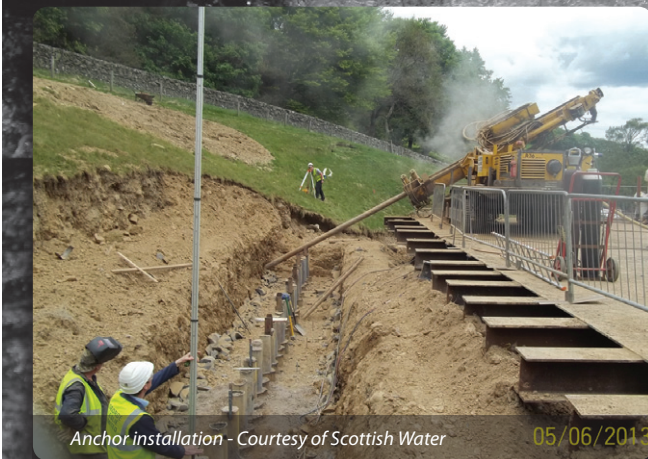
Anchor installation - Courtesy of Scottish Water

Bored pile retaining wall: George Leslie and their consultant partner Atkins designed and installed a waterproof bored pile retaining wall and capping beam tied back with rock anchors along the uphill (east) side of the overflow chamber to remove the loading on the structure from the hillside under which it is buried.

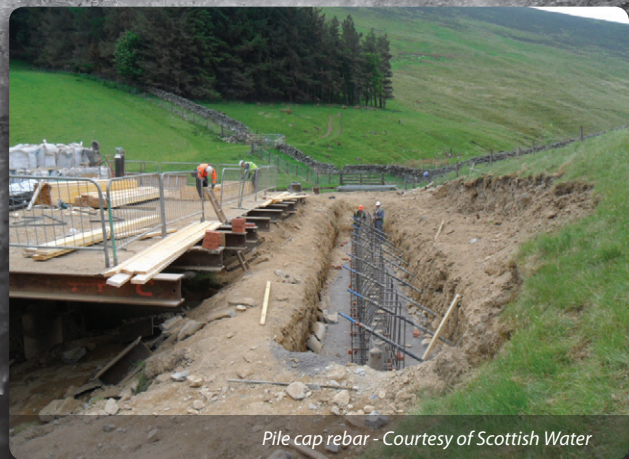
Pile cap rebar - Courtesy of Scottish Water

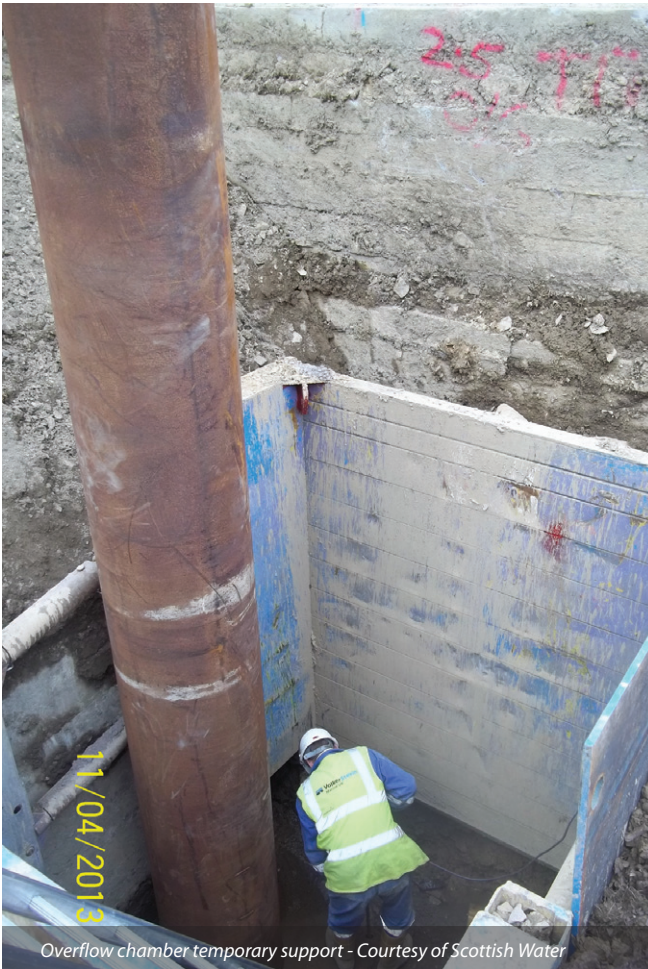
Overflow chamber temporary support - Courtesy of Scottish Water

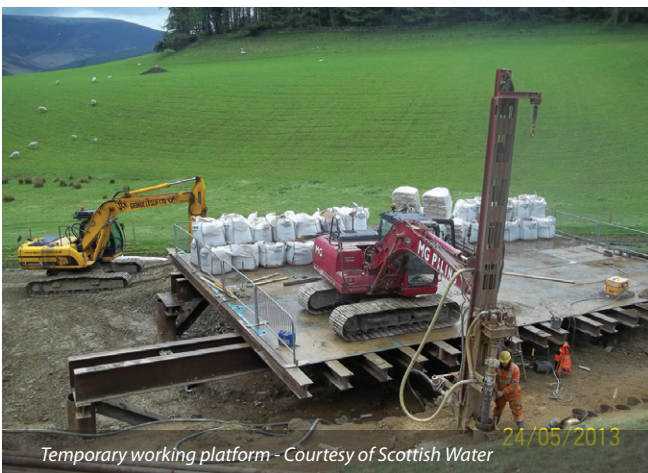
Temporary working platform - Courtesy of Scottish Water

- Construction of a temporary working platform on one side of the overflow chamber for piling, excavation, backfilling and other construction operations to avoid adding construction loading onto the overflow chamber and the aqueduct.
- Provision of a working platform over the live aqueduct channel within the overflow chamber to allow concrete repair works to be carried out. The platform was completely sealed to prevent any cleaning debris or effluent or repair materials entering the aqueduct at any stage of the works including during removal of the platform to avoid accidental pollution of the aqueduct.

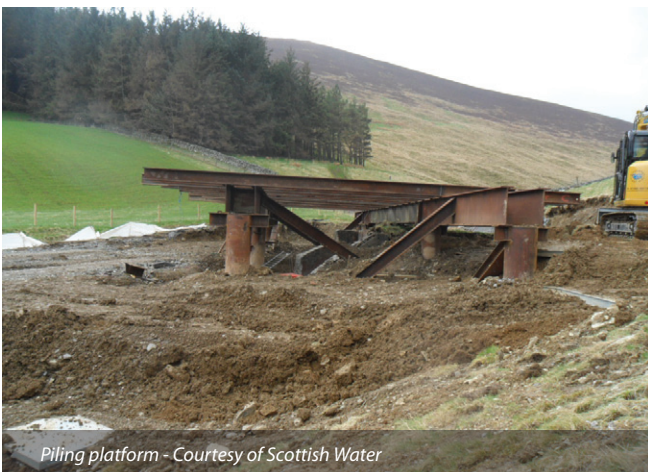
Piling platform - Courtesy of Scottish Water

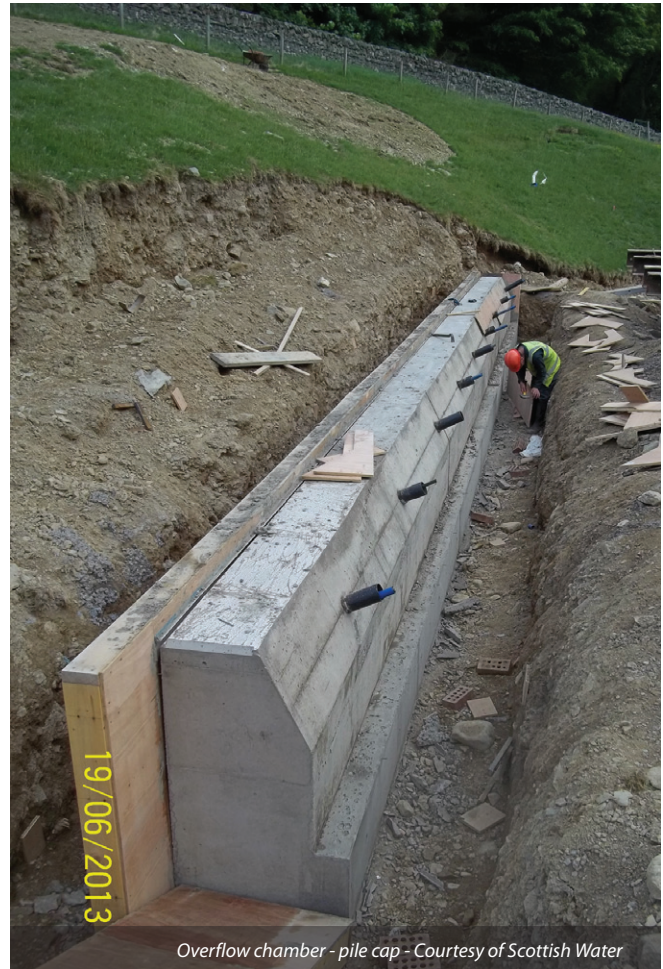
Overflow chamber - pile cap - Courtesy of Scottish Water

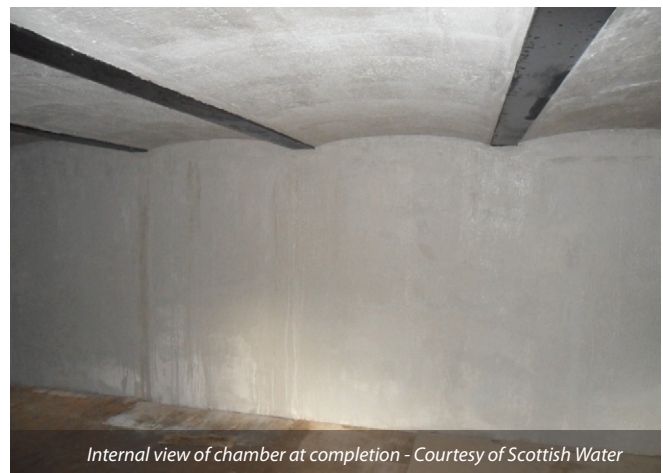
Internal view of chamber at completion - Courtesy of Scottish Water

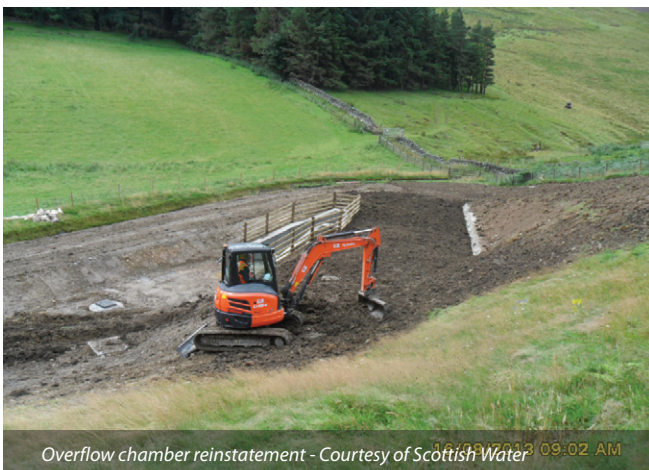
Overflow chamber reinstatement - Courtesy of Scottish Water

Reinstatement of all ground to the existing levels and condition recorded on site during the pre-construction dilapidation survey was carried out with the agreement of the landowner.

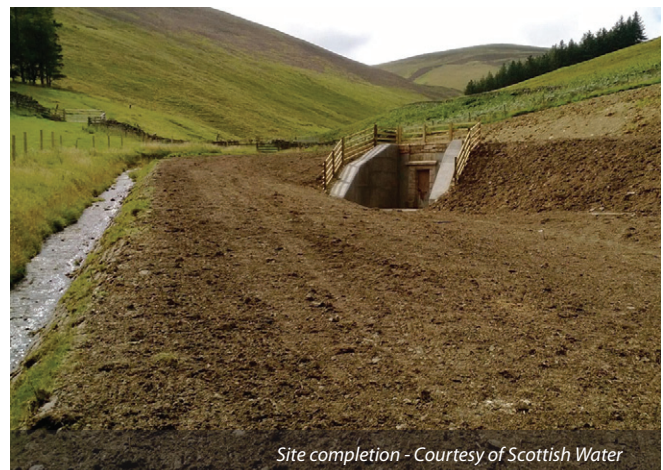
Site completion - Courtesy of Scottish Water
