Upper Neuadd Dam Stability

stabilising a historic dam within the Brecon Beacons National Park for Dŵr Cymru Welsh Water

by Nathan Walding CEng MICE & Rick Grosfils CEng MCIWEM

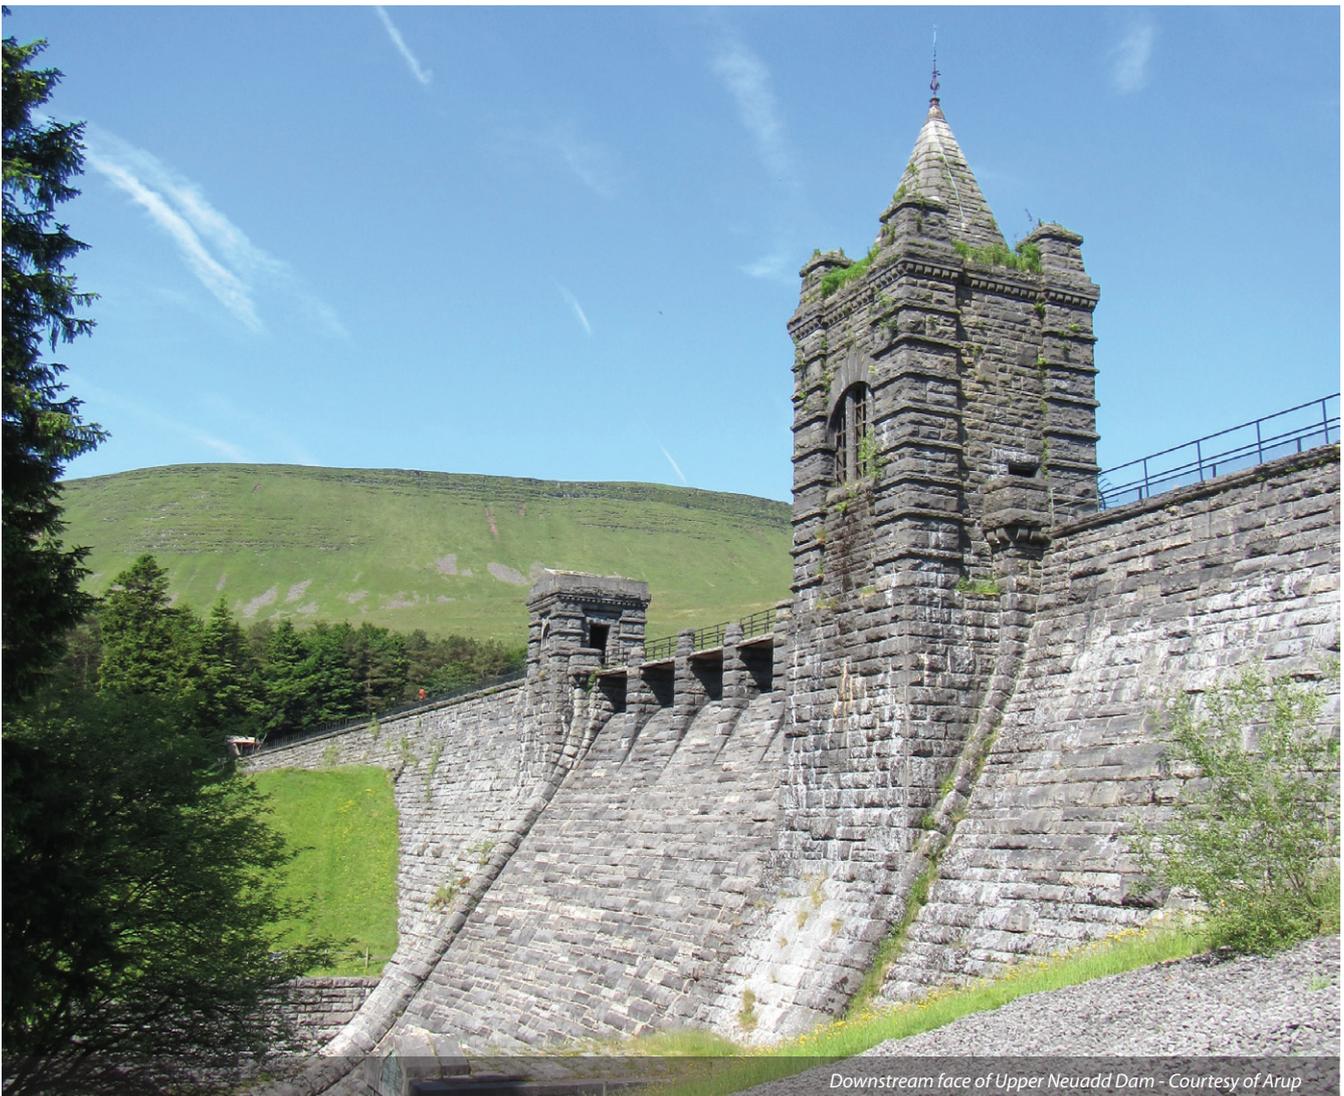
Downstream face of Upper Neuadd Dam - Courtesy of Arup

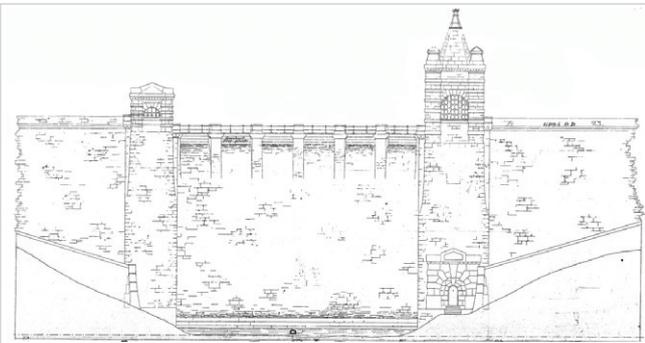
Elevation of spillway section
Courtesy of DCWW

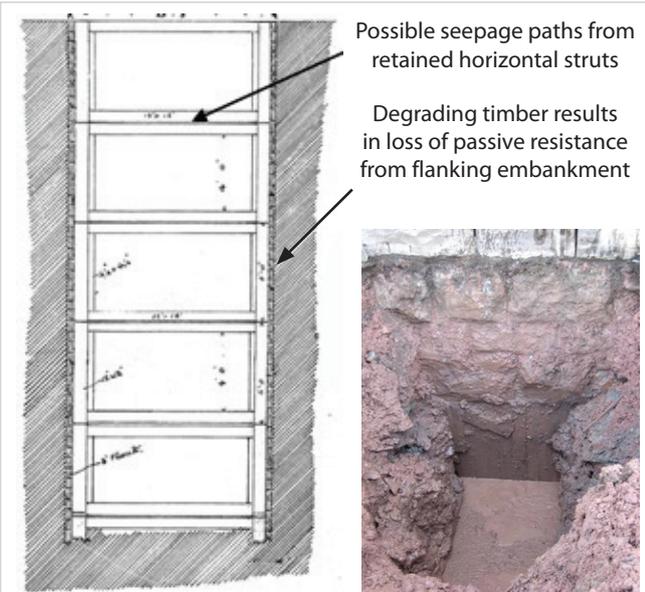
However, the exploratory excavations against the upstream face of the dam confirmed the presence of substantial timber formwork, used to support the trenches during construction. This had

degraded over time, and it was considered likely that the formwork struts could have been left in place, potentially providing seepage paths through the dam.

Evidence of timber formwork in trial pit, related back to record drawings.
Courtesy of DCWW.

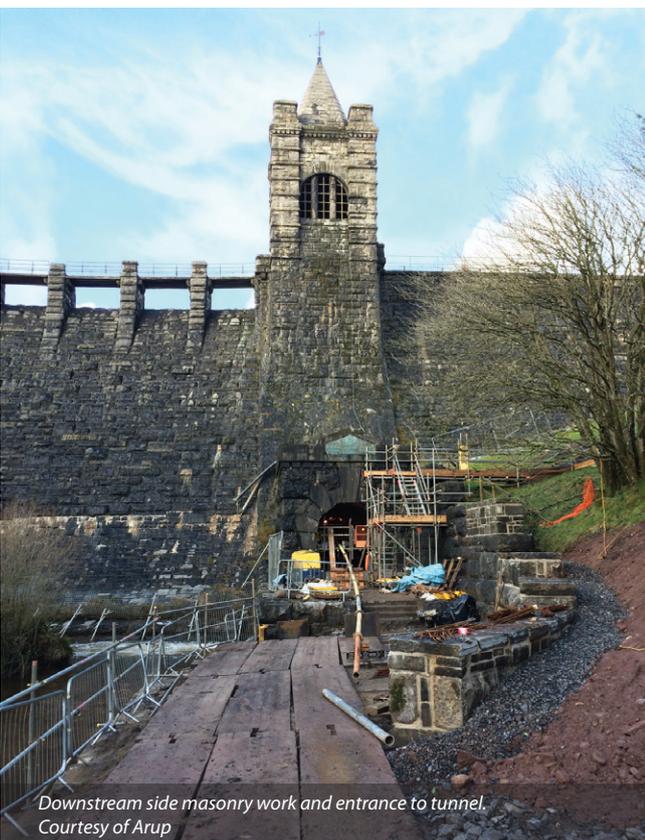
Downstream side masonry work and entrance to tunnel.
Courtesy of Arup

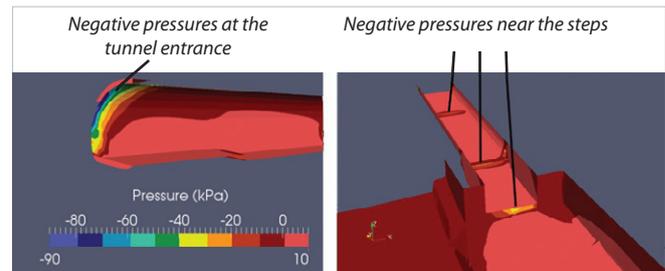
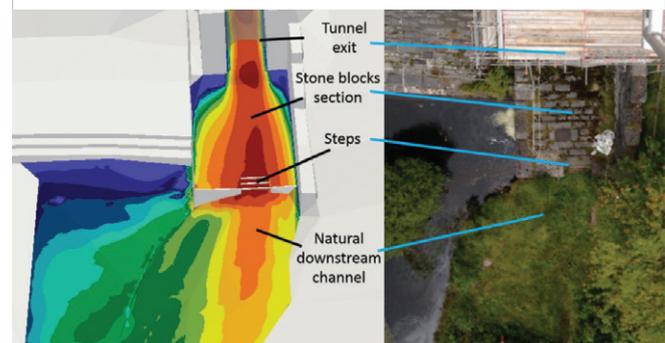
- During a PMF event negative pressures would be developed in the tunnel with peak values of -80kPa at the tunnel entrance.
- The flow rate through the tunnel is predicted to be 64m³/s during a PMF event with a maximum velocity of 16.5m/s.
- Under the 150 year return period flood, the maximum velocities in the downstream channel are of the order of 14m/s.

There was therefore some concern regarding the potential for negative pressures to 'pluck out' the masonry immediately above the tunnel inlet and the ability of the existing brickwork that lined the tunnel to withstand the negative pressures and high velocities predicted.

Above: Negative pressure zones in the proposed tunnel - PMF event
Below: Variation of the maximum flow velocity above the downstream channel bed - 150 year event - Courtesy of Arup

To mitigate these, a 150mm thick reinforced concrete lining to the tunnel was designed to improve the hydraulic performance and resist the negative pressures at the entrance and across the internal steps. Furthermore, the upstream entrance was also to be protected by a stainless steel liner ('top hat') that was tied into the concrete lining. This overlaps the stone masonry and brickwork on the upstream face of the dam.

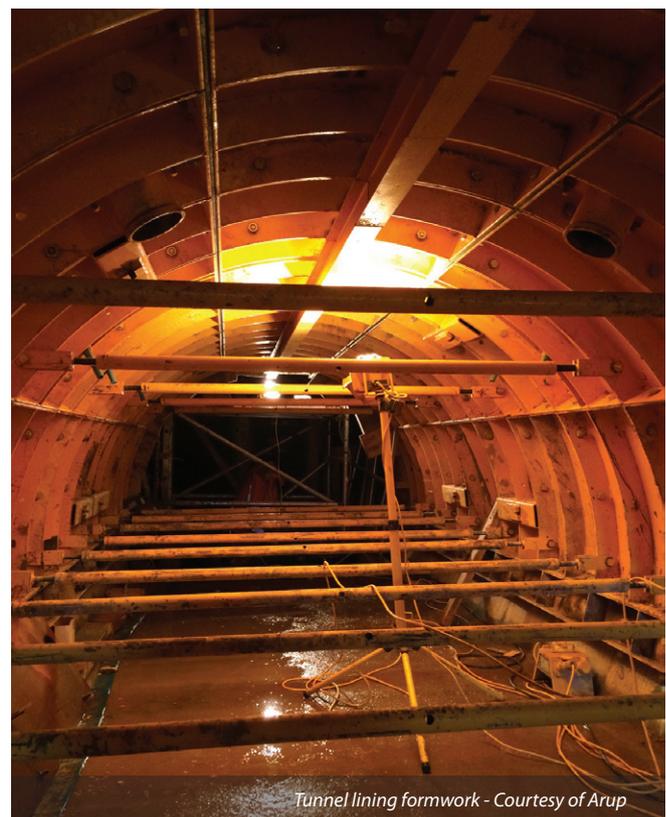
Tunnel lining formwork - Courtesy of Arup

Construction works commenced in September 2015 following an extended planning/listed building consent determination process. The works on the downstream side of the dam comprising the new masonry apron, curved deflector wall and tunnel lining, progressed well as these works could largely be completed independent of water levels in the upstream reservoir basin. The 150mm thick reinforced concrete tunnel lining was achieved using curved steel formwork panels bolted together to fit the required profile of the tunnel, and pumped concrete was compacted using bolt on external shutter vibrators.
