# Portland Sewer Collapse

## replacement of existing above ground critical sewer after extreme weather conditions cause severe flooding and several landslides within Portland Harbour

by Andrew Roberts BSc (Hons)

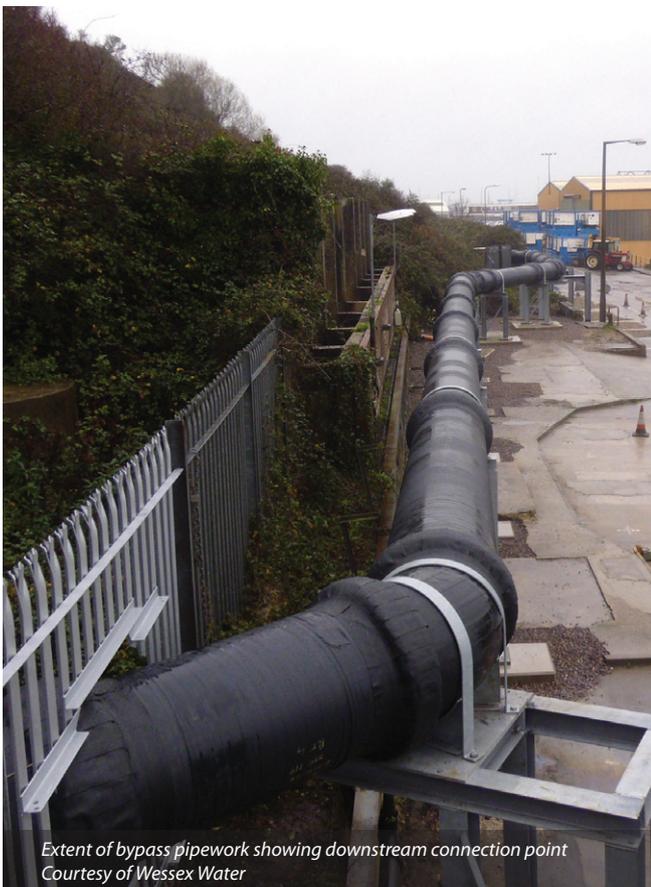
Extent of bypass pipework showing downstream connection point  
Courtesy of Wessex Water

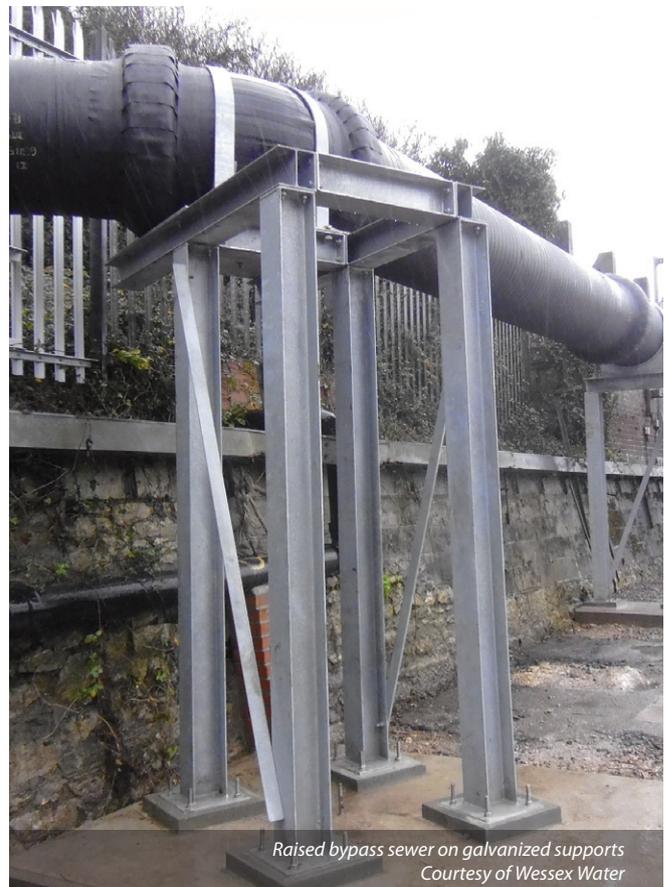
Raised bypass sewer on galvanized supports  
Courtesy of Wessex Water

The pipework was supported along its length by galvanized support legs with either two support legs or four depending on their positioning. Flows within the pipe can exceed 500l/s so the design had to allow for acting forces and ground conditions.

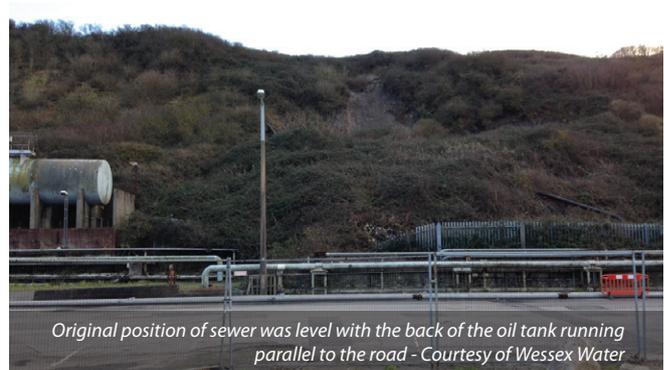
Once on site, the Repair and Maintenance (R&M) team discovered that the entire bank behind the above-ground sewer had collapsed, due to an extensive landslide moving a large section of the sewer and its concrete supports approximately 20m down the bank. Access to the sewer was very difficult and dangerous due to its position set back off the Port Haulage Road built along the line of

*Original position of sewer was level with the back of the oil tank running parallel to the road - Courtesy of Wessex Water*

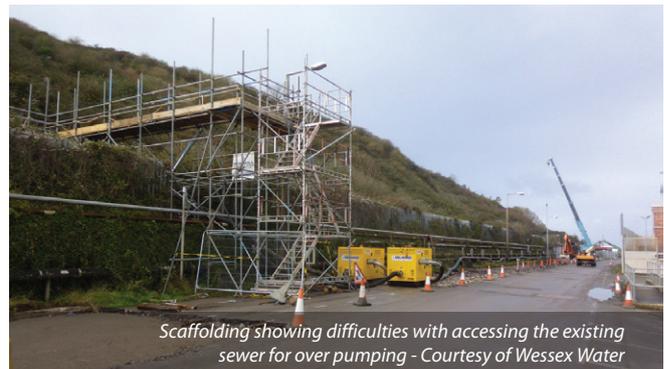
*Scaffolding showing difficulties with accessing the existing sewer for over pumping - Courtesy of Wessex Water*

The R&M team worked around the clock in shifts setting up over 1.8km of extensive overpumping utilising an existing structure within the Port and converting it into a temporary wet well. Two submersible pumps were then positioned within the wet well (operating duty/ standby) powered by generators (duty/standby).

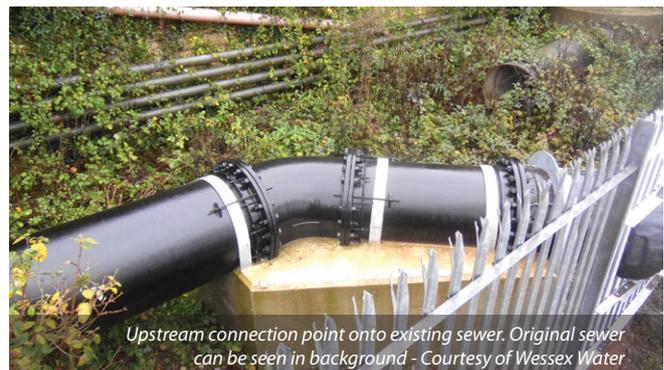
*Upstream connection point onto existing sewer. Original sewer can be seen in background - Courtesy of Wessex Water*

The investigation showed the rest of the sewer to be in good condition. Upstream of the collapse the sewer was accessed using scaffolding allowing an area to be cleared in order to find the sewer; here the existing sewer would be cut to allow the bypass section of sewer to be installed and connected onto the existing sewer upstream of the damaged section.

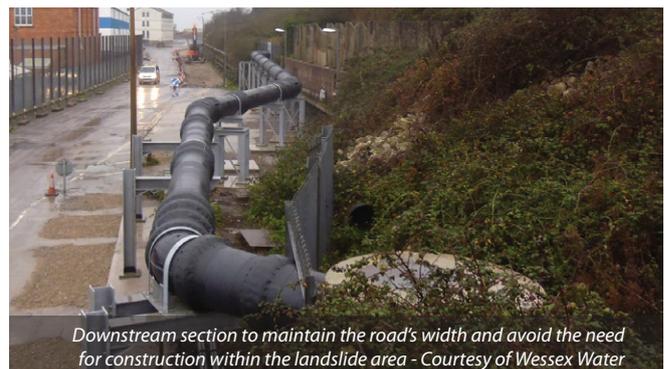
*Downstream section to maintain the road's width and avoid the need for construction within the landslide area - Courtesy of Wessex Water*

The line of the bypass sewer came out into the haulage road in one area in order to maintain a buffer zone between the land slip and the sewer and supports in case further land slips occurred. More recently, towards the end of 2015 Wessex Water realigned this section of sewer as the Port Authority had plans to widen the haulage road.

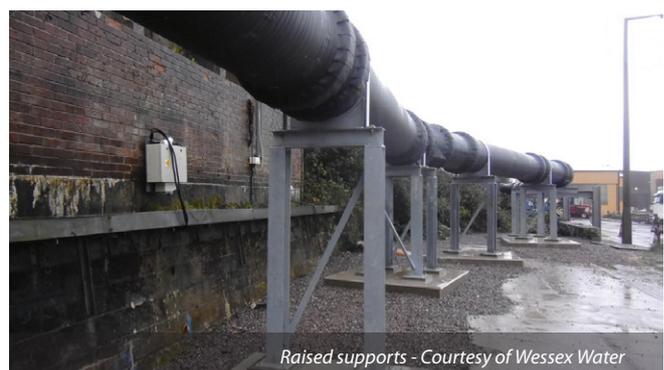
*Raised supports - Courtesy of Wessex Water*

Wessex Water's in-house design team designed below ground cantilever supports which allowed the bypass pipework to effectively hang over the landslide area allowing Wessex Construction Services to construct the support framework within a safe area away from the landslide. The cantilever supports also keep the pipework out of the busy Port Haulage Road as specified by the Port to allow them to continue with their development.
