Llyn Teifi Spillway Rehabilitation Works

improvements to the overflow and spillway required keeping the reservoir close to top water level for the duration of the works in order to maintain supplies

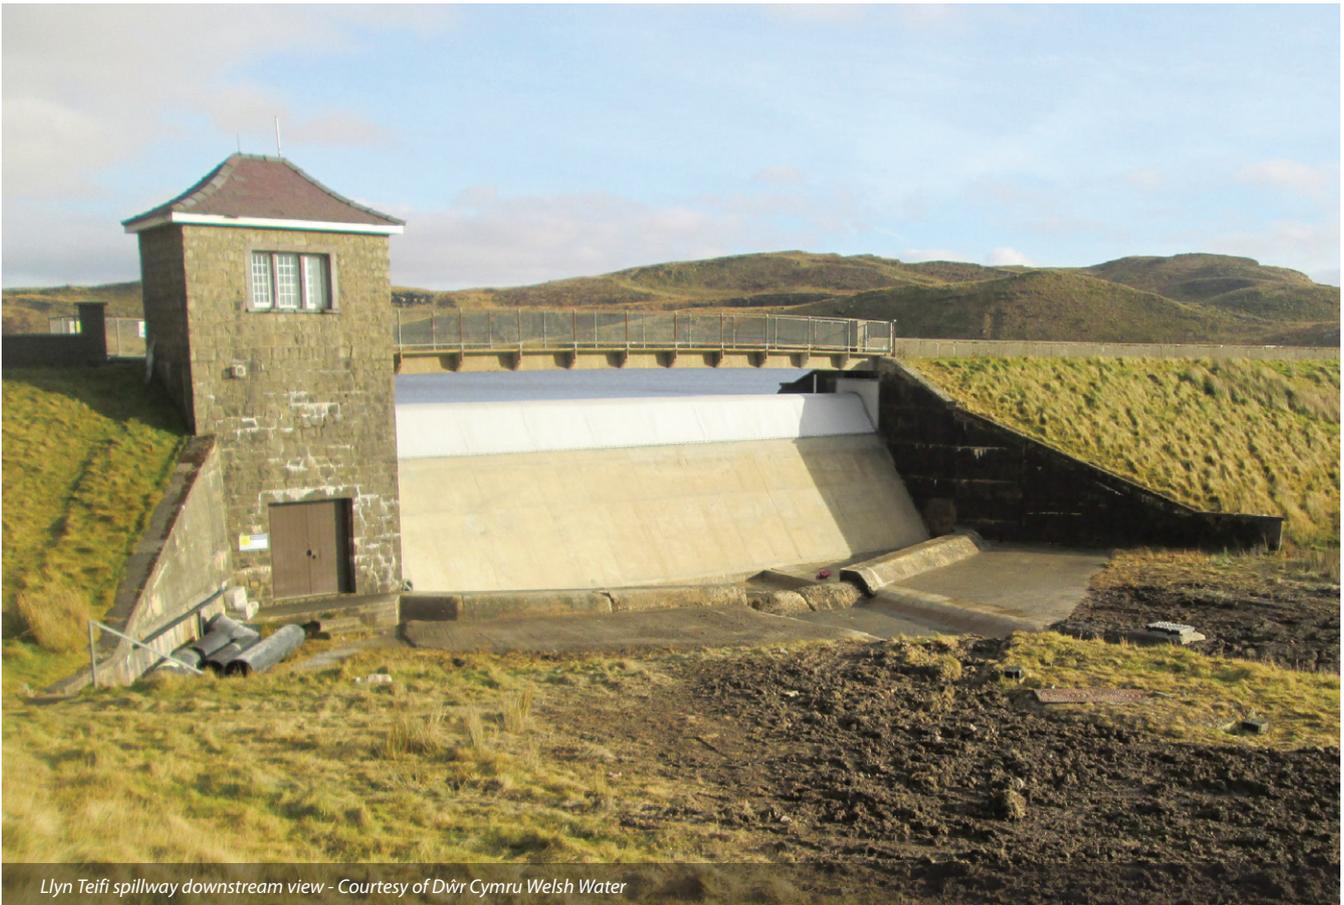
Llyn Teifi spillway downstream view - Courtesy of Dŵr Cymru Welsh Water

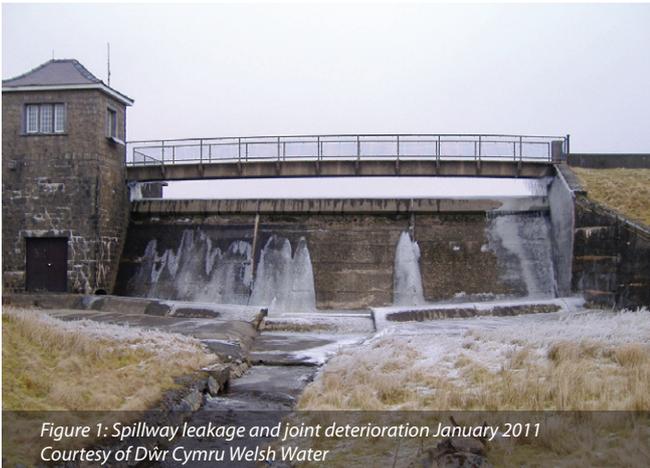
Figure 1: Spillway leakage and joint deterioration January 2011
Courtesy of Dŵr Cymru Welsh Water

situation over the years. In 1984, the reservoir had been drained to allow refurbishment of both the upstream and downstream joint faces. However, by 2004, when Black & Veatch carried out an inspection, it was reported that *'when water levels are high, the top two horizontal construction joints (about 400mm and 700mm below the underside of the recent crest raising structure) each show evidence of a direct seepage path, with spouts of water emerging during heavy wave action. Even with the water level 1.15m down during this inspection there was evidence of seepage from both of these joints'*.

Figure 1 is a photograph from January 2011 with ice coverage on the downstream spillway face identifying seepage locations; Figure 2 is from February 2016 and clearly shows evidence of both the continued seepage and joint deterioration particularly at the connection of the raised overflow section with the abutments.

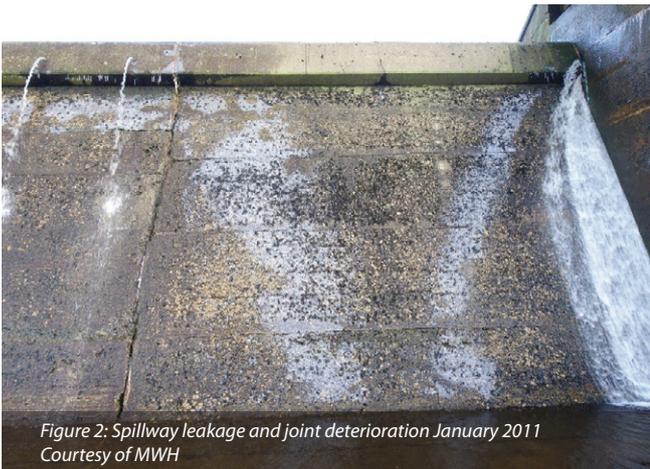
Figure 2: Spillway leakage and joint deterioration January 2011
Courtesy of MWH

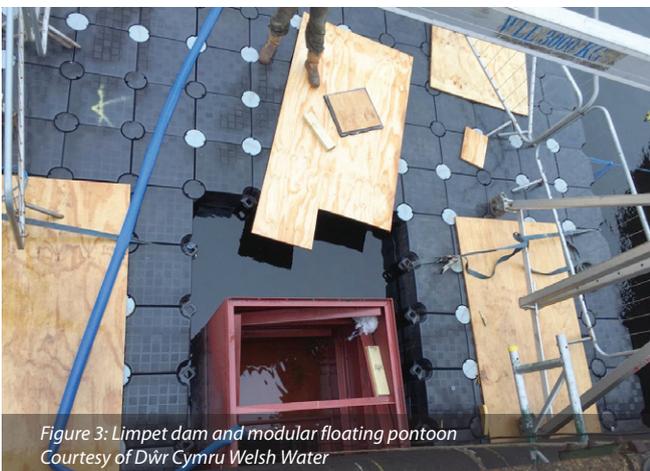
Figure 3: Limpet dam and modular floating pontoon
Courtesy of Dŵr Cymru Welsh Water

Kaymac's first task was to core drill a 175mm diameter hole through the base of the existing spillway structure, install and grout in the gravity drainage pipes for each of the three liner compartments. To facilitate this Kaymac designed and fitted a limpet dam to the upstream face of the spillway using a floating modular pontoon, thereby allowing all works to be undertaken in the dry (see Figure 3 taken from the bridge over the spillway).

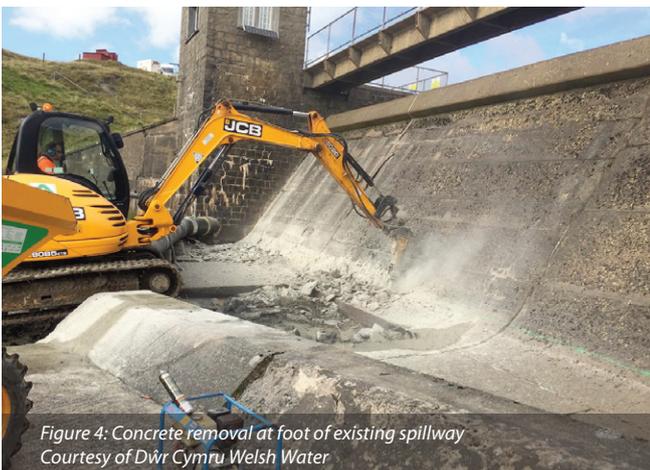
Figure 4: Concrete removal at foot of existing spillway
Courtesy of Dŵr Cymru Welsh Water

After breaking out of some existing concrete at the foot of the spillway (Figure 4) and placement of reinforcement (Figure 7) a proprietary formwork system designed by RMD Kwikform (Figure 8) was used for construction of the concrete wedge. This allowed the works to be completed in three vertical lifts using a concrete pump situated on ground to the north of the reservoir some 40m away. Carpi Tech, with divers from their partner, Lucatelli Diving of Trieste, commenced installation of the waterproofing liner on 1 November 2016. Figures 9 and 10 shows the installation works in progress.

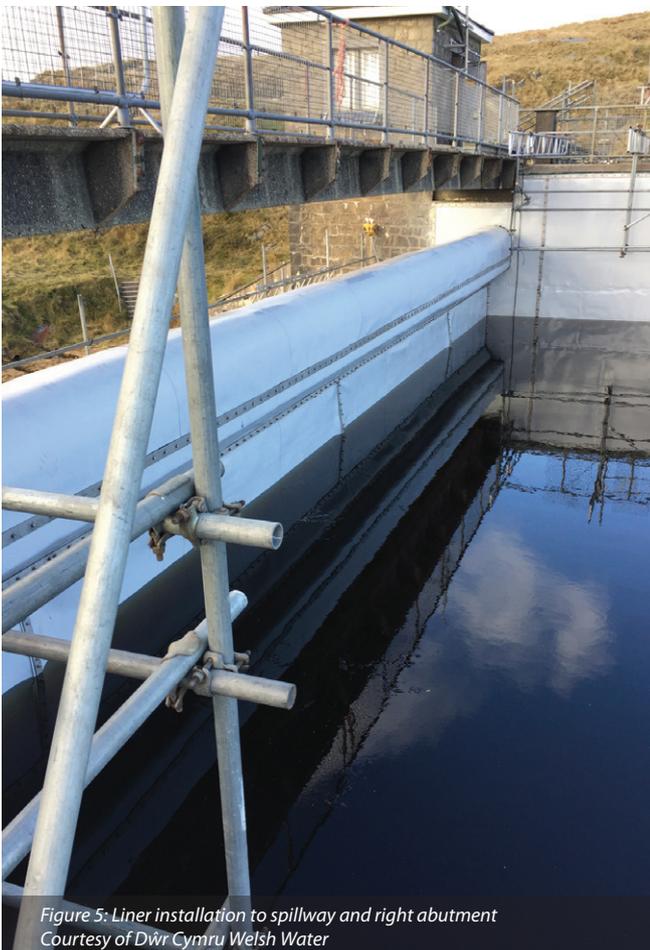
Figure 5: Liner installation to spillway and right abutment
Courtesy of Dŵr Cymru Welsh Water

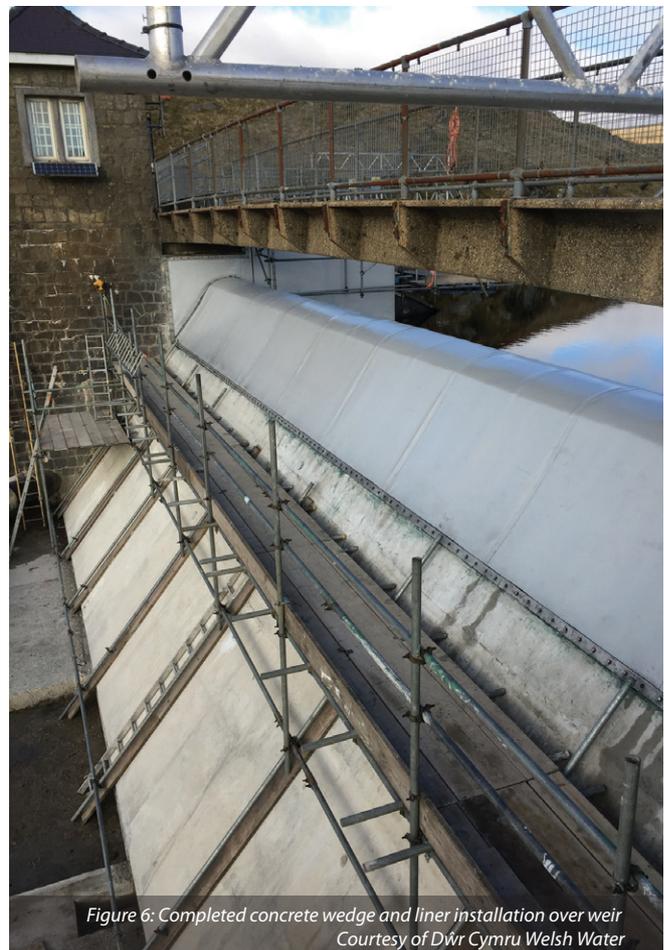
Figure 6: Completed concrete wedge and liner installation over weir
Courtesy of Dŵr Cymru Welsh Water

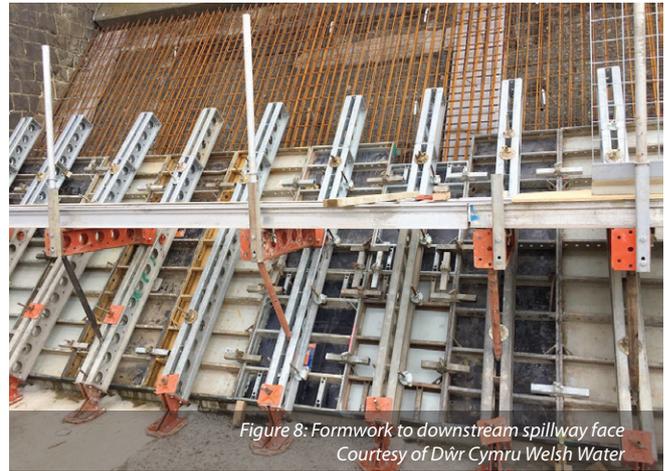
Figure 8: Formwork to downstream spillway face
Courtesy of Dŵr Cymru Welsh Water

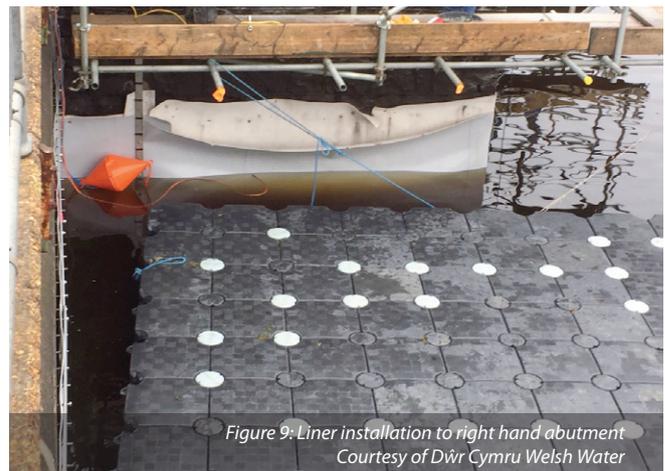
Figure 9: Liner installation to right hand abutment
Courtesy of Dŵr Cymru Welsh Water

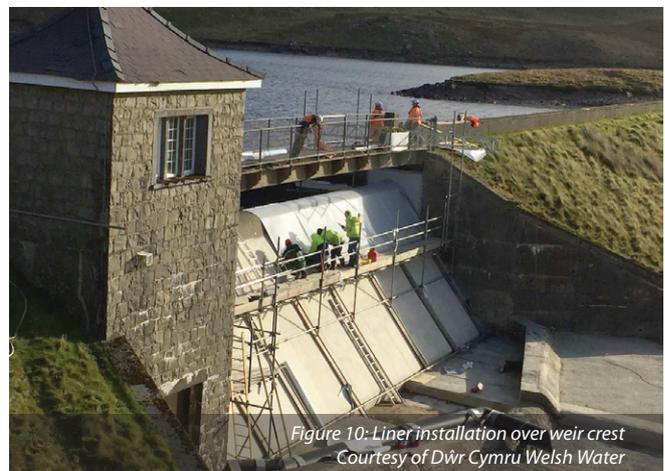
Figure 10: Liner installation over weir crest
Courtesy of Dŵr Cymru Welsh Water

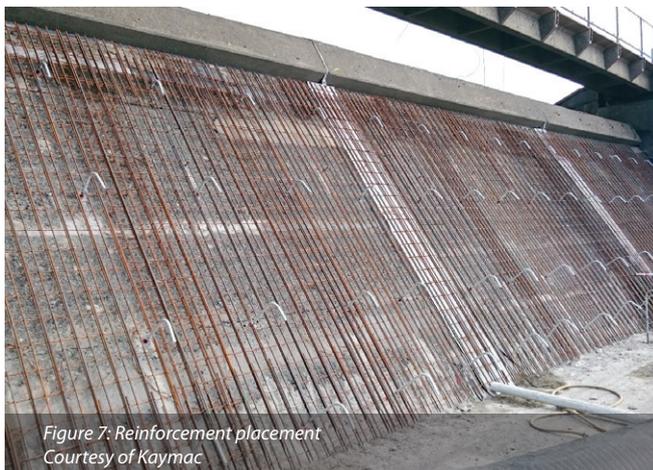
Figure 7: Reinforcement placement
Courtesy of Kaymac

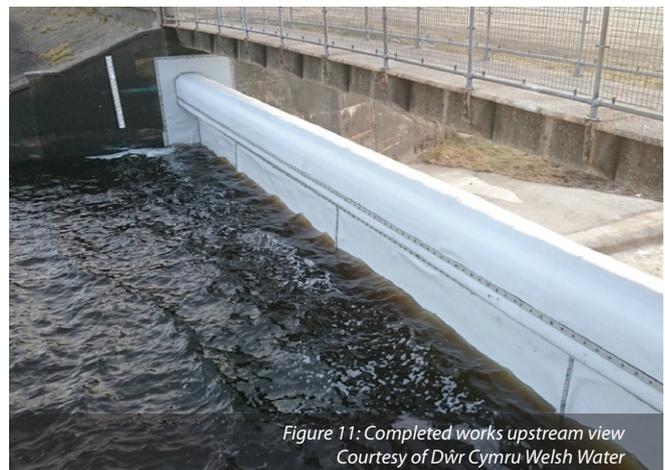
Figure 11: Completed works upstream view
Courtesy of Dŵr Cymru Welsh Water

All construction was successfully completed before Christmas 2016 and Figure 11 shows the upstream view of the completed works.
