# New Malden Trunk Mains Project

## rehabilitation of aging large diameter trunk mains along the New Malden pipe-track to prevent future pipe failures

by Kikuo Matsushima MSc CEng MCIWEM MICE

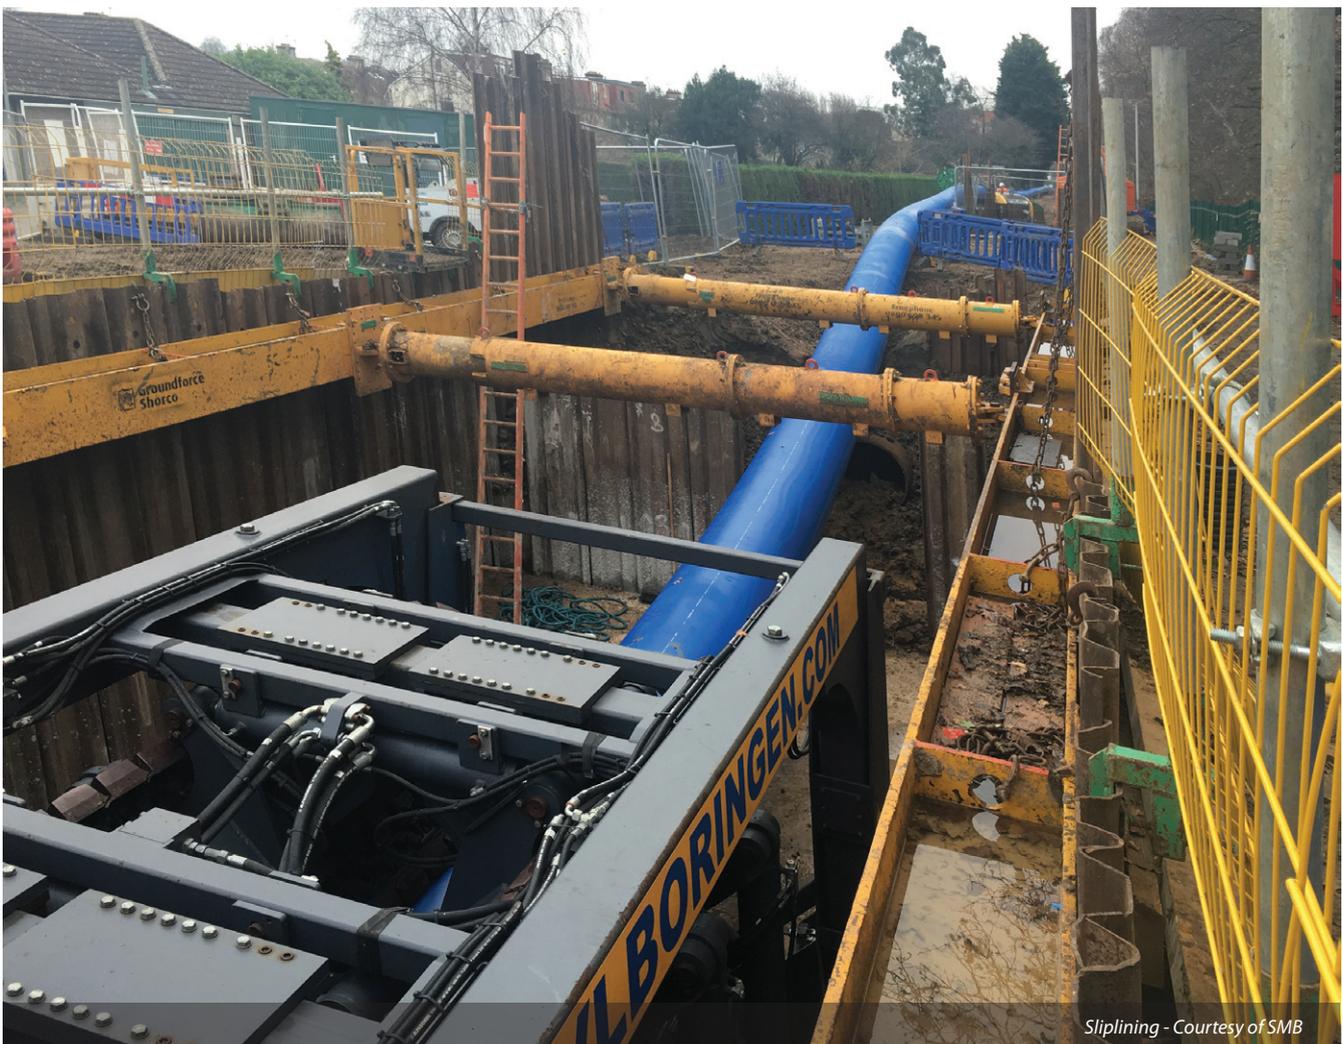
*Sliplining - Courtesy of SMB*

The pipeline rehabilitation method was sliplining a fully structural PE liner into the host mains. The selected PE liner was a 710mm OD PE100 SDR11 pipe for the existing 30" CI mains and a 1000mm OD PE100 SDR13.6 pipes for the 48" CI main.

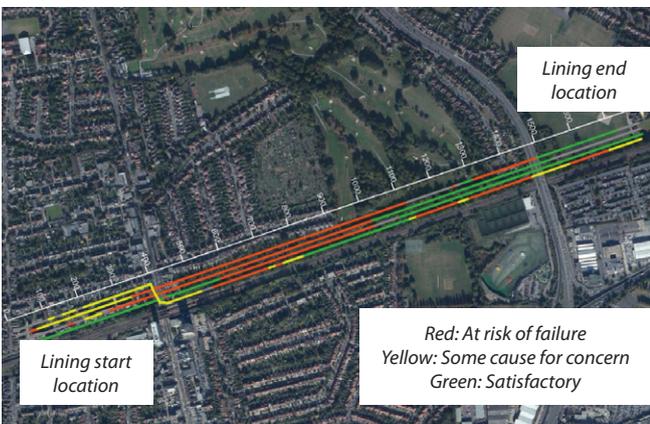
Fig 1: Graphical image of pipe condition assessment results - Courtesy SMB

The results of the pipe condition assessment are shown in diagrammatic form in Figure 1 (previous page), which summarises the outputs by using a colour coded scale along the length of the pipelines. The colours depict the condition rating along the pipelines categorised by:

- Red: At risk of failure.
- Yellow: Some cause for concern.
- Green: Satisfactory.

The scope of the pipeline rehabilitation was defined by using the results of this assessment.

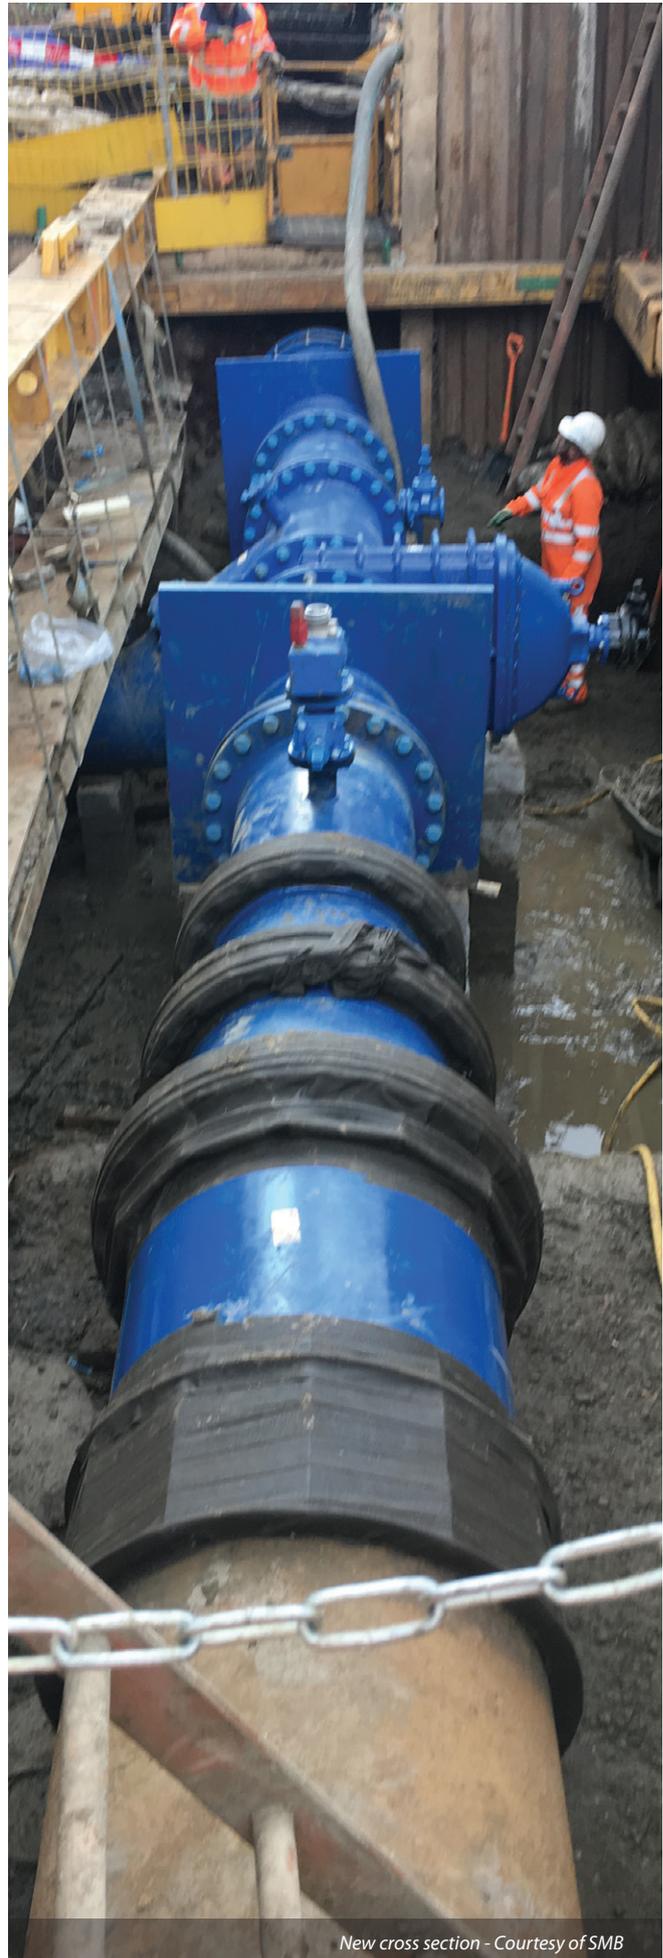
The existing mains along the pipe-track are buried at very shallow pipe cover depths in some sections. It was proposed to raise the existing ground surface levels to achieve a minimum of 600mm pipe cover depth at these locations.

The additional 300mm pavement thickness will ensure a minimum of 900mm pipe cover depth is maintained when the new cycleway is built over the pipe-track. This will ensure the existing mains (including the pipeline sections which are not to be rehabilitated

*New cross section - Courtesy of SMB*

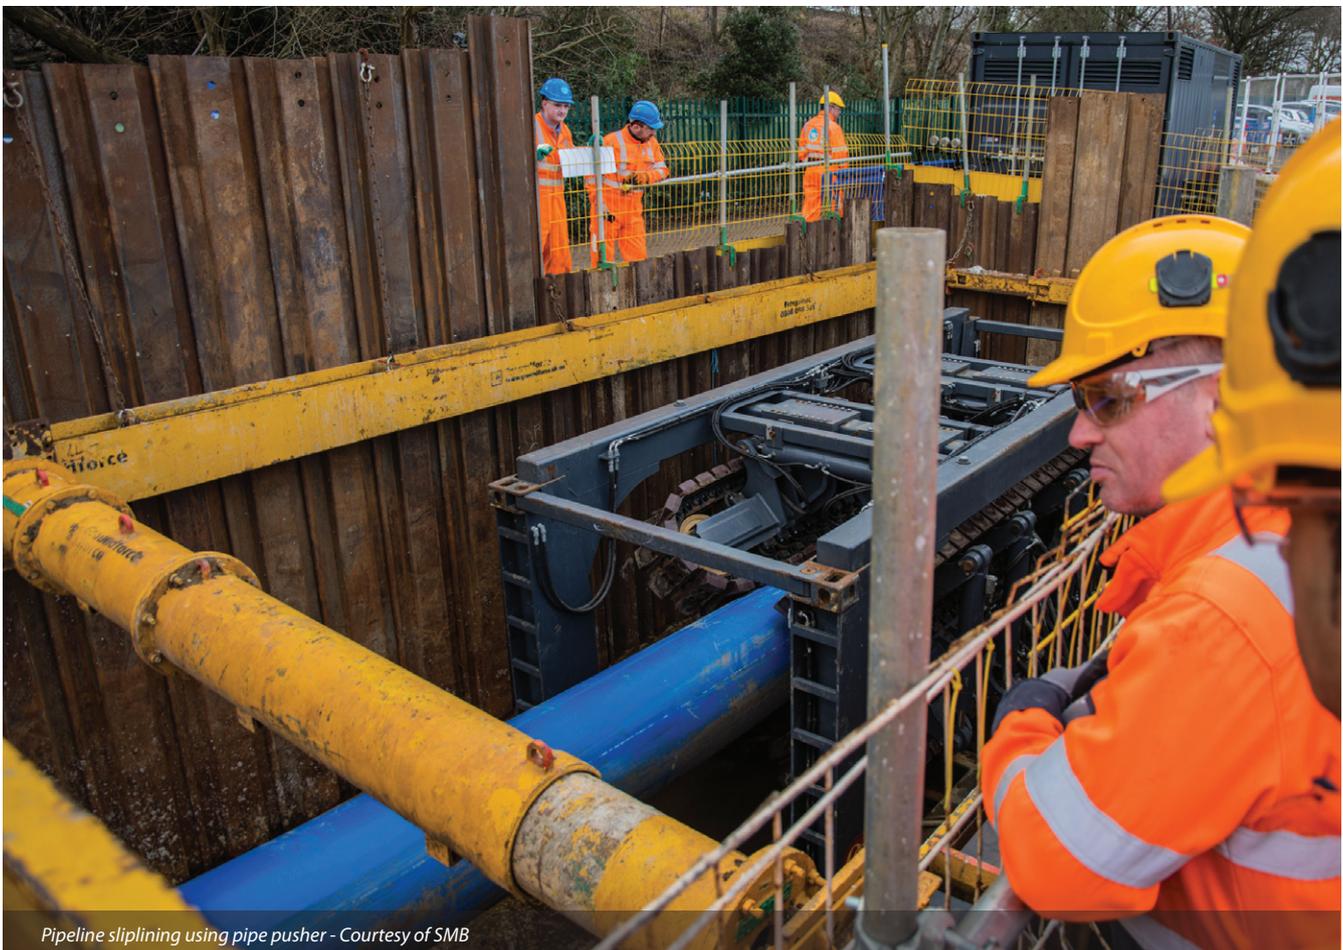
For the sliplining works, a pipe pusher, capable of pushing 130 tonnes, was used to slipline 2 (No.) mains (both 30" and 48" mains). 1200m of 710mm OD PE liner and 1140m of 1000mm OD PE liner were installed with a single pipe push operation.

Pipeline sliplining using pipe pusher - Courtesy of SMB
