Cotherstone Pipe Bridge & Mains Refurbishment

the Balder Pipe Bridge Project will return production and supply resilience to the Teesside and Teesdale network

by Gary Cassells MAPM

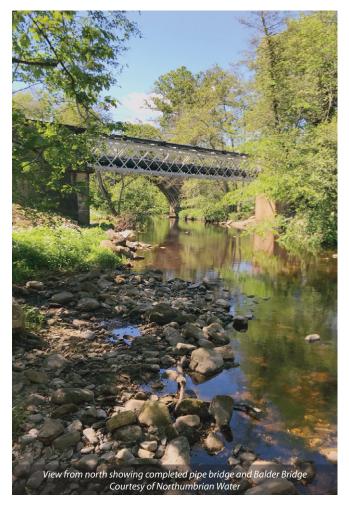
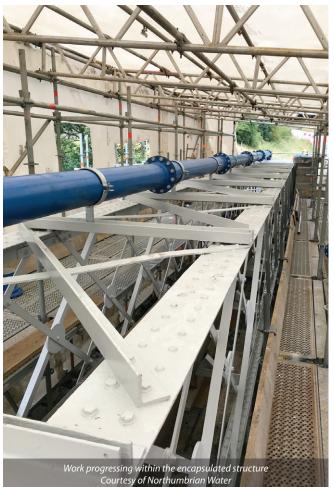
Although the bridge showed signs that it required maintenance at the time it did not show any signs of failure that would put any of the three mains at risk. Specific attention was given to the supports and strapping of the main in the location of the northern 45° bend and it was noted that it was secure.

In 2015 the 24" main failed close to the 45° bend; in affect it had lifted off its supports opening up the socket and spigot joint near to the 45° restraint. The restraint itself had not actually failed. It was immediately taken out of commission under emergency conditions and the resulting leak stopped. Although the two distribution mains were unaffected, the loss of the 24" line decreased the supply of raw water into Lartington WTW. The resulting shortfall in treated water output from the works had to be subsidised by providing 11 MLd from Broken Scar WTW in Darlington. This arrangement was deemed to be temporarily sustainable but the business made a decision that this was not the long term solution and the 24" water main would have to be repaired and brought back online. In 2017 an investigate and define study was launched to provide options.
