Aubrey Street Reservoir

taking the heat out of UU reservoir project

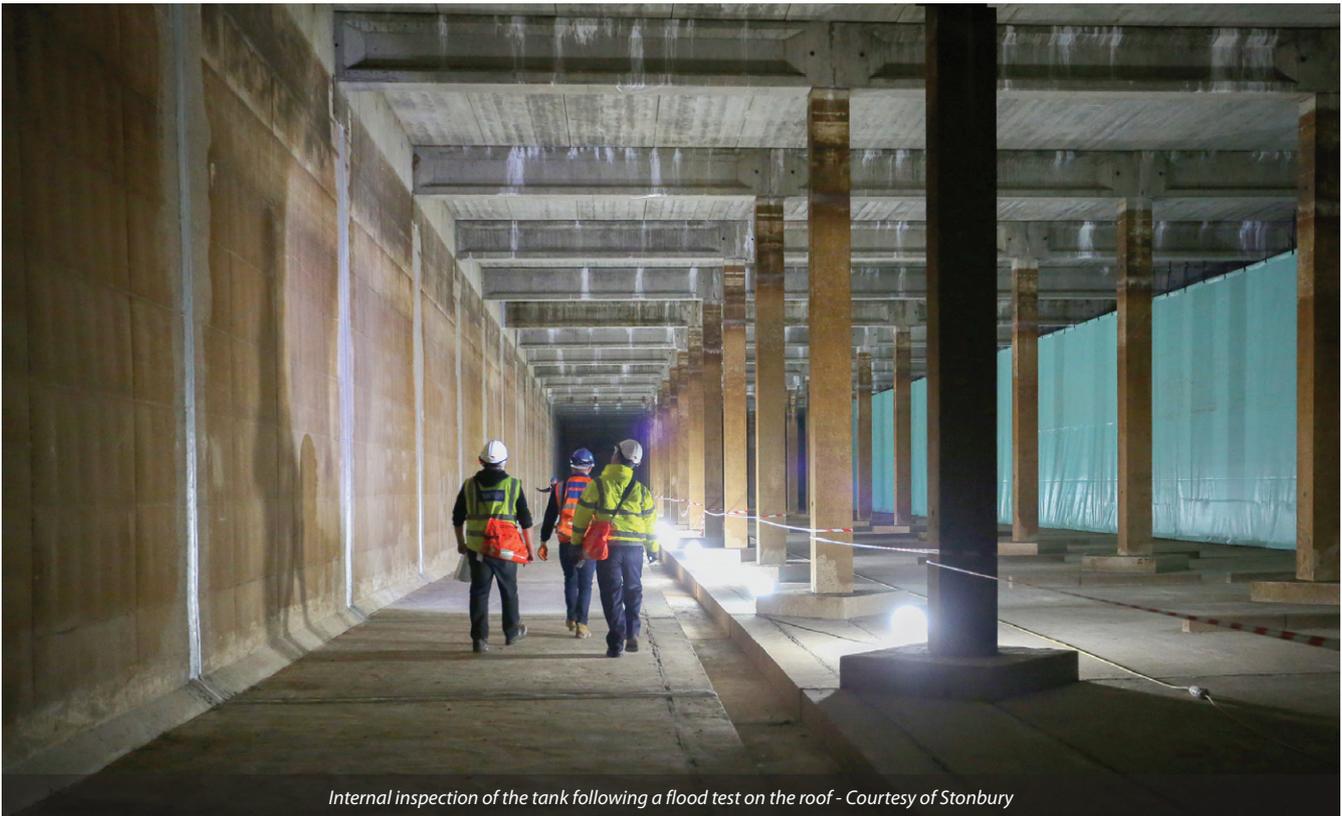
Internal inspection of the tank following a flood test on the roof - Courtesy of Stonbury

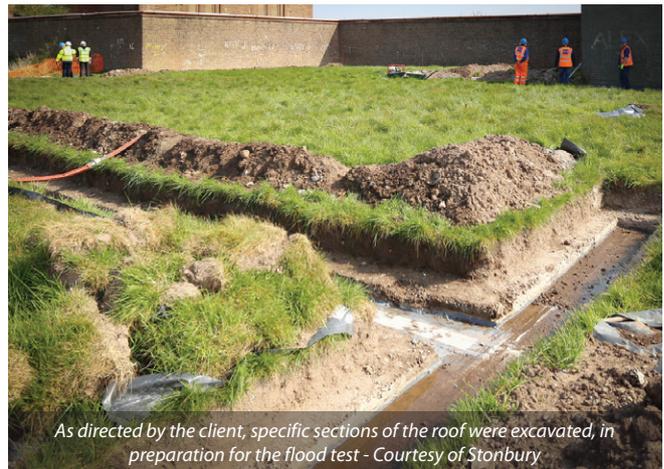
As directed by the client, specific sections of the roof were excavated, in preparation for the flood test - Courtesy of Stonbury

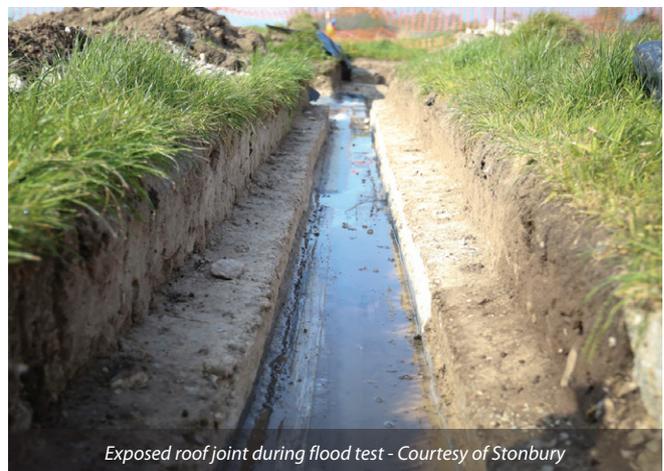
External works to seal the roof were prioritised to be delivered first, to prevent rainwater from entering the roof structure. The ingress was caused by the deterioration of the joint sealant between the concrete panels, a common problem in tanks of this age.

Exposed roof joint during flood test - Courtesy of Stonbury

The concrete roof panels were prepared first, using grinders, before being thoroughly cleaned. MasterSeal 933 was applied with brushes before the 300mm-width overbanding was rolled out along the 27 roof joints in each tank.

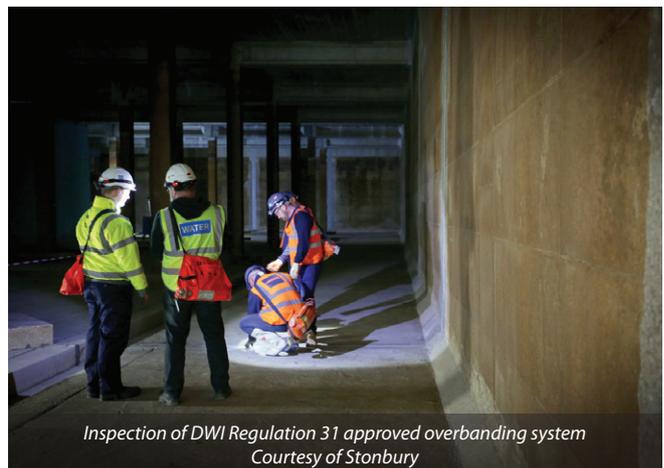
*Inspection of DWI Regulation 31 approved overbanding system
Courtesy of Stonbury*

Some 800 linear meters (40 rolls) of BASF MasterSeal 930 overbandage were used in each of the two compartments, fixed to the adhesive-coated walls. Lengths were run down each wall joint and two meters onto the floor to ensure the tanks were completely watertight.
