Tunstall Reservoir

design & construction of the repairs to the lower part of the spillway, abandoned siphon recommissioning and the infill of a tunnel

by Borja Aguilar CEng MICE

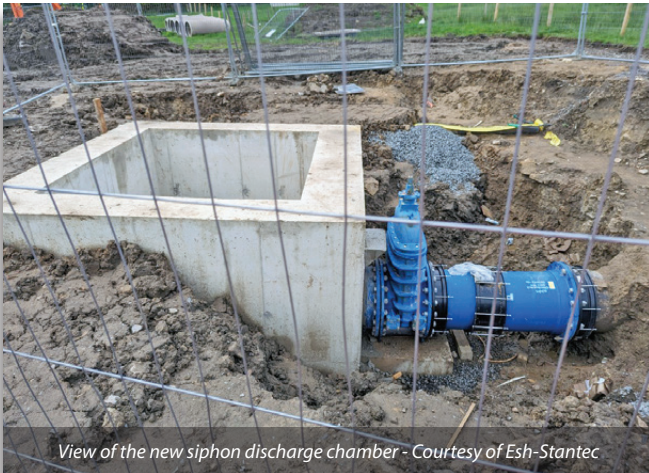
View of the new siphon discharge chamber - Courtesy of Esh-Stantec

- a. A siphon discharge chamber to break the siphonic effect. This was decided given the uncertainty about the existing

system and the significant difference in levels in the downstream leg. Thus, the water would flow by gravity between the chamber and the outfall. This discharge chamber also functions as a thrust block to restrain the thrust acting on the new gate valve that has been installed immediately upstream of the chamber.

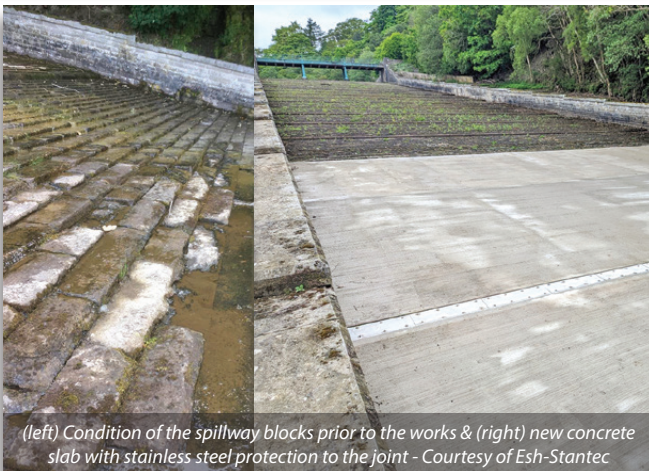
The original Victorian spillway structure is formed by sandstone blocks bedded in concrete. However, the Inspecting Engineer identified that the majority of the blocks in the lower part of the

spillway presented signs of wear and tear and needed replacement. The proposed solution consists of four new reinforced concrete slabs that have been placed over the existing spillway, except the most upstream slab where blocks had to be removed to tie-in with the existing structure and avoid a step. An expansion joint was necessary in the centre of the new slabs. The flexible sealant in this joint has been covered by a stainless steel plate that has been designed to protect the sealant from the predicted high velocities expected in the flows and reduce the maintenance requirements.

(left) Condition of the spillway blocks prior to the works & (right) new concrete slab with stainless steel protection to the joint - Courtesy of Esh-Stantec

A number of groundwater relief drains have also been incorporated into the design in order to capture the emerging groundwater at the lower part of the spillway and both reduce the hydraulic load on the new slabs and improve the long-term reliability of both the new concrete and the remaining sandstone blocks. These discharge to a new headwall in the bank downstream of the end of the spillway.

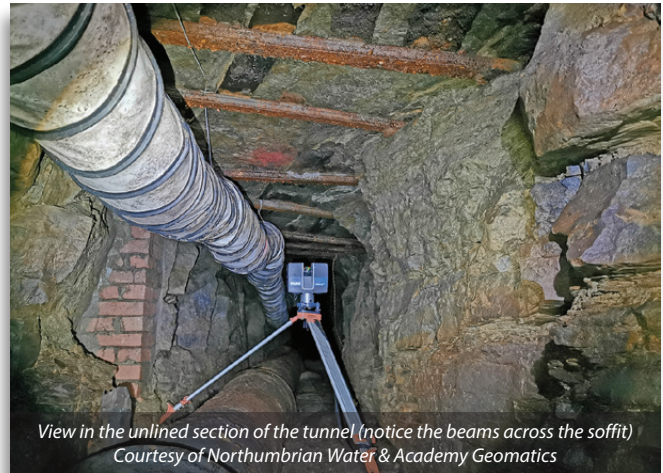
When the dam embankment at Tunstall was completed and the filling of the reservoir began, significant leakage was observed through the eastern abutment. A concrete cut-off wall extending into the hillside was constructed in 1879 which significantly reduced the leakage rate. Nevertheless, as some leakage continued, a tunnel and shaft were constructed downstream of the cut-off wall, and an 18-inch cast iron diameter pipe was installed inside the tunnel to capture the leakage and convey it to the treatment works.

*View in the unlined section of the tunnel (notice the beams across the soffit)
Courtesy of Northumbrian Water & Academy Geomatics*

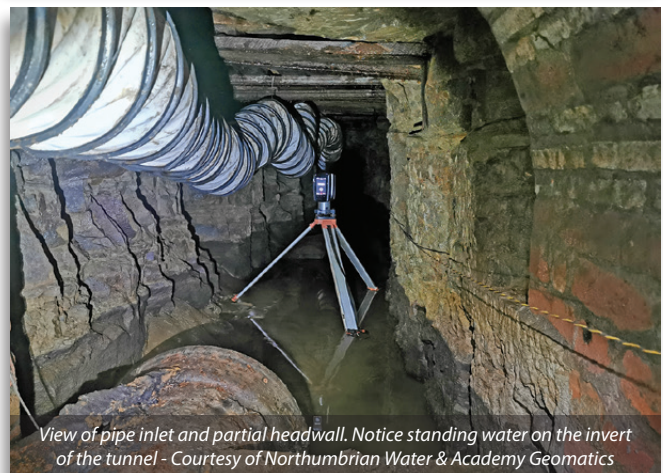
View of pipe inlet and partial headwall. Notice standing water on the invert of the tunnel - Courtesy of Northumbrian Water & Academy Geomatics

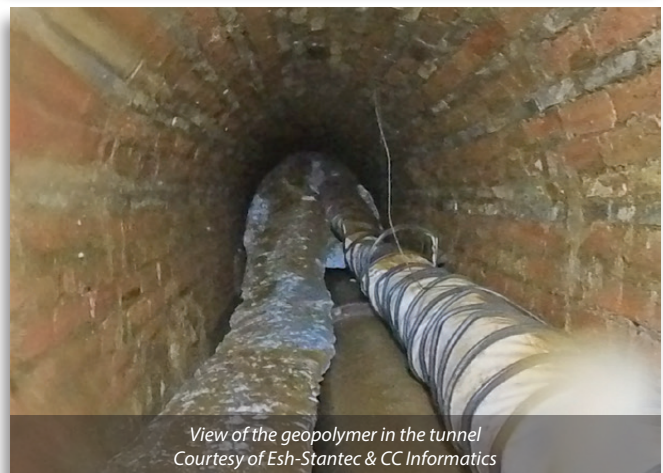
*View of the geopolymer in the tunnel
Courtesy of Esh-Stantec & CC Informatics*

The filling was undertaken via a number of injection holes that were drilled from the surface at 10 metre intervals, and expanding geopolymer was injected via these injection points. The progress on site was as follows:

- Once the project team was satisfied that the drilling had not cause any damage to the pipe, the injection began, advancing at 10 metres per day on average.

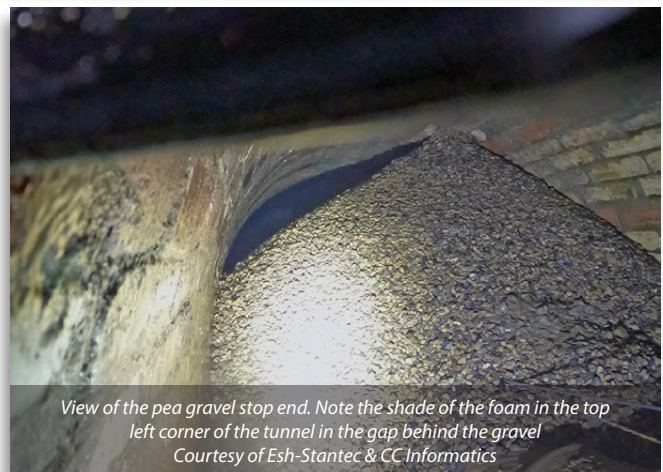
*View of the pea gravel stop end. Note the shade of the foam in the top left corner of the tunnel in the gap behind the gravel
Courtesy of Esh-Stantec & CC Informatics*

- Pea gravel was introduced through the final injection point in order to create a mound that would stop the advance of the geopolymer and prevent it from blocking the pipe. The use of the gravel mound avoided the need to carry out works inside the tunnel with the associated risks of working in the confined space.
