Longman WwPS

the restoration of operational assets at to improve system reliability and ensure regulatory compliance

by Eryn Skinner & Struan Ross

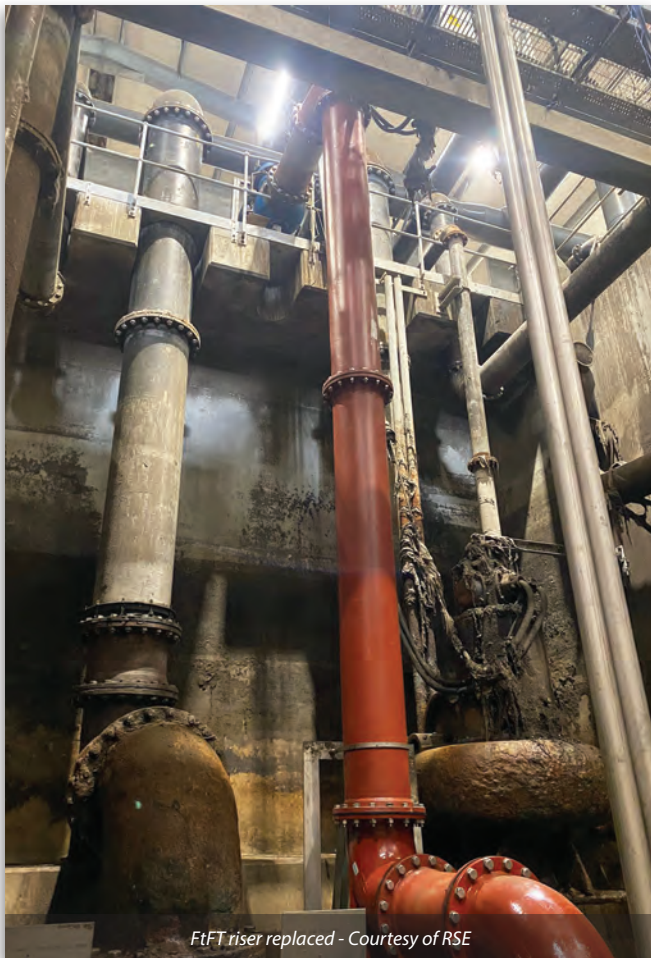
FtFT riser replaced - Courtesy of RSE

The new FtFT pump riser and associated pipework were installed by a joint effort from the RSE mechanical team and Stoddart Crane Hire. The new riser was designed to withstand the harsh environmental conditions and excessive seawater flow that had previously led to corrosion in the old riser. By selecting corrosion-resistant materials and ensuring precision in installation, the project team successfully restored the system's operational integrity. New pump guide rails and brackets were installed before FtFT Pump 902 was reinstalled into the west wet well.

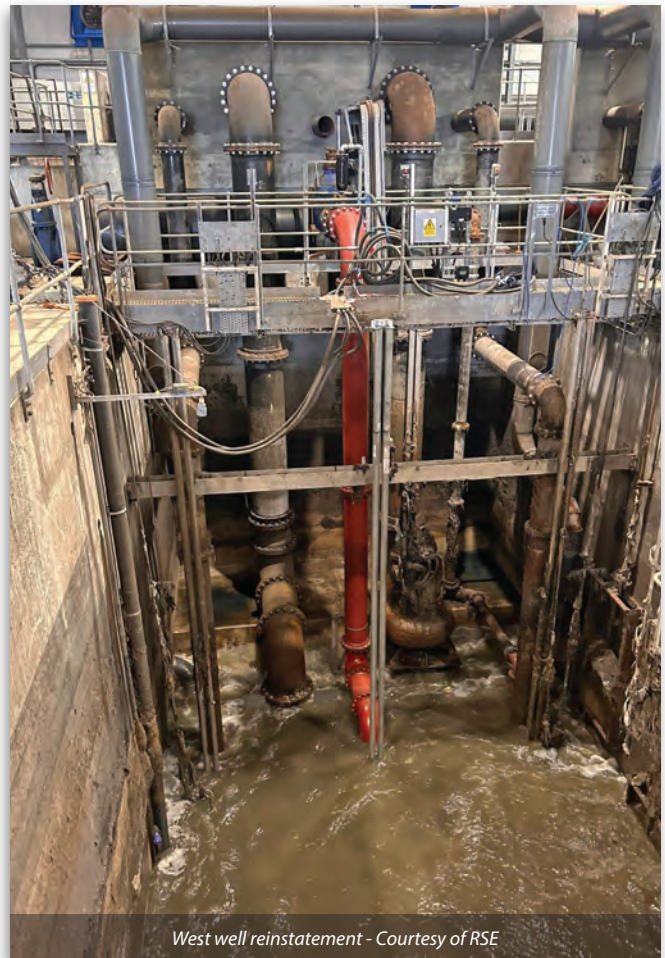
West well reinstatement - Courtesy of RSE

Once the pipework, pump guide rail and all relevant fittings were installed, the flows to the west wet well were reinstated and the pipework was checked to ensure no leakages were occurring.

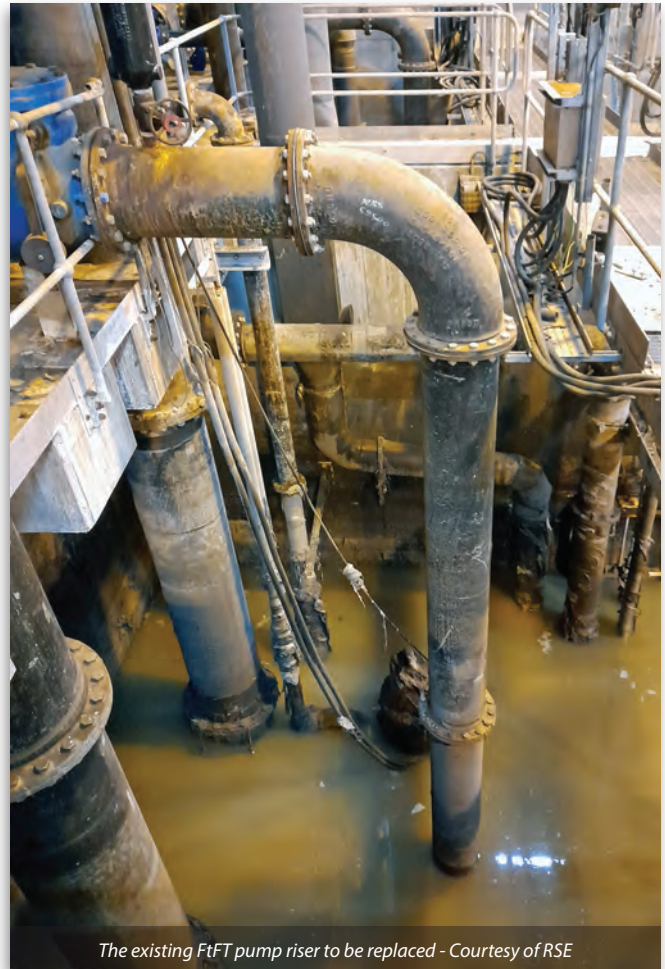
Following a corrosion-related defect of a standby flow to full treatment (FtFT) pump riser, the west wet well chamber at Longman WwPS was left vulnerable to failure. This posed a critical risk to the station's operation for pumping wastewater to Allandale and required action to restore the well's full functionality and ensure system reliability.

The immediate driver for the project was the discovery of significant corrosion within the FtFT pump riser, which was compounded by excessive seawater flow through the system. The corrosion weakened the riser structure, creating a potential failure point that could have left the standby chamber non-operational. Since the

The existing FtFT pump riser to be replaced - Courtesy of RSE

FtFT pump riser removal & replacement: The corroded FtFT pump riser was dismantled by the RSE mechanical team. Stoddart Crane Hire provided the necessary crane services under a contract lift to remove the pipework out of the wet well.

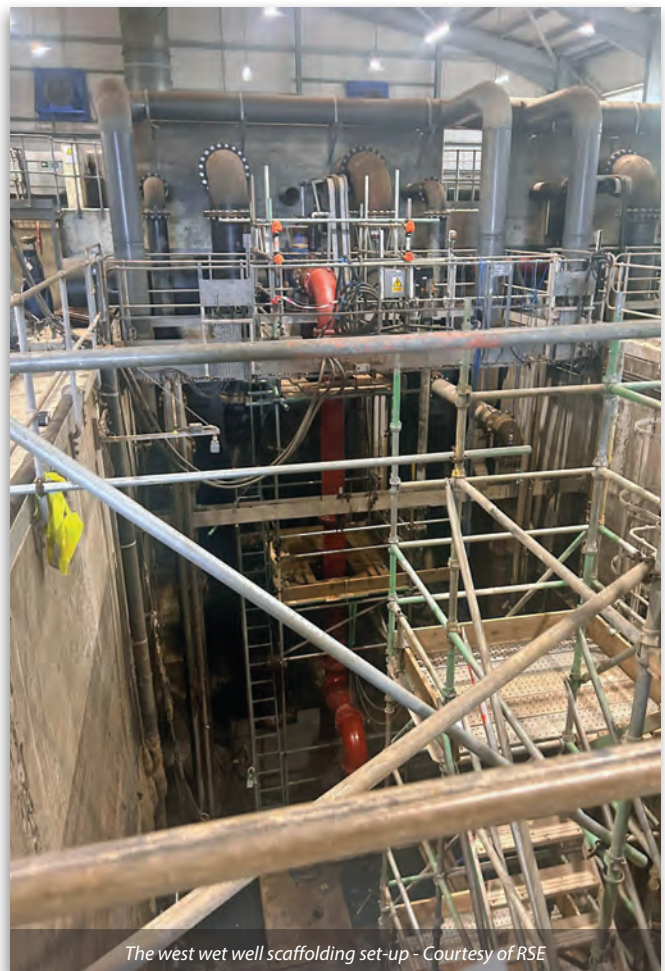
The west wet well scaffolding set-up - Courtesy of RSE

Scaffolding installation: To facilitate the removal and replacement of the pump riser, Global Energy Services were subcontracted to install scaffolding. The scaffolding ensured that workers and equipment could access the site securely, particularly for the crane lift operation. Stair access scaffolding was installed as well as scaffolding access around the riser flanges.

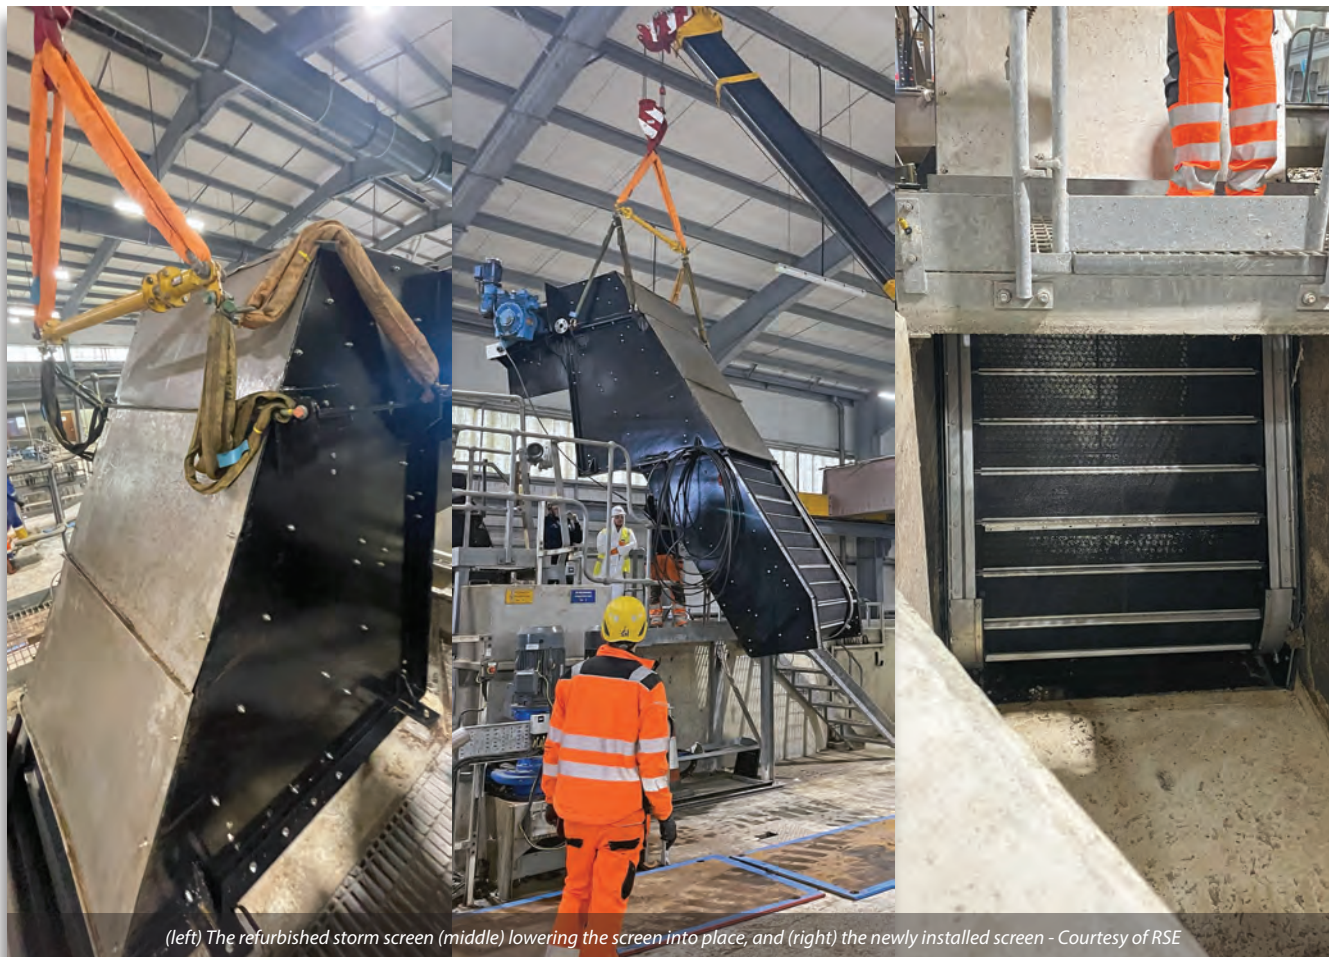
The storm fine screen was heavily corroded and required extensive refurbishment. RSE's mechanical and electrical teams disconnected the screen and transported it to the Muir of Ord workshop for overhaul. The refurbishment involved:

2. **Corrosion & structural integrity:** The existing screen frame and mechanical components were severely corroded, which increased the complexity of the removal and reinstallation process.

(left) The refurbished storm screen (middle) lowering the screen into place, and (right) the newly installed screen - Courtesy of RSE

- Inspection of reusable components not included in OEM refurbishments kit.
- Fabrication of replacement parts for any reusable components unfit for service.
- Reassembly of storm screen.
- Function testing to verify operational performance.

Once the refurbishment was complete, the screen was transported back to the site and reinstalled. RSE's commissioning team conducted a thorough testing and validation process to confirm that the screen was operating within the specified performance parameters. The work was completed without any significant disruption to the station's overall operation.

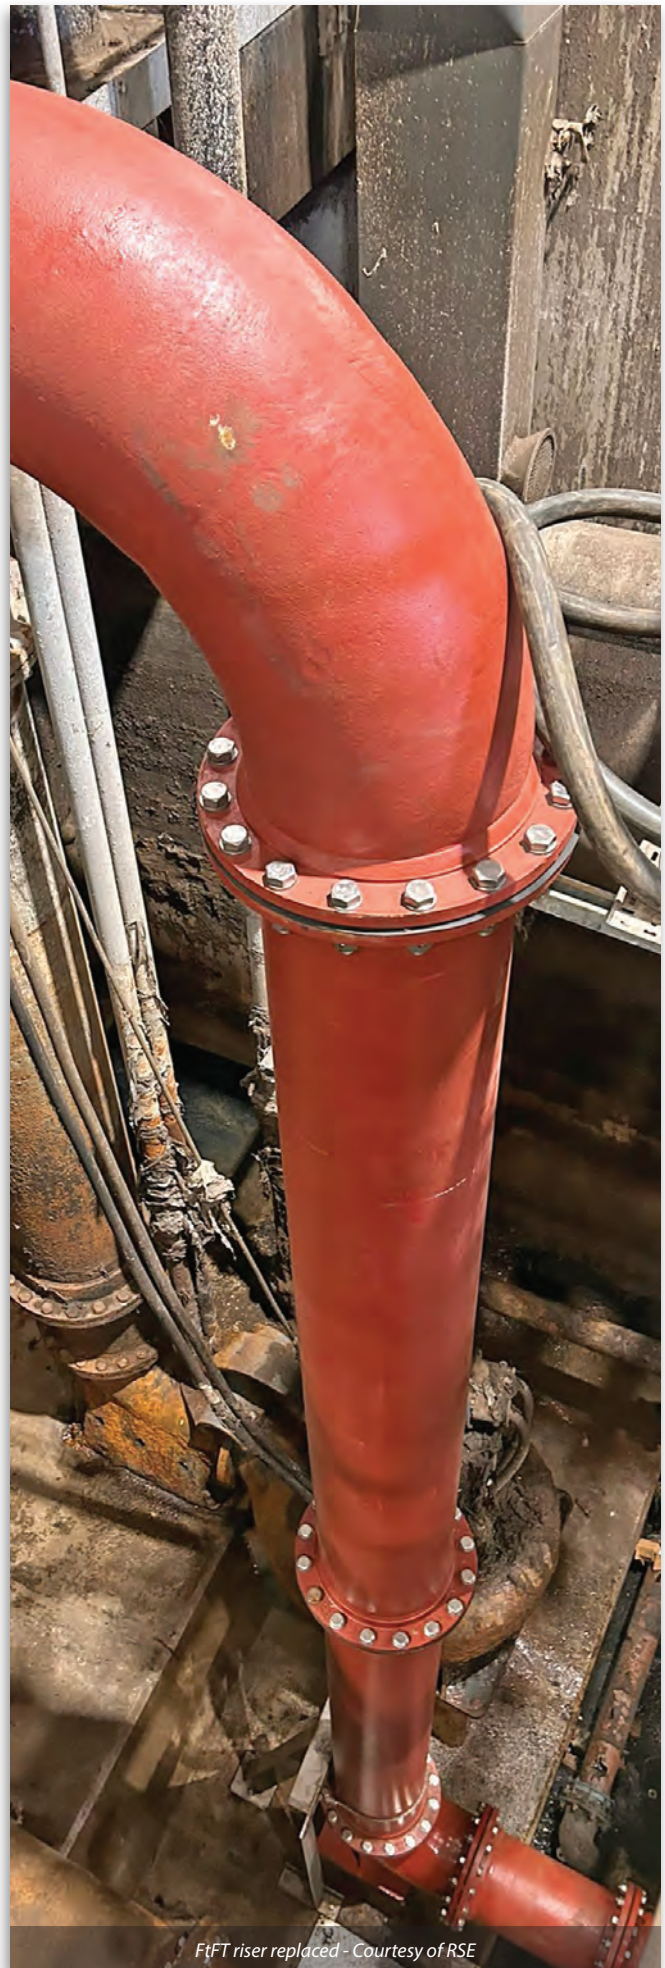
FtFT riser replaced - Courtesy of RSE
