Wortley East - Rotating Biological Contactor

ingenious solution saved six weeks, cut risks, and costs

by Phillip S Worrall

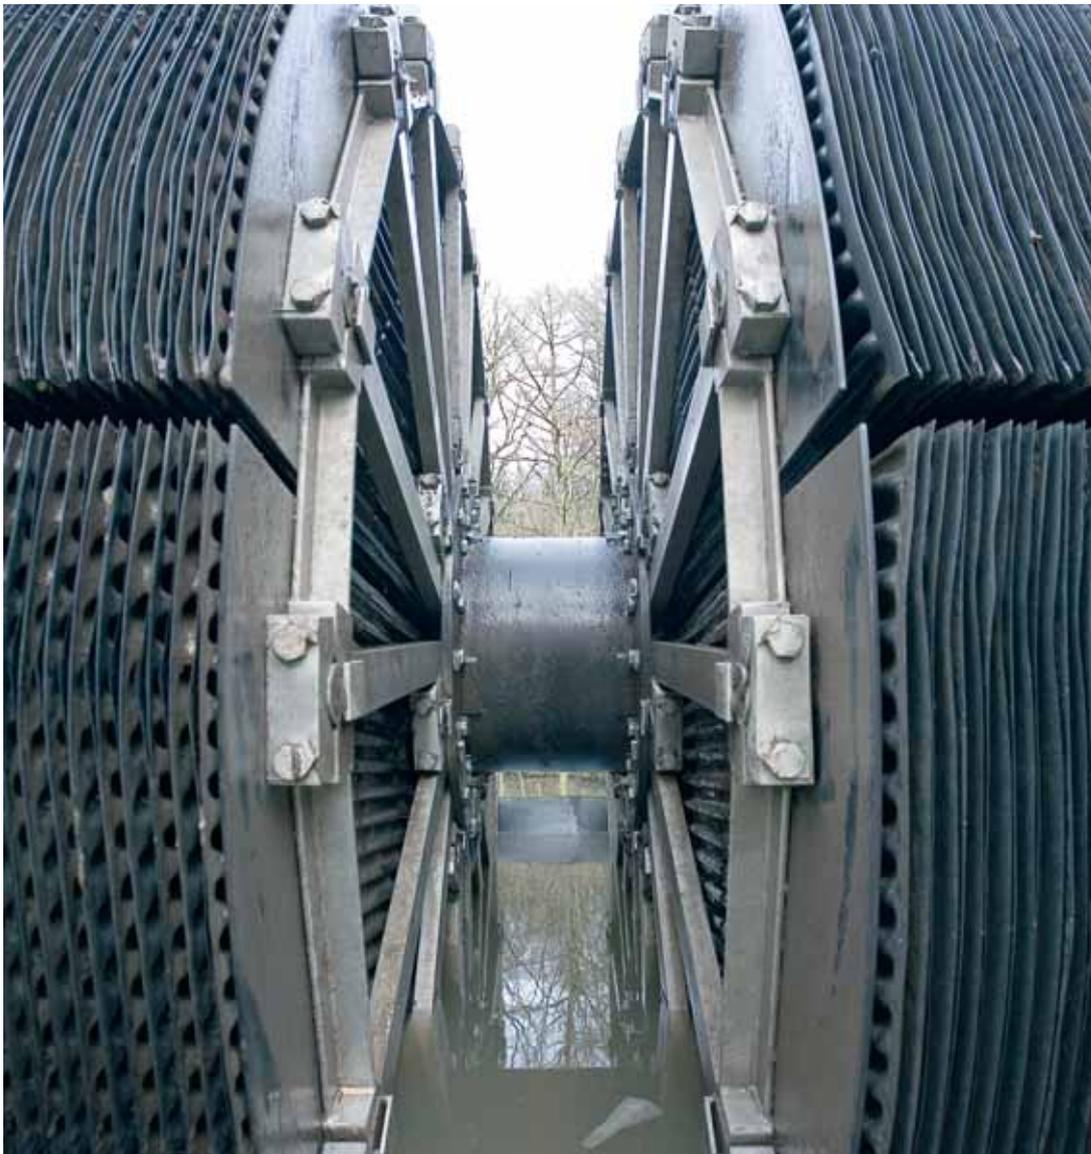
Wortley East: Rotating Biological Contactor in temporary tank preparing for installation

Watermark devised a solution to reduce this overall commissioning time to less than half that described. Rather than providing a temporary plant, a low cost, fabricated steel trough was produced to support the new RBC rotor and provide a temporary biozone on site, adjacent to the existing plant. The influent was then pumped from the existing primary zone into and through the temporary biozone trough with new RBC rotor and returned to the existing RBC rotor for treatment.

Following the successful seeding of the new RBC rotor (circa 6 weeks), the old rotor was then simply isolated (influent taken away by tanker for several hours) and removed by crane. The

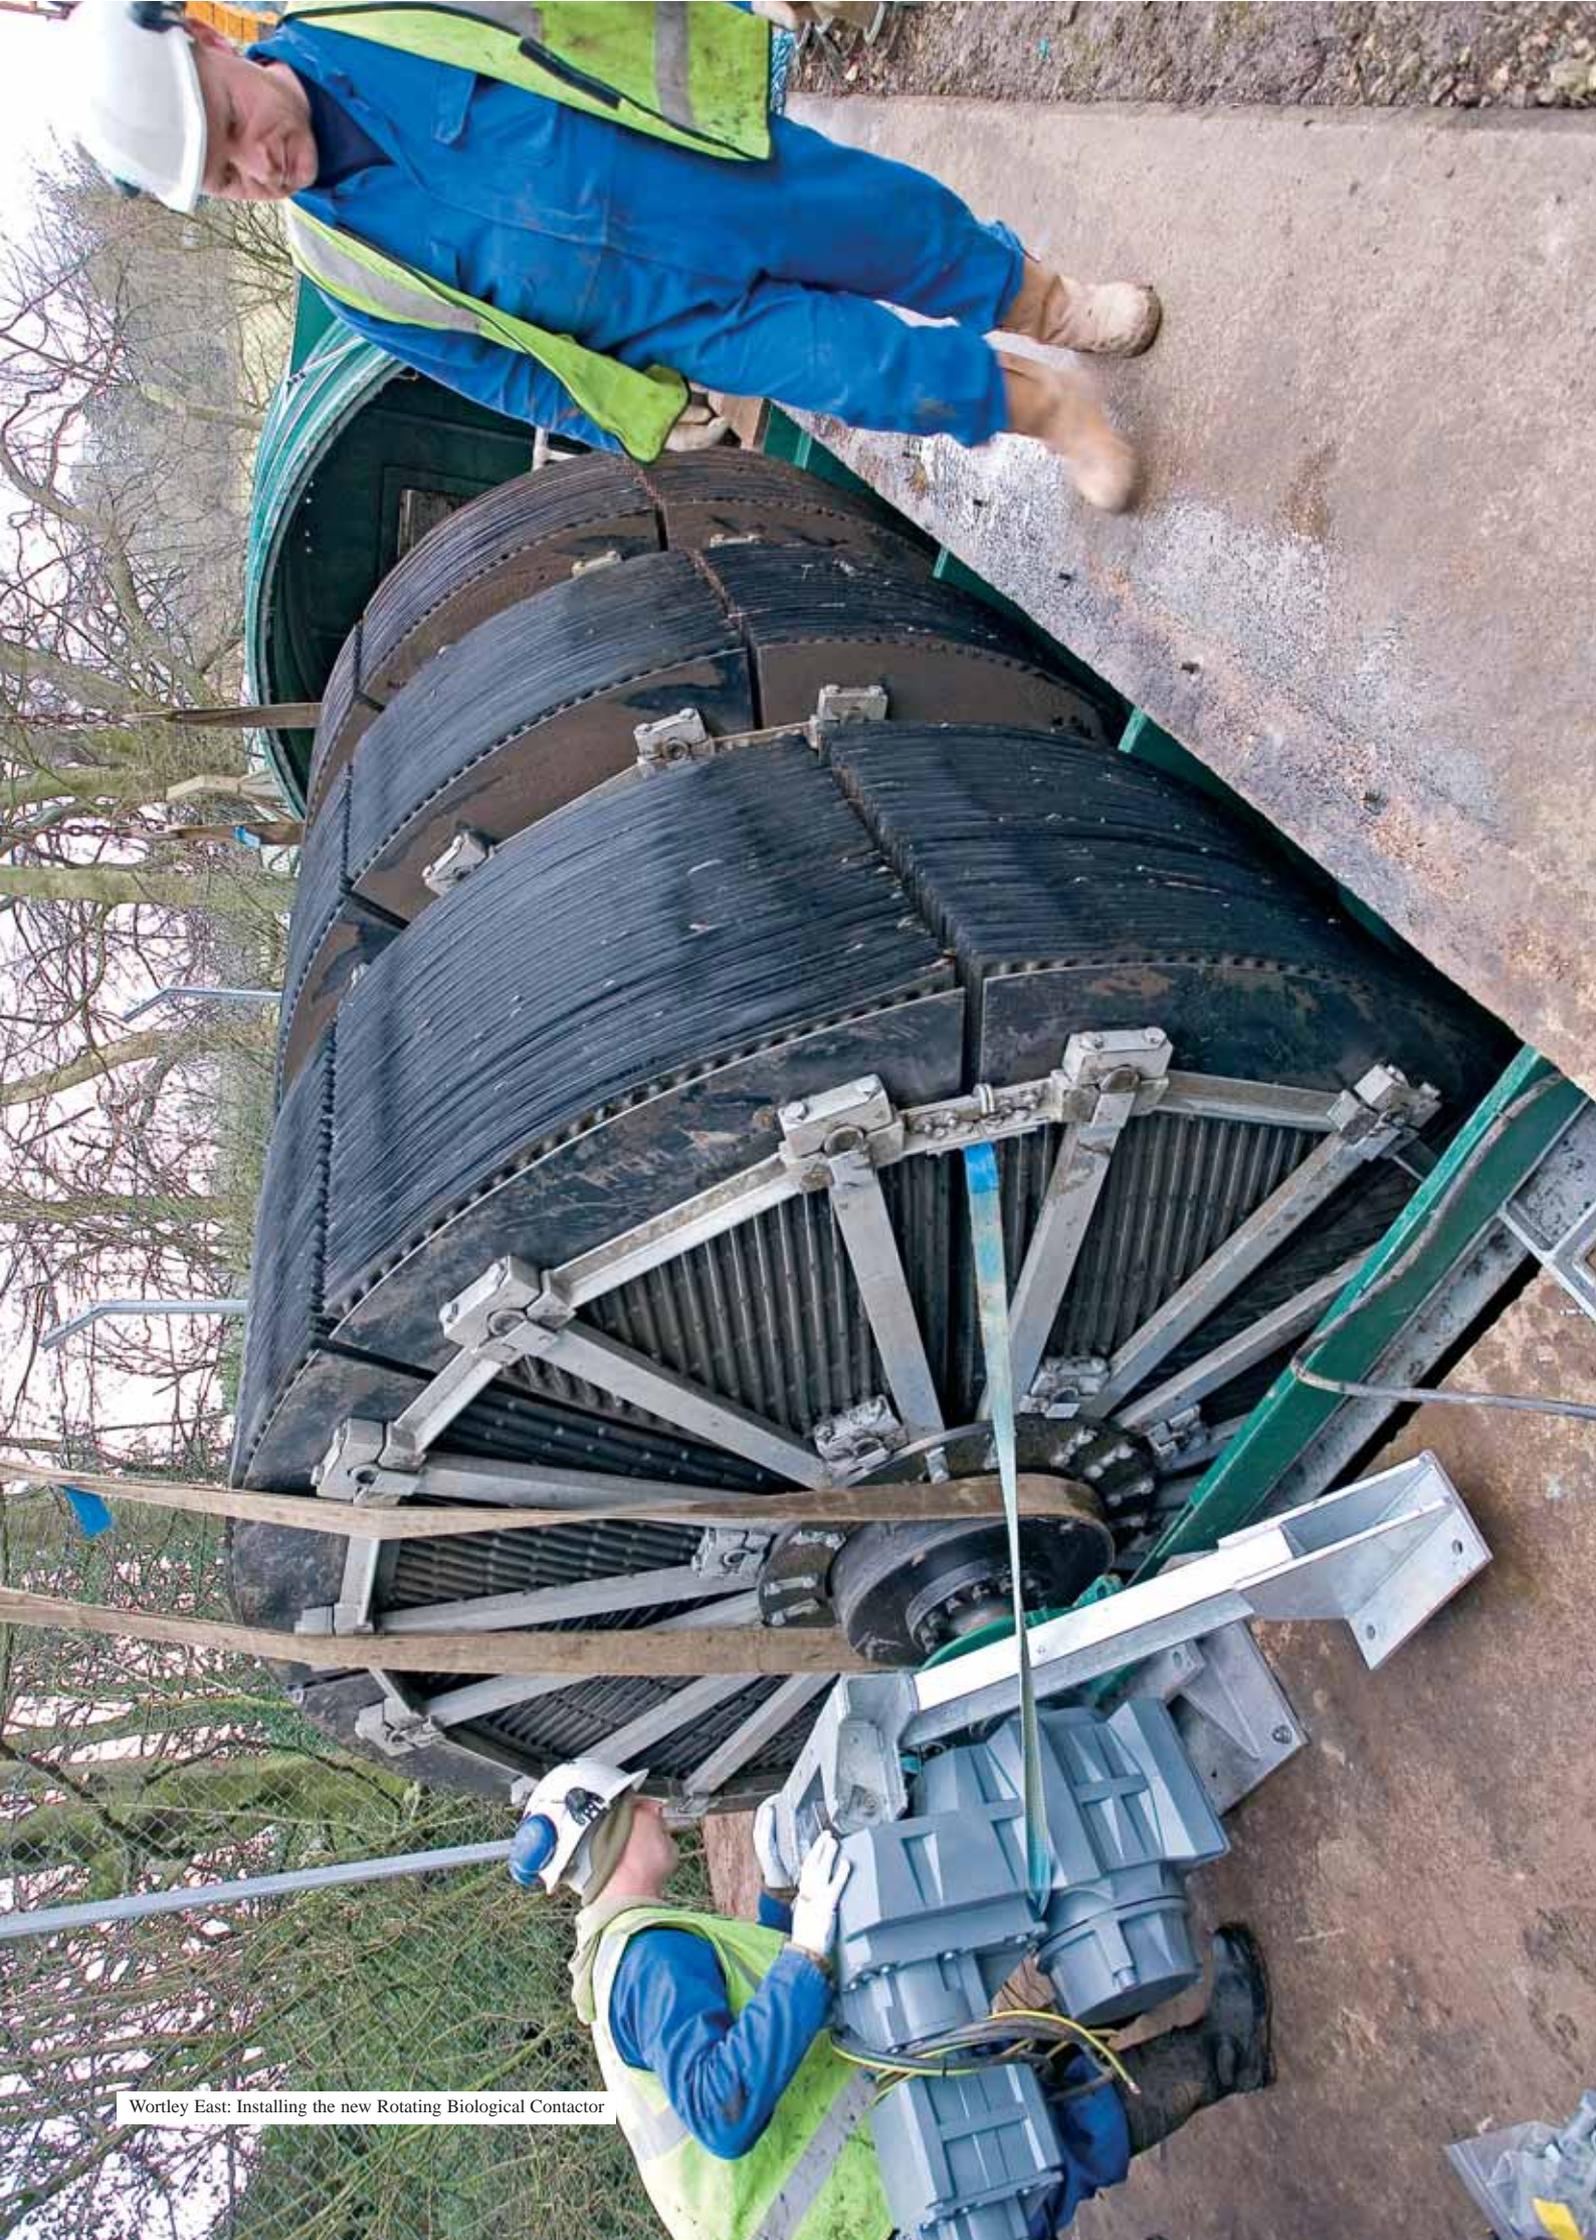
Wortley East: Installing the new Rotating Biological Contactor

The proposed solution was to simply replace the existing deficient RBC rotor, housed in its concrete structure. This structure was found to be adequate following a minor strengthening under one of the two bearing supports. The replacement rotor was supplied by *Copa Limited*, which included the latest improvements in RBC design following many years of research.

new rotor was placed into the existing structure by the same crane and resumed treatment immediately all on the same day.

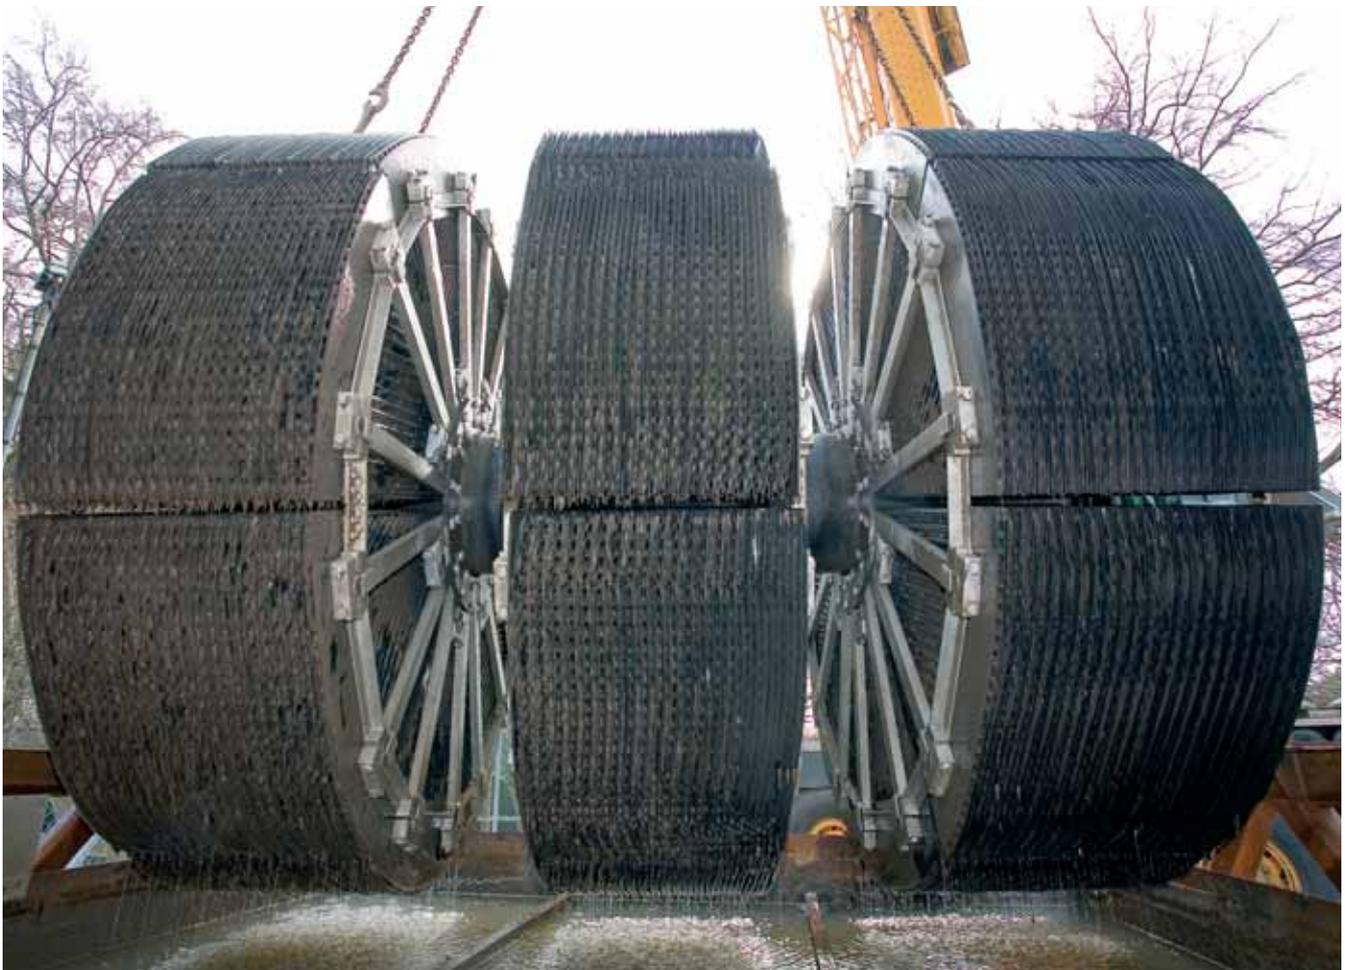
Wortley East: Lifting the new Rotating Biological Contactor into place
