# Thirlmere Aqueduct Refurbishment

## 134km aqueduct supplying major city - refurb story continued

**This paper describes the work carried out in 2007 as part of the major project to refurbish the aqueduct.**

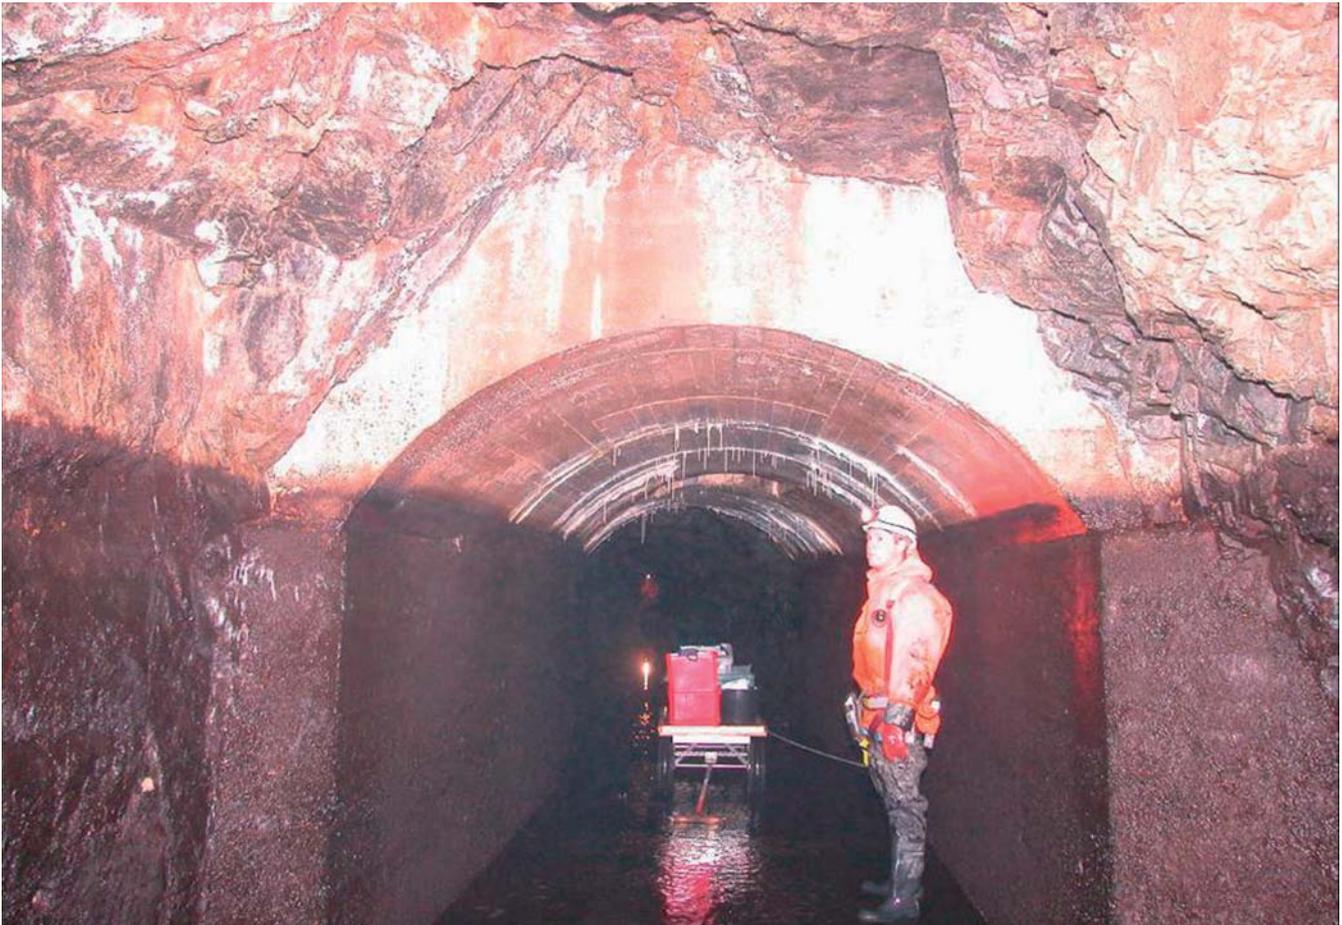
*Aqueduct shows change of construction from unsupported rock to concrete lined tunnel*

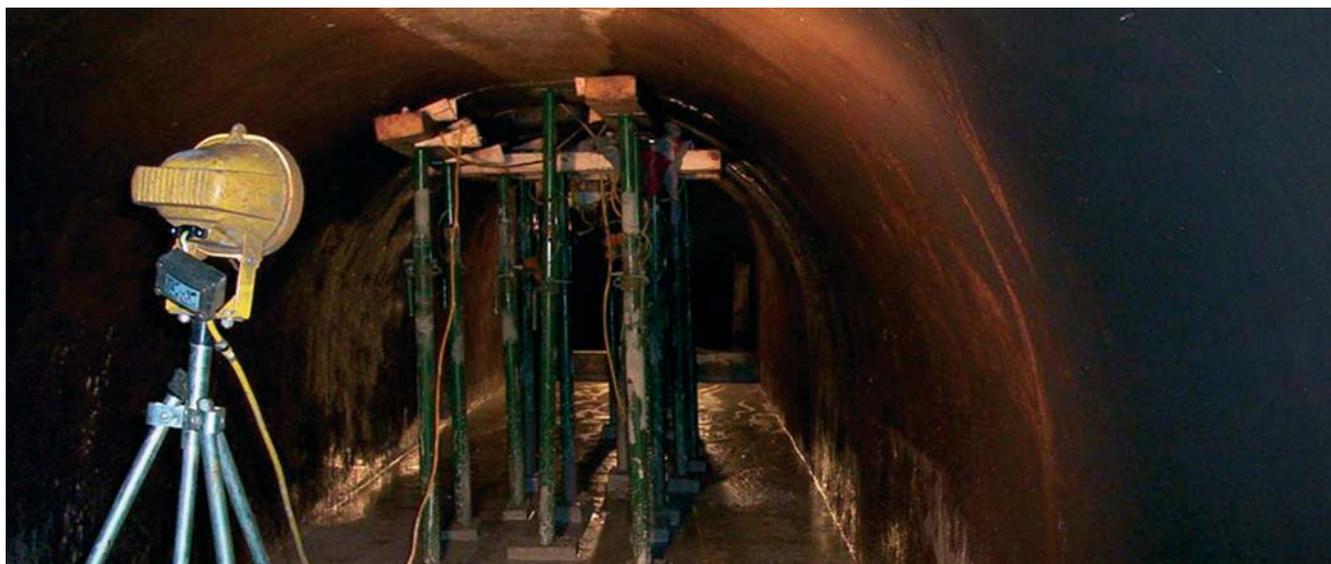
*Thirlmere Aqueduct: Permanent repair to aqueduct floor*

The inspections had revealed that the condition of the 103 years old aqueduct was generally very good, however a considerable number of repairs were required to ensure the continuing longevity of the tunnels and conduits. The repairs were broken down by type and importance (criticality). Defects to the base and the base wall joint were of particular concern and these defects have the potential to result in ground loss, leading to undermining of the aqueduct. Hollow base defects were repaired using low pressure (gravity) grouting, whilst the base/wall joint defects were resin injected and repaired using a modified cementitious mortar.
