# Lower Carno Dam Remediation

## B&V demonstrates the effectiveness of a fully integrated consulting and construction business

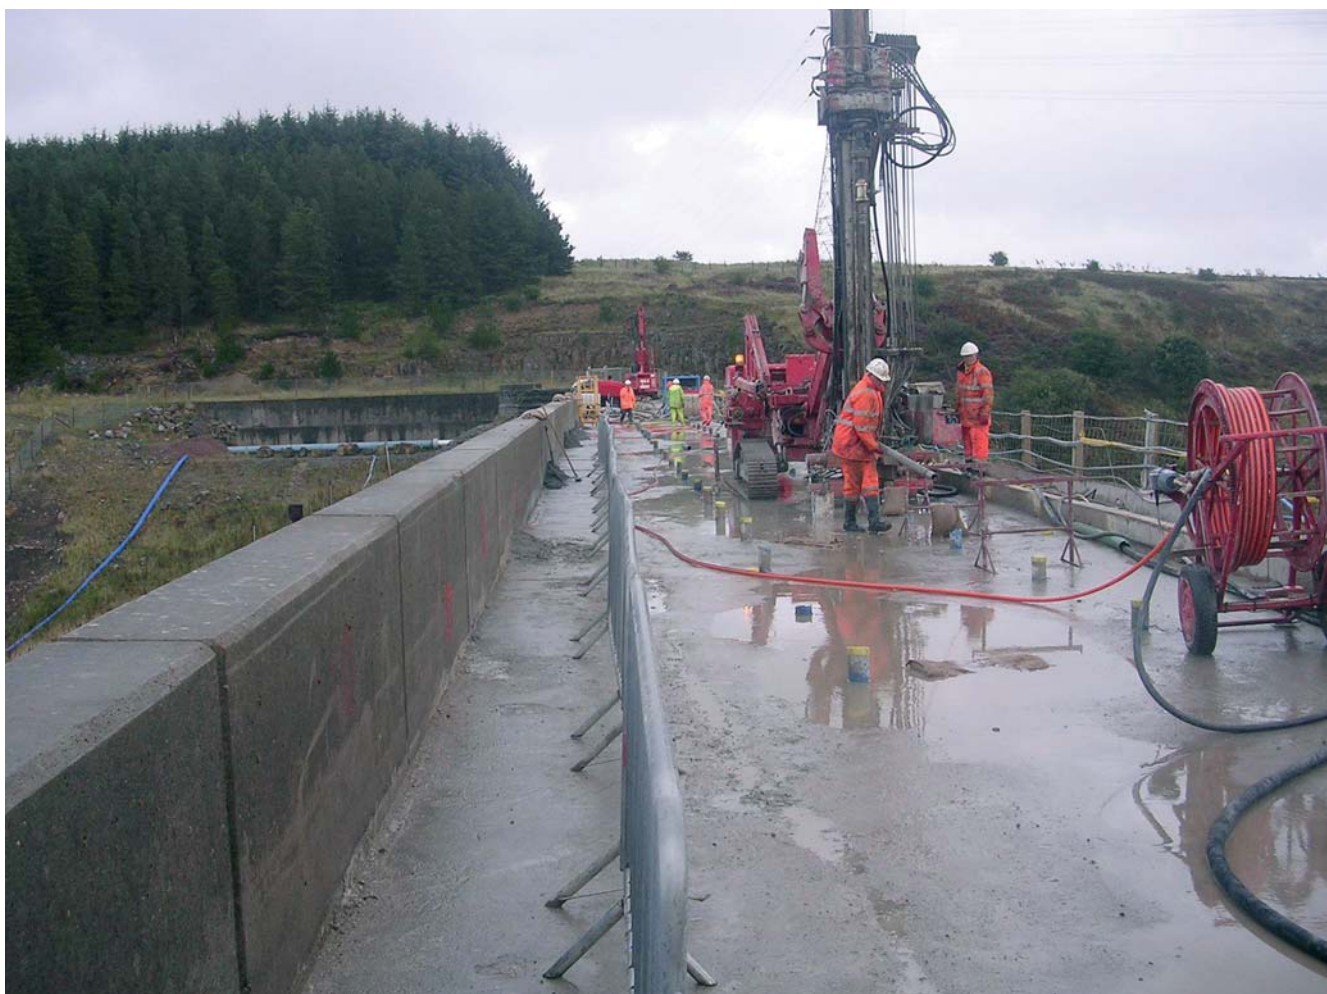
*Lower Carno Dam remediation work underway*

The B&V design incorporates a 40m-deep bentonite slurry wall to replace the centre of the clay core, a 10m deep grout curtain in the rock foundation, with contact grouting between the two, contact grouting around the scour pipe culvert and spillway structures and radial grouting arrays from within the culvert. Installation was by

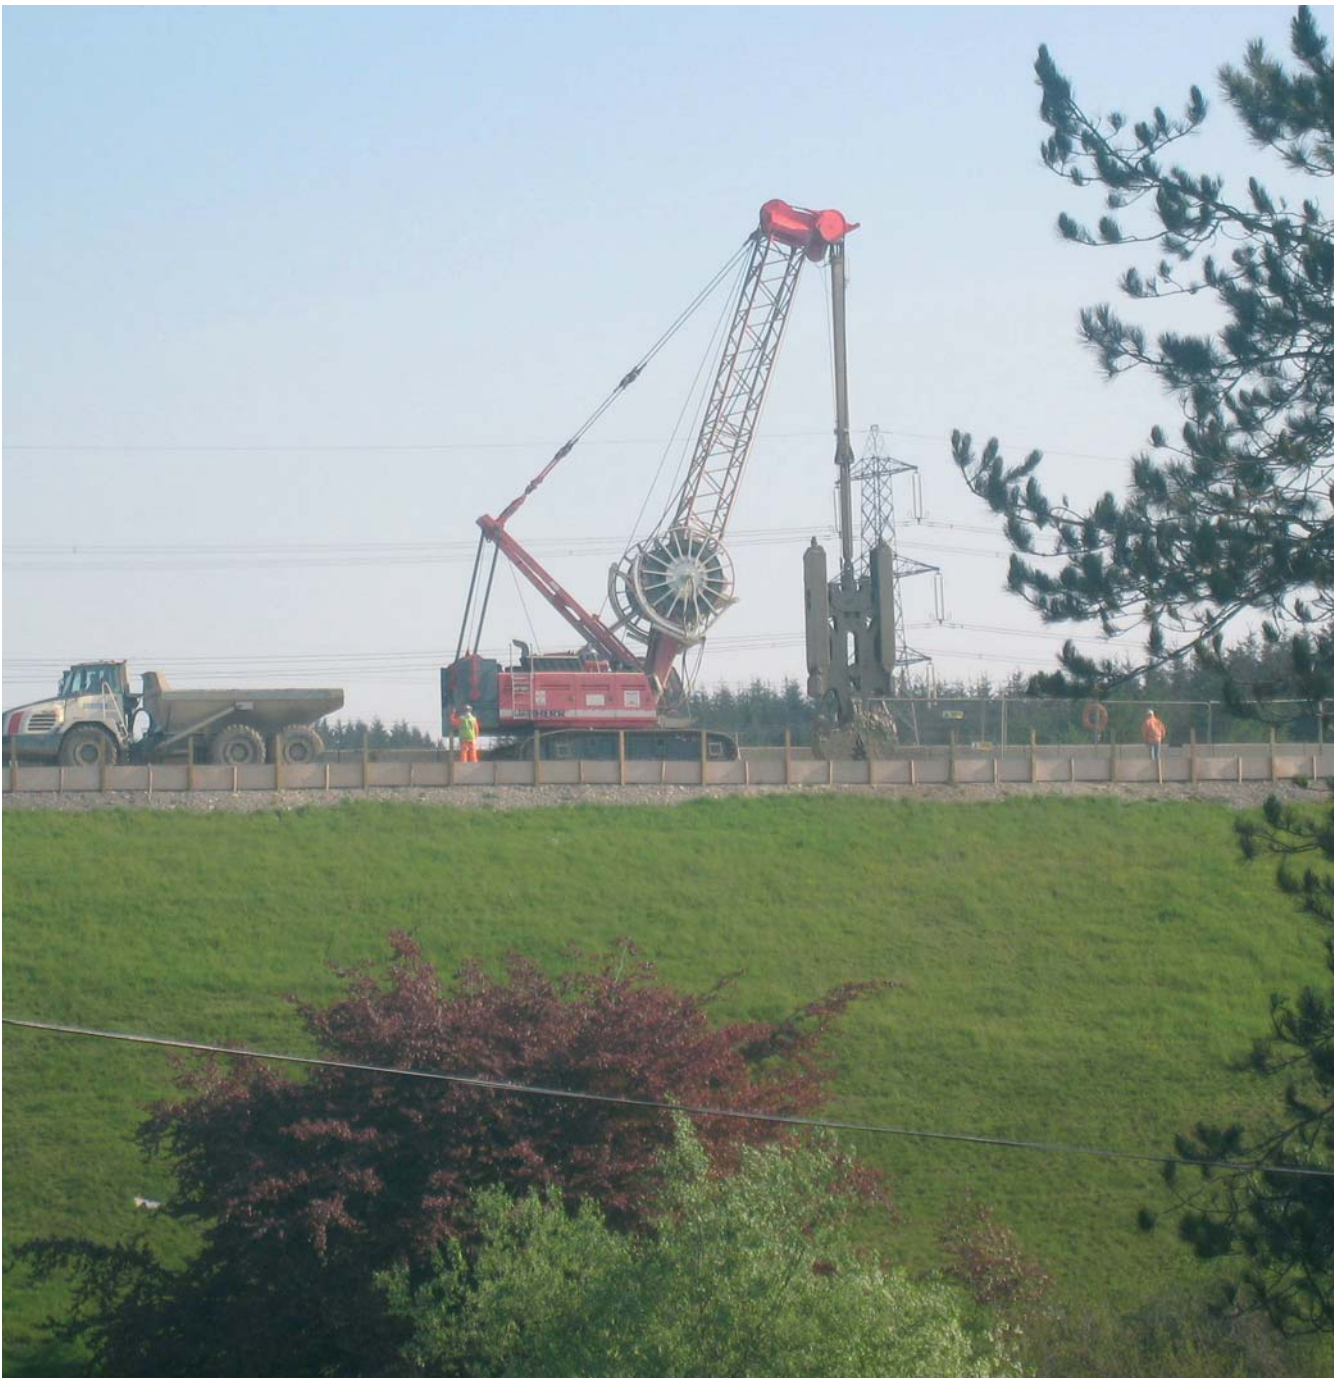
Lower Carno Dam remediation work underway
