Baystone Bank Impounding Reservoir Safety

the restoration of Whicham Beck provides ecological benefits, risk reduction and reduced OPEX costs

by Carl Sanders

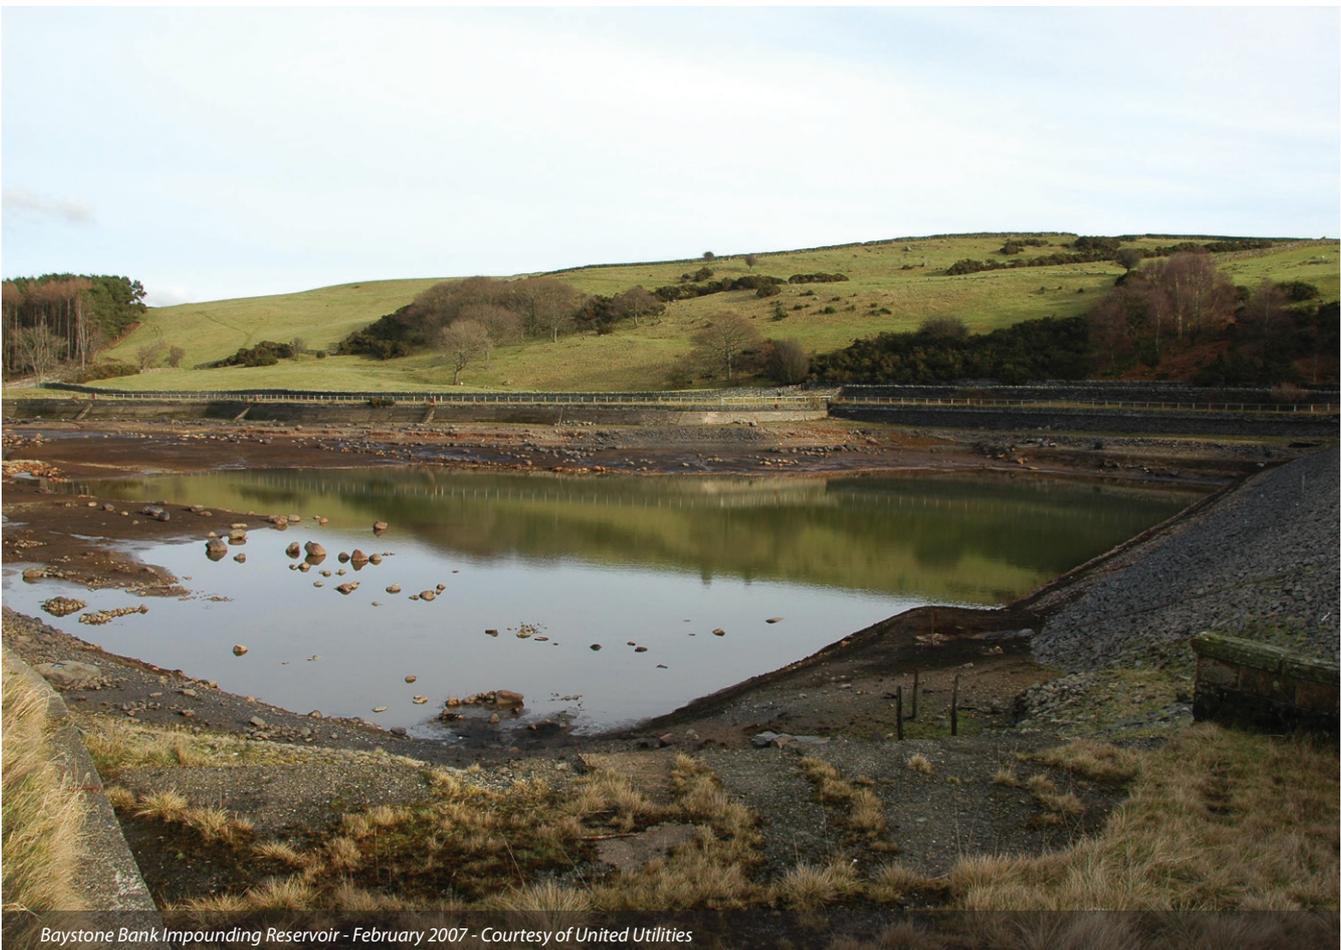
Baystone Bank Impounding Reservoir - February 2007 - Courtesy of United Utilities

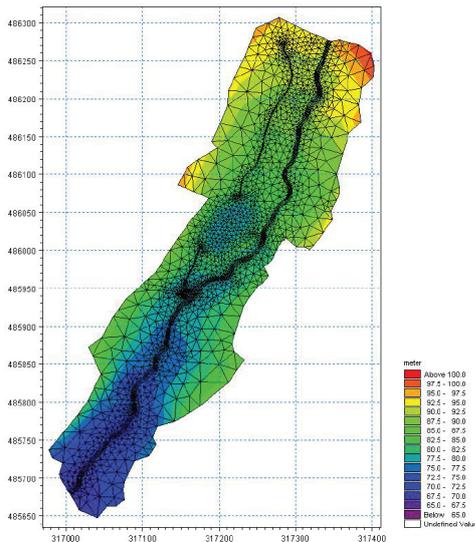
MIKE 21 Mesh showing the river and pool arrangement. Courtesy of MWH

Having established the proposed concept and got agreement from all the stakeholders that this design better met the original intentions, the design process continued. A hydraulic model of the proposed concept was then created by MWH to check how the

watercourse and pond would operate during a flood event. The hydraulic modelling was undertaken using Mike21 FM.

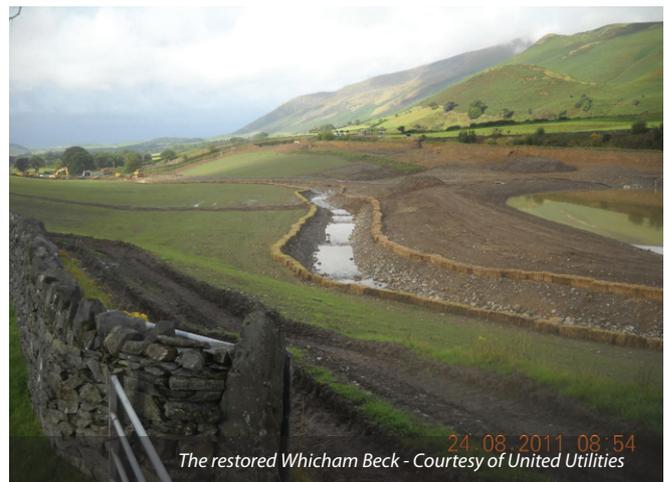
The restored Whicham Beck - Courtesy of United Utilities

As the vegetation has become established the location of the former dam and reservoir basin has become very difficult to identify, with the new watercourse/ground profile blending seamlessly into the landscape. The new river channel has continued to evolve over time, as sediment is moved within the channel. Gravel has accumulated, moved and eroded, adding further natural variability. Evidence of Otters using the pond has also been identified. The project has been very well received by all parties, including the Environment Agency and the adjacent landowner.
