# Birkenburn Reservoir

innovative method of lowering a reservoir's water level to allow for remedial works, without introducing suspended solids into the water discharge

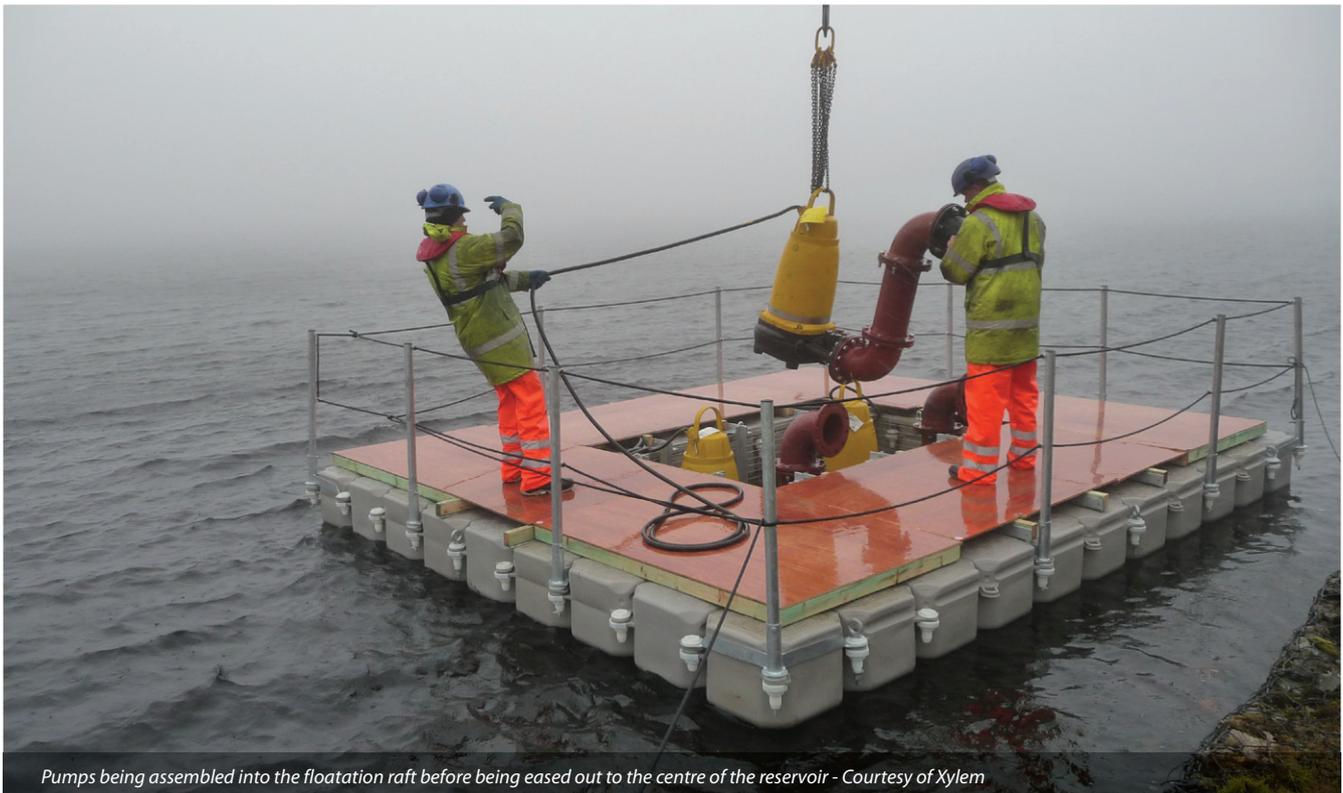
*Pumps being assembled into the floatation raft before being eased out to the centre of the reservoir - Courtesy of Xylem*

solids into the water discharge. Their solution was to install a floating pontoon at the deepest point in the reservoir which would contain 3 (No.) off-electric submersible pumps powered by a temporary generator on the bank. The plan required the pumps to be located in a basket which would ensure that the suction side remained at a constant depth of 500mm below water level. This would then allow only clean water being pumped and a minimum disturbance of any silt layer.

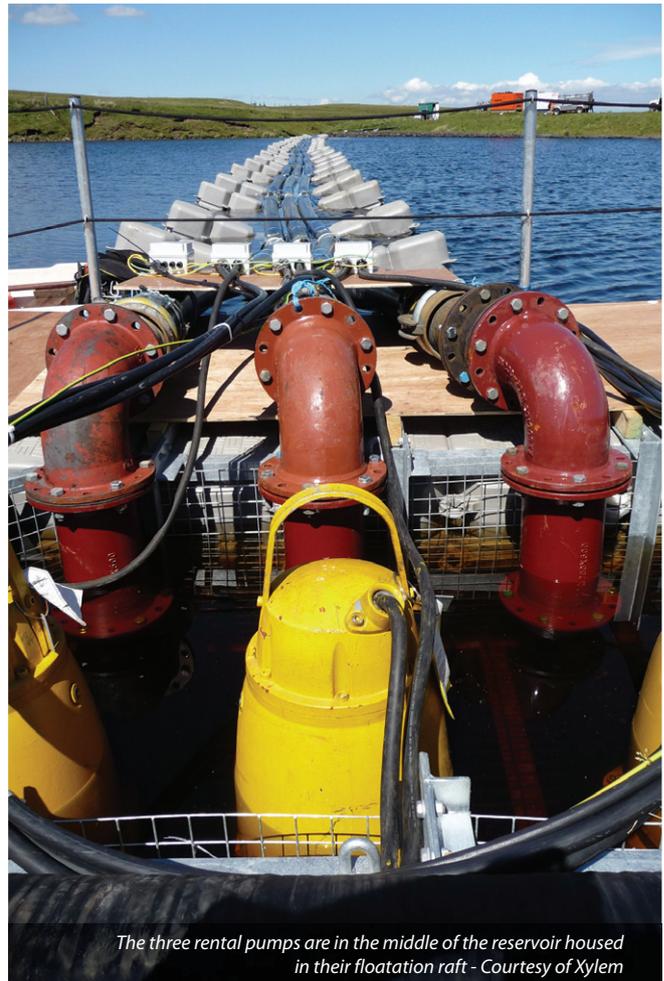
The three rental pumps are in the middle of the reservoir housed in their floatation raft - Courtesy of Xylem

The plan was for the discharge hoses from the pumps to be directed into the spillway and, as the water level fell, the pontoon would drop to the required level. The pumps would operate at a capacity of 575l/s, enough to overcome incoming flow and reduce the water level while keeping within the maximum output permissible.

With this pumping solution, the maximum discharge was only required at the start of pumping operations while the level was being dropped. Once the minimum level was achieved, only maximum incoming flow needed to be pumped. Because the pumps were located 500mm below water level at all times, the silt levels could be monitored below the pumps, which could be stopped in the event that any silt was disturbed.
