Coalport STW

primary treatment and activated sludge plant improvements

by Ian Johnson BEng CEng MICE and Peter Davies MEng CEng MICE

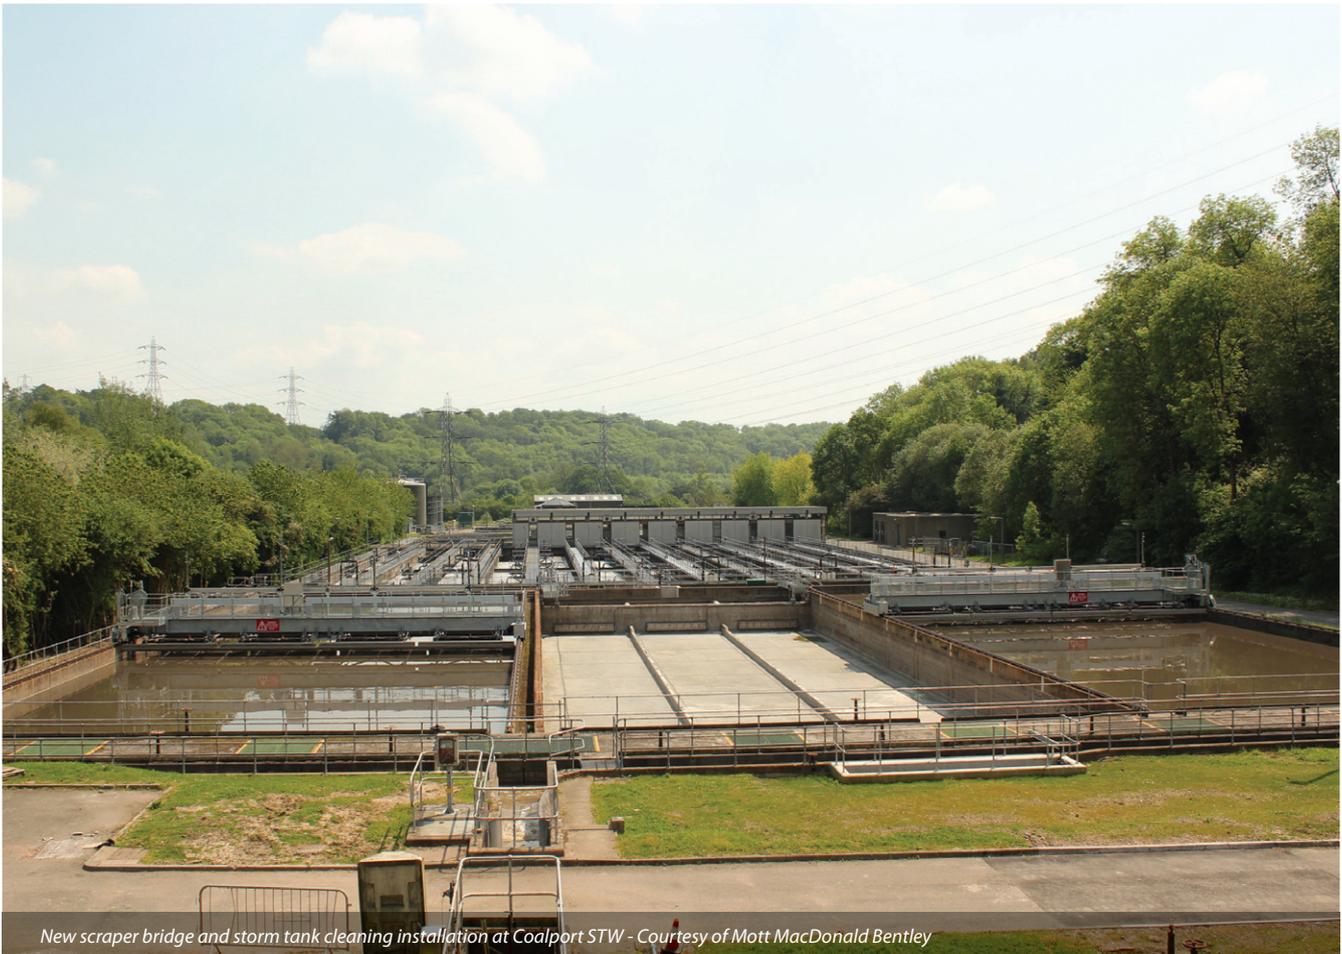
New scraper bridge and storm tank cleaning installation at Coalport STW - Courtesy of Mott MacDonald Bentley

The solution was to re-configure the function of the three tanks, such that the central tank became the storm tank, with a PST either side. The storm tank could then be fitted with an appropriate cleaning system, removing the need for a scraper bridge on the central tank.

The whole life cost of different storm tank cleaning systems was considered, alongside the programme and technical risks. This led to the selection of a proprietary flushing gate system to provide an automated storm tank cleaning system.

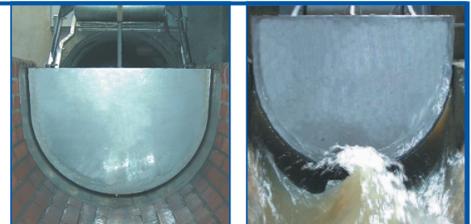
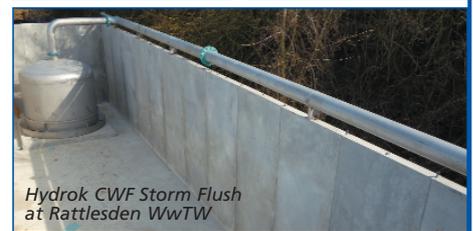
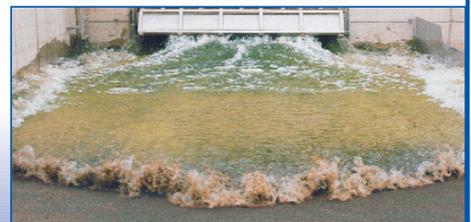
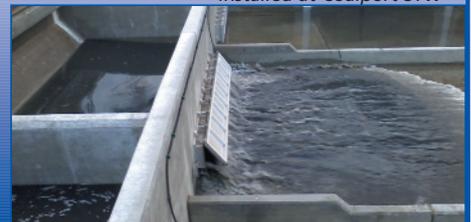
HydroSelf Rectangular -storm tank flushing as installed at Coalport STW

A planned site visit to an existing storm tank flushing gate installation at Ray Hall STW and 3-dimensional sketches, were used to articulate design concepts to the operational site staff at Coalport STW, enhance the design process and secure stakeholder support for the recommended solution.

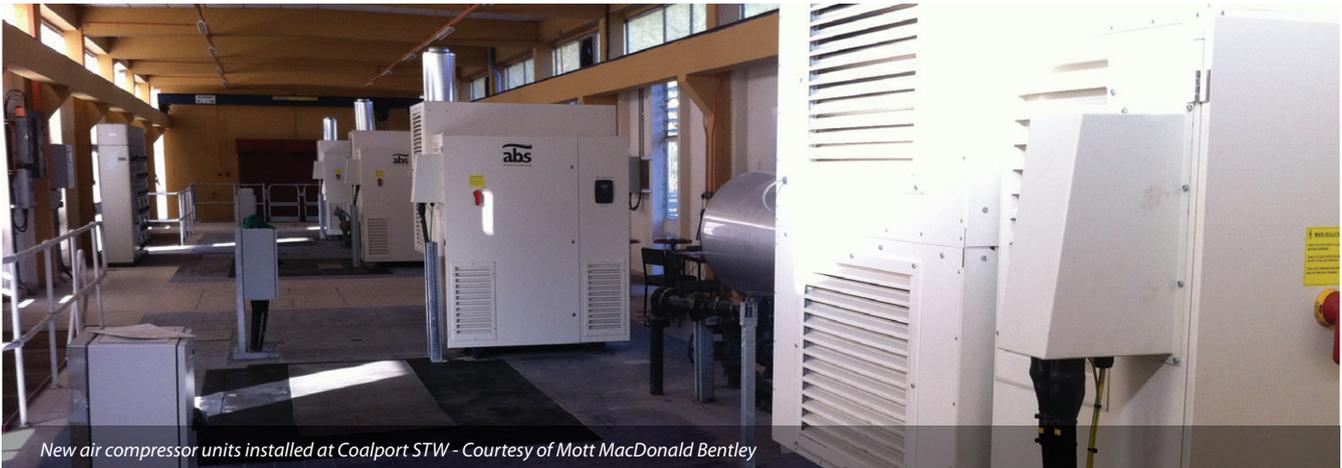
New air compressor units installed at Coalport STW - Courtesy of Mott MacDonald Bentley

- Replace all 4 (No.) existing air compressors with new radial centrifugal compressors, which have a broader operating range and are less prone to surges and stalls.
- Replace all 12 (No.) air control valves with smaller diameter units, to improve air flow control.
- Replace the control system to provide a modern, maintainable asset.

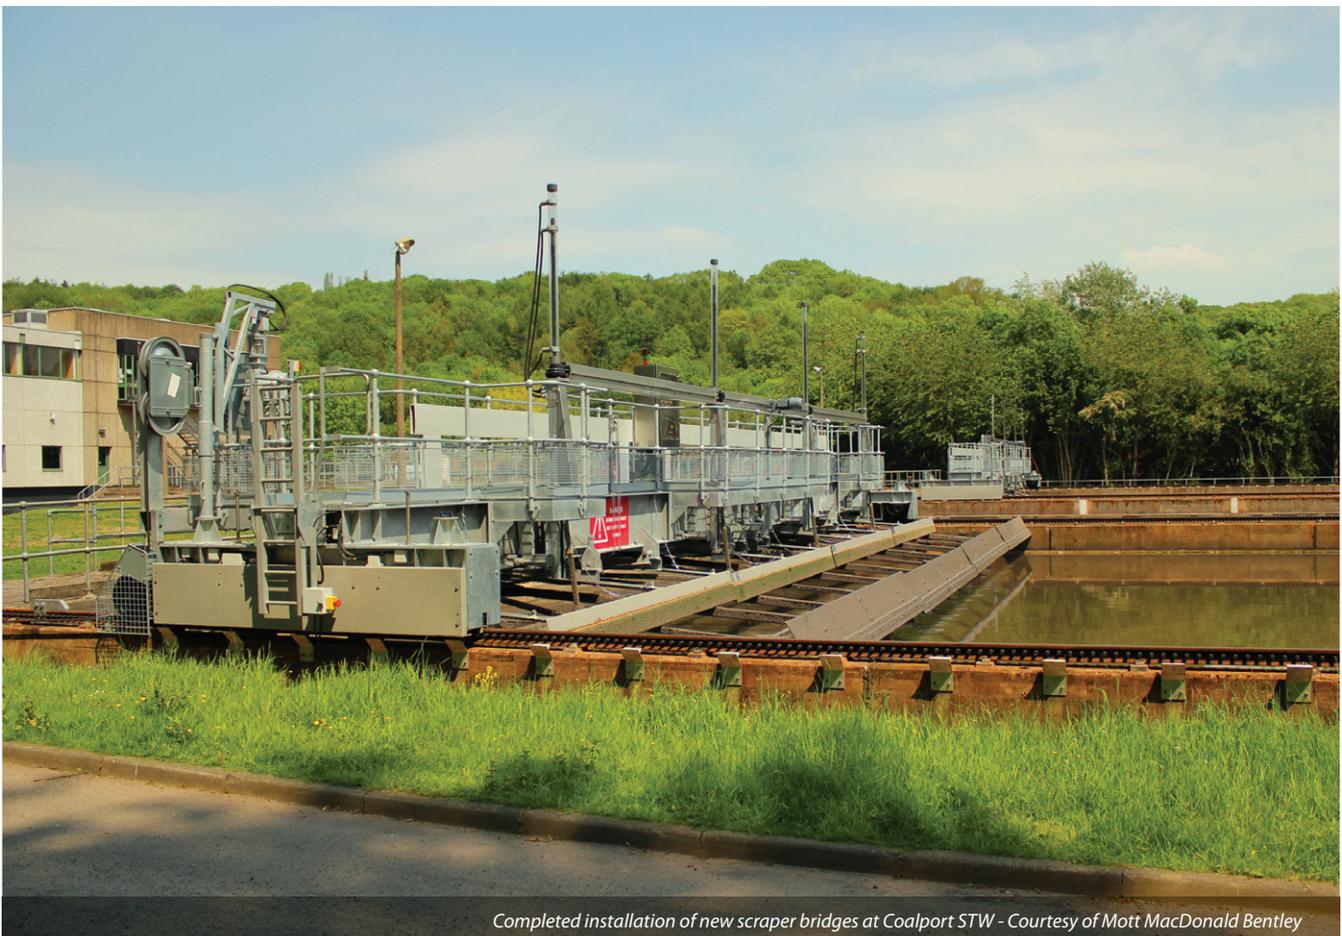
Completed installation of new scraper bridges at Coalport STW - Courtesy of Mott MacDonald Bentley

the third providing storm storage for flows in excess of 3DWF. The two PSTs were served by a single 40m long scraper bridge, with a separate scraper bridge on the storm tank.

The bridge across the two PSTs was installed in the 1980s and in recent years had required approximately 200 hours of maintenance work per annum, an average of half a day per week. Concern was growing that the bridge may catastrophically fail. Every failure of the scraper bridge left the site without effective sludge removal in both PSTs, leading to increased solids carry over into the secondary treatment, putting the discharge consent at risk. An independent scraper bridge for each PST was required to give the site reliable performance and to allow maintenance on one PST without affecting the second PST.

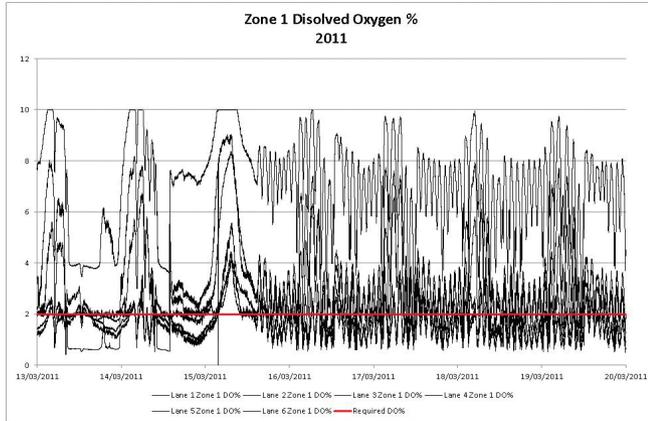
Figure 1. Dissolved Oxygen Levels, ASP, 2011

The dissolved oxygen levels within the ASP at Coalport have historically been highly unstable, as shown by the graph in Figure 1. The installation of the new equipment has dramatically improved control of the dissolved oxygen levels, as shown in Figure 2.

The study concluded that the poor condition of the existing air compressors and control valves caused these two vital components to respond at different rates. This caused frequent surges and stalls of the air compressors and therefore under-aeration of the lanes.
