Lower Laithe Reservoir

spillway improvements and clay core raising

by Natalie Evans, MEng

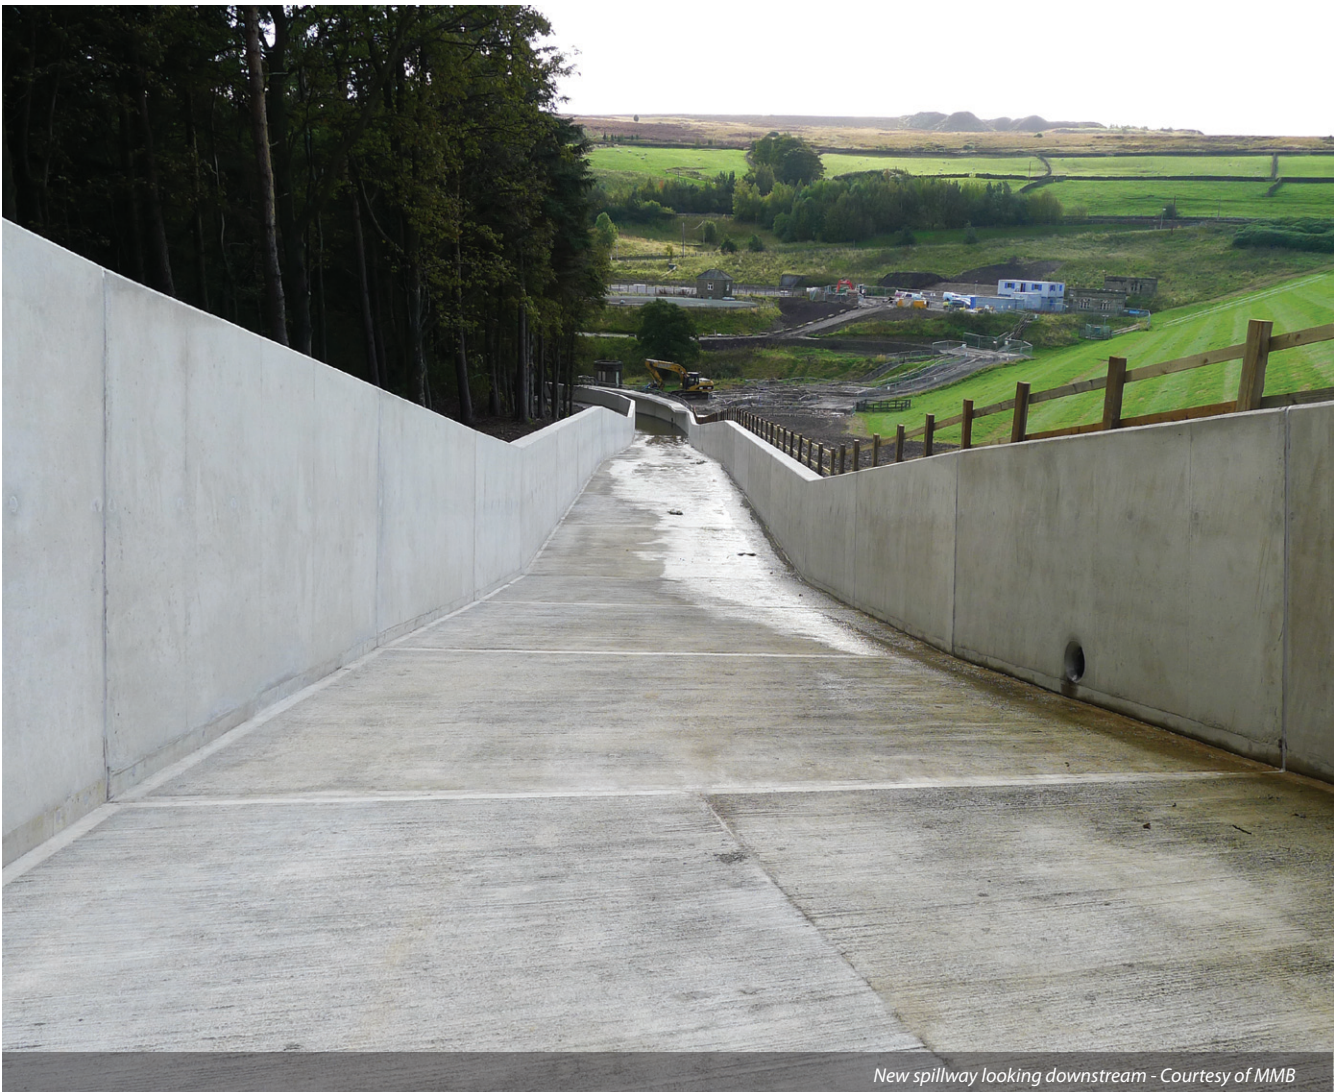
New spillway looking downstream - Courtesy of MMB

Due to the space constraints on site, and cost considerations, it was decided to undertake the required modifications to the existing spillway channel as opposed to constructing a new channel. The new channel lining is of reinforced concrete construction; dictated by the high flows in the channel.

Relining has taken place from 25m downstream of the crest bridge, where spill flows exceed 8m/s. The spillway walls have also been raised in concrete to provide a freeboard for the spill flows. This has resulted in an internal wall height of 2.5m on the outside of the channel, and 2m on the inside. Upstream of the transition with the existing channel, some wall raising has also taken place in masonry to tie in with the existing spillway construction.

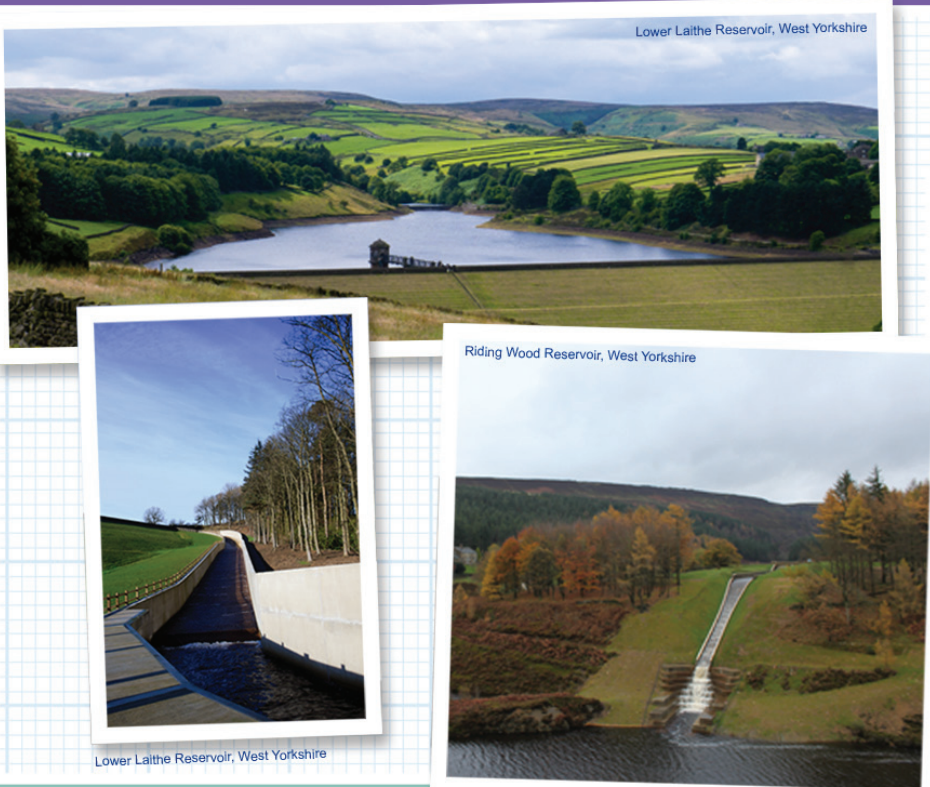
An innovative solution was also required in the stilling area to direct flows into the watercourse, preventing damage to the embankment

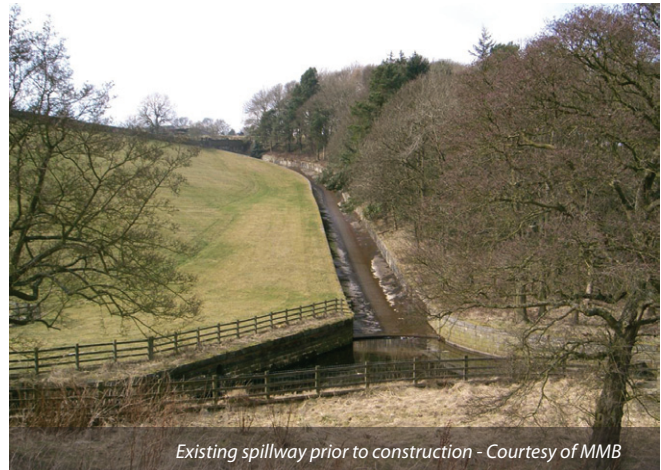
Existing spillway prior to construction - Courtesy of MMB

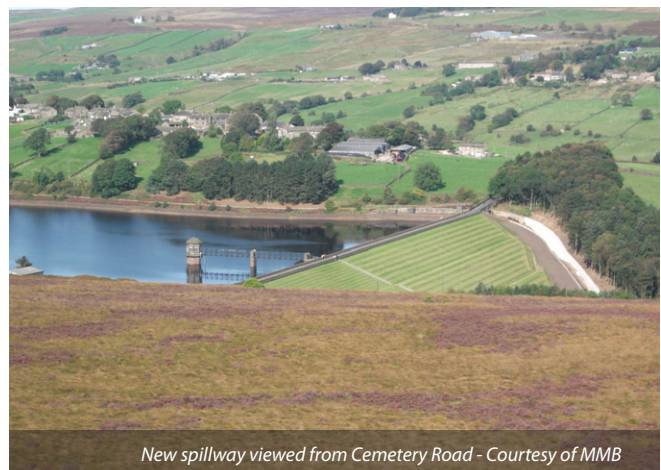
New spillway viewed from Cemetery Road - Courtesy of MMB

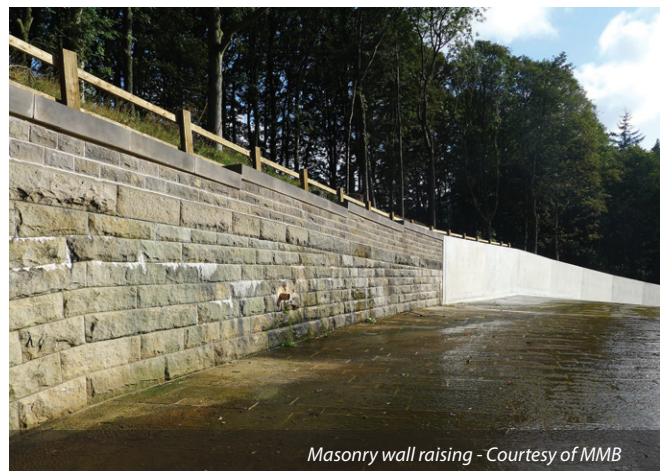
Masonry wall raising - Courtesy of MMB

Use of a fair faced concrete finish has meant it has not been possible for the new concrete lining to match the existing Victorian masonry construction. In spite of this, the project team have worked hard to ensure that the new works cause the minimum possible impact to the landscape. Therefore, at the transition, the concrete and masonry meet in a stark contrast between new and old. The upstream wall raising has been constructed in masonry to maintain this transition, with the new section of wall stepping down to meet the existing; mimicking the design of the existing bridge parapet.

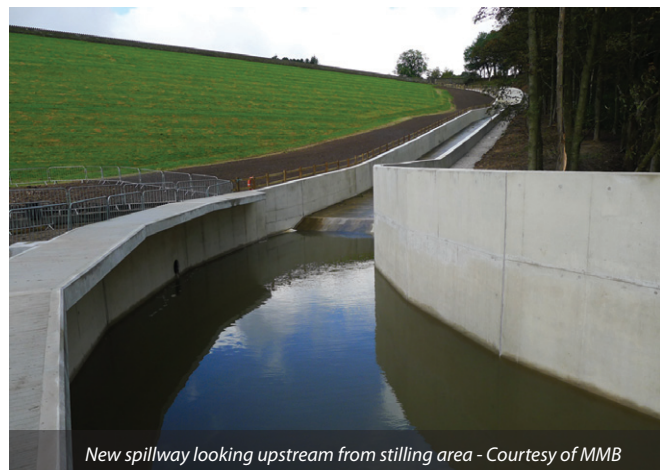
New spillway looking upstream from stilling area - Courtesy of MMB

toe. This has been achieved by constructing a training wall with an overhang within the existing stilling area to direct high velocity flows back into the channel. This has allowed for a smaller wall than would traditionally have been required; delivering efficiencies in the design, and minimising the impact of the works.
