# Bloomfield Road Tunnel Sleaving

an innovative solution to secure a key asset

by Brian Sharp BSc (Hons) C Eng MICE MAPM, David J Morgan BEng (Hons) C Eng MICE & Graham Collinson BSc (Hons) C Eng

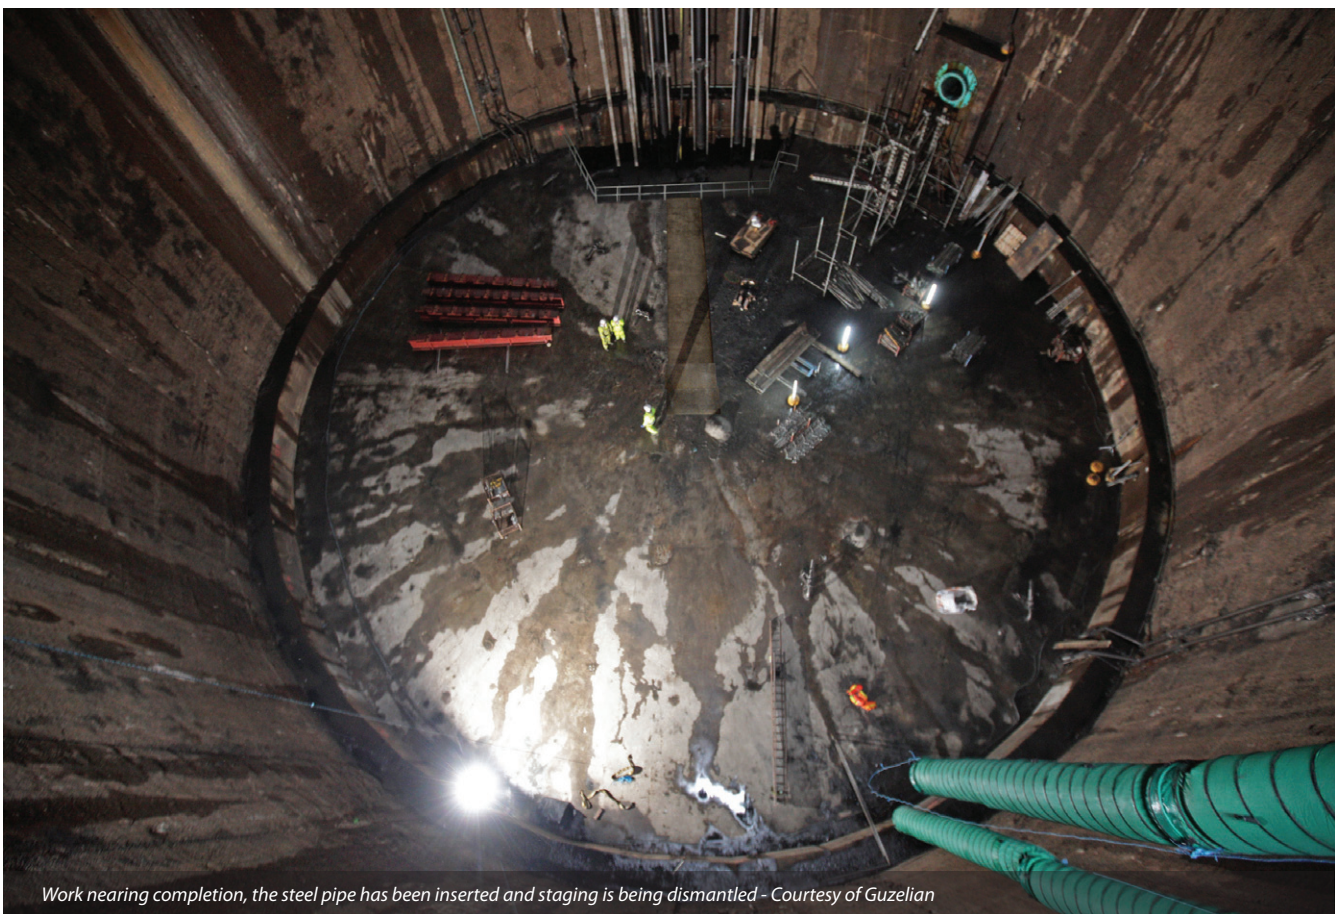
Work nearing completion, the steel pipe has been inserted and staging is being dismantled - Courtesy of Guzelian

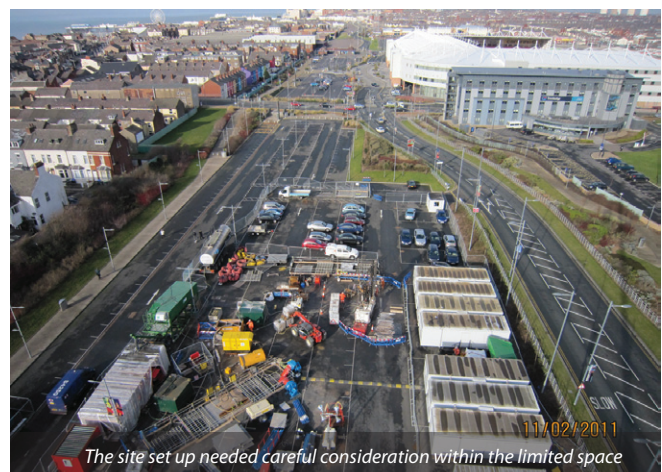
The site set up needed careful consideration within the limited space

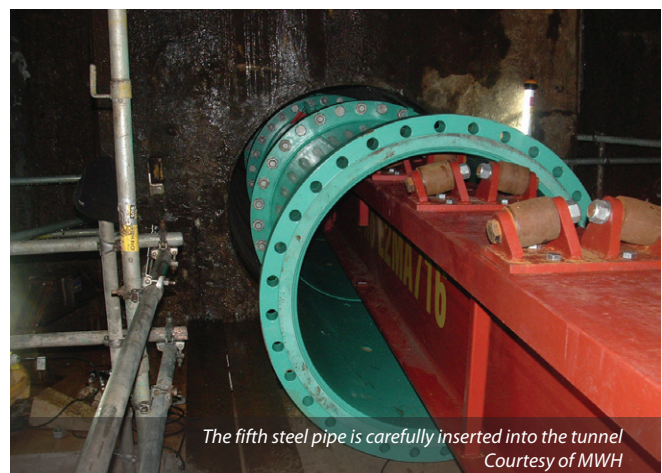
The fifth steel pipe is carefully inserted into the tunnel  
Courtesy of MWH

Works resumed on site in October 2012 and a period of development took place to overcome the complex deflections, sequencing and safety of the exercise. With Christmas looming the site team moved onto a twelve hour day, seven days a week working practice. With continuing difficulties being overcome, the final pipe was installed at 9pm on Friday 21 December 2012. The following weekend was utilised to fill the void between the pipe and tunnel via a grout in three lifts, leaving the tunnel secured just before Christmas.

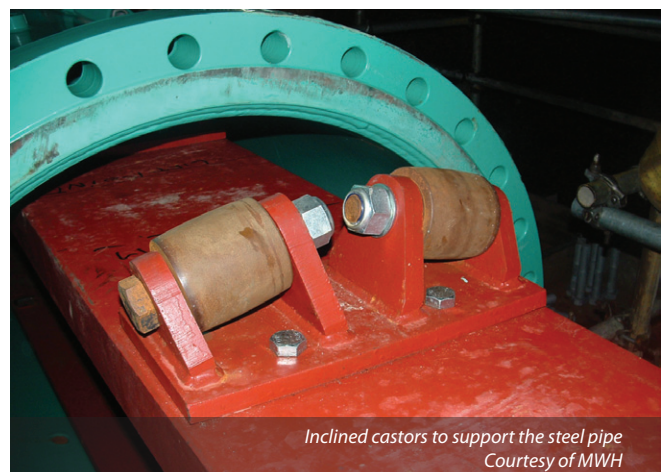
Inclined castors to support the steel pipe  
Courtesy of MWH

The original design intention was to travel the pipe into the tunnel on castors but, as the surveys and 3D modelling of the tunnel were developed, it became clear that the tunnel had a high point which would attract an 11T point load from the pipes as they were inserted. This raised concerns as to the effect of this load on the tunnel. Since it was not feasible to quantify the residual strength of the tunnel, and with the requirement to bring the tanks back into operation for the bathing season in May 2012, site work was stood down; the risk to the tunnel was deemed to be too great for work to proceed.

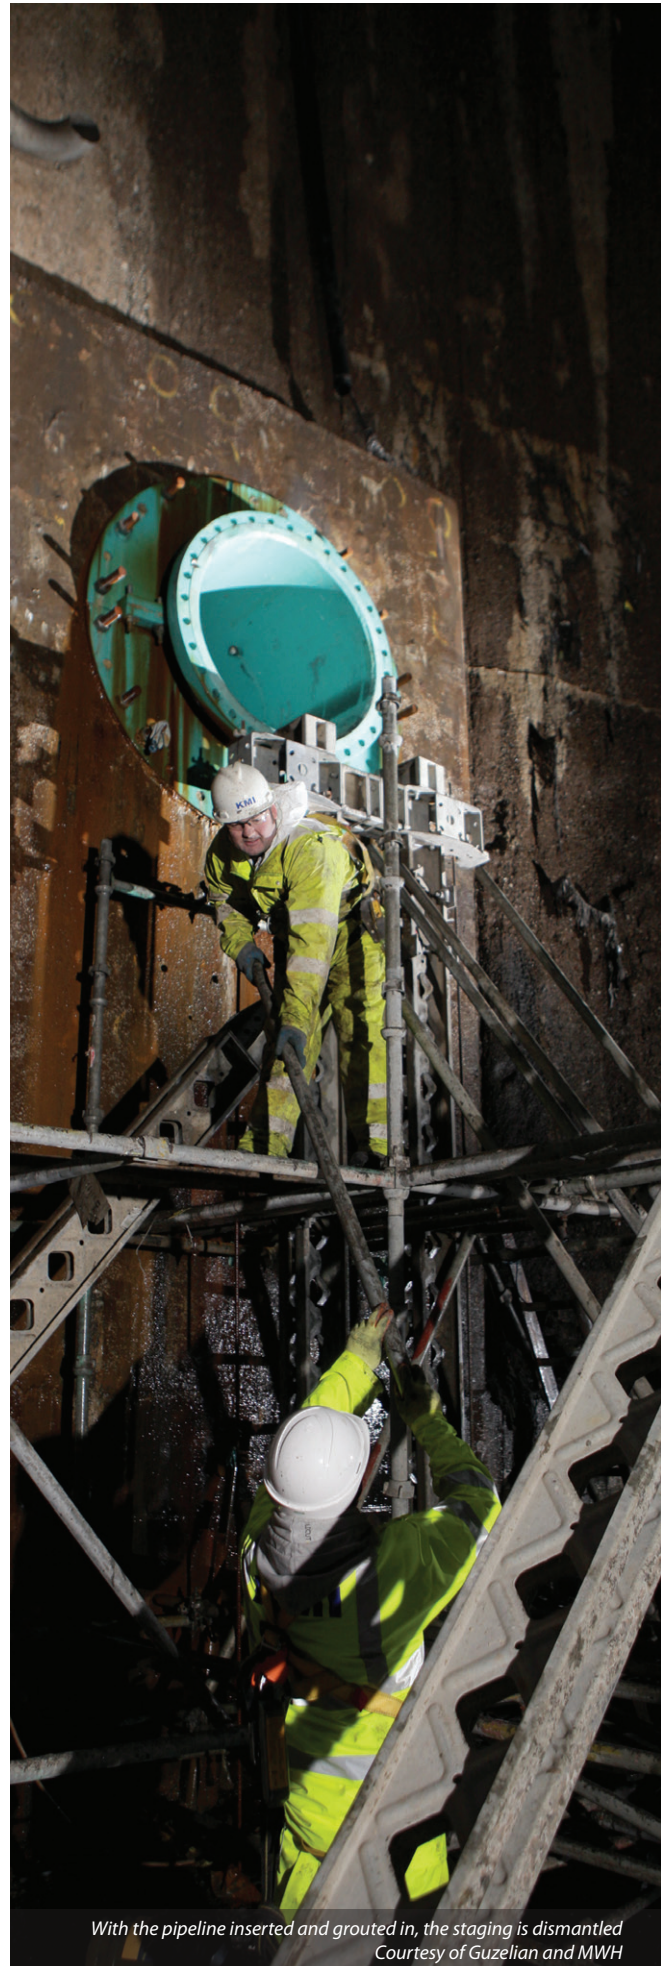
*With the pipeline inserted and grouted in, the staging is dismantled  
Courtesy of Guzelian and MWH*
