Dukinfield (Wharf Street) UIDs

United Utilities network scheme provides screening to storm flows to the River Tame in East Manchester

by Stewart King

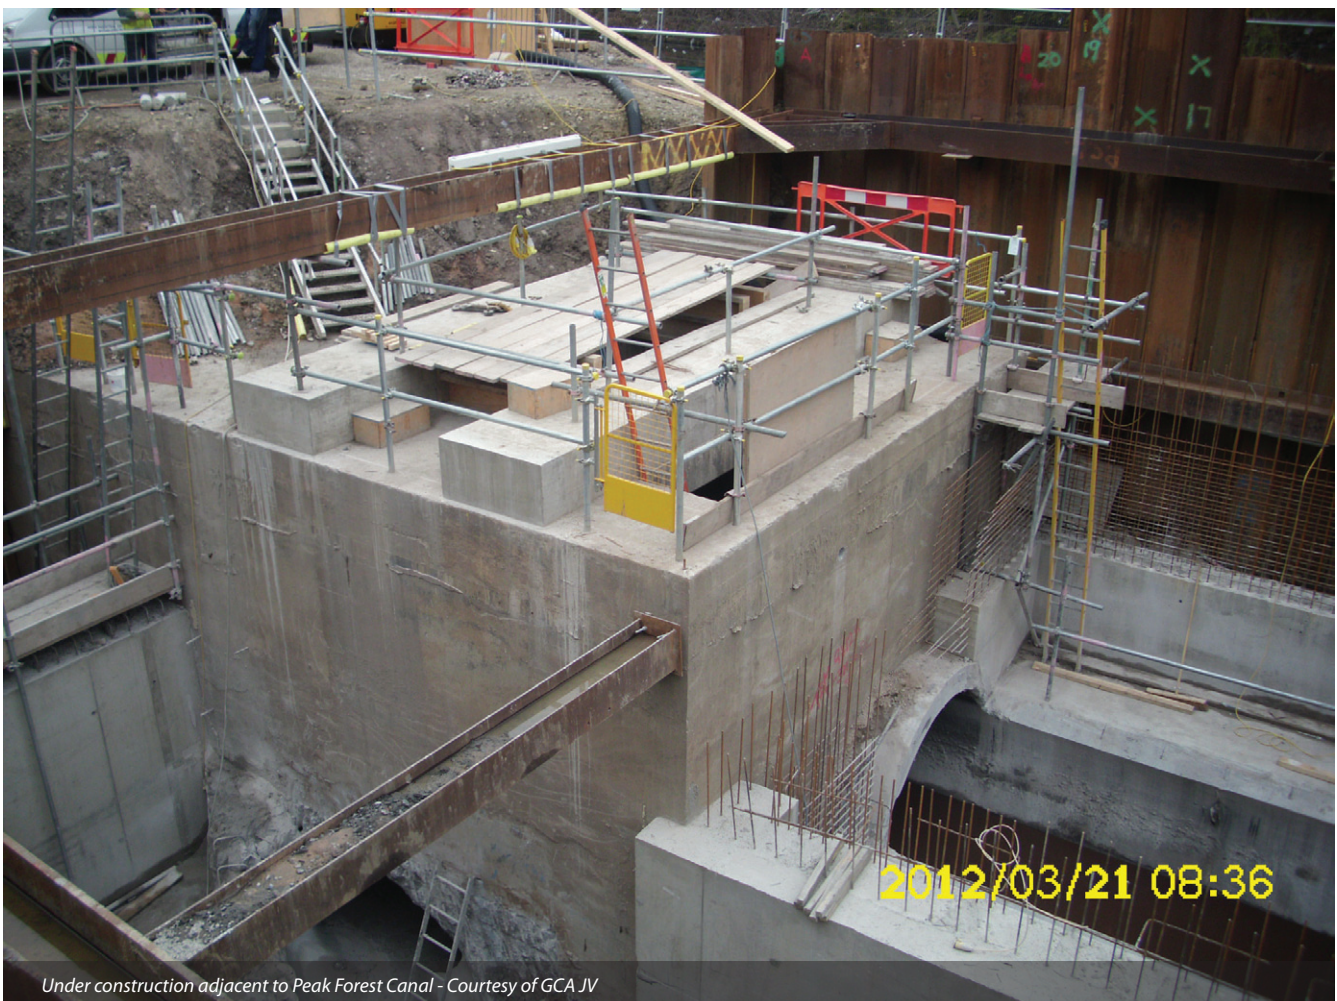
Under construction adjacent to Peak Forest Canal - Courtesy of GCA JV

The existing unscreened CSO is located in a tightly constrained area in open land, off Wharf Street, Dukinfield and is bounded by the Peak Forest Canal to the West, the River Tame to the East and the Manchester-Stalybridge railway line to the North.

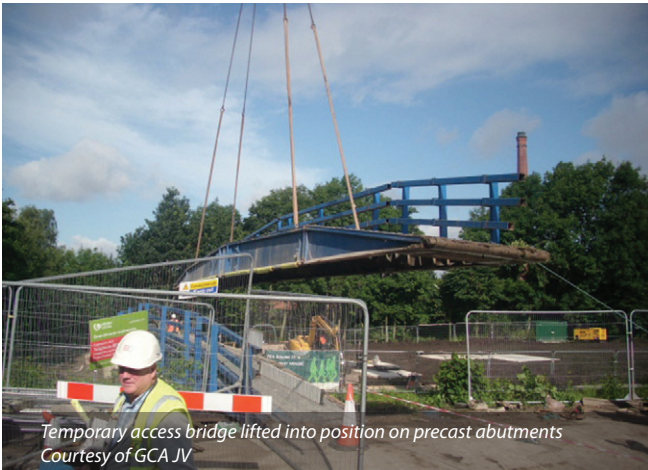
Temporary access bridge lifted into position on precast abutments
Courtesy of GCA JV

The alternative access route was designed utilising a temporary military (Mitchell) bridge sat on a modular precast abutment allowing construction traffic to access the works safely and efficiently.

Key to the timely installation of the site access bridge was the close liaison between UU's third party coordinator and British Waterways to understand their requirements to maintain a navigable canal and demonstrating that the temporary bridge was designed to prevent any risk of construction debris falling in the canal.

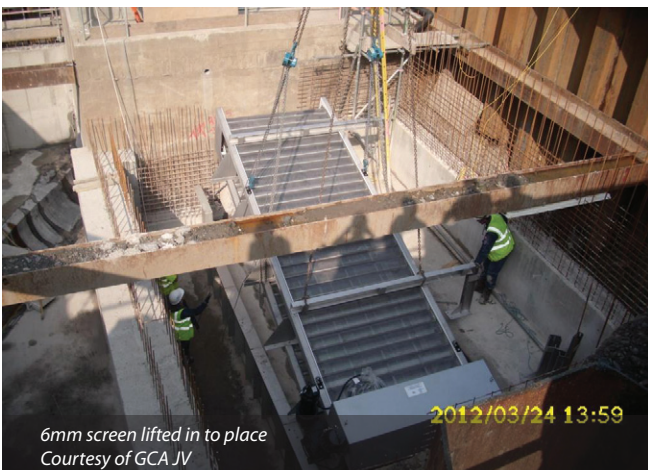
6mm screen lifted in to place
Courtesy of GCA JV

The existing sewer was known to be a segmental tunnelled construction and it was decided that this would remain intact for the majority of the works and cut out when ready to accept the screen. The screen was designed to fix to the exposed pipe faces which were determined to be acceptable following some trial cores. Following successful installation of the screen, the pipe was cut out using a combination of wire sawing and circular sawing techniques.

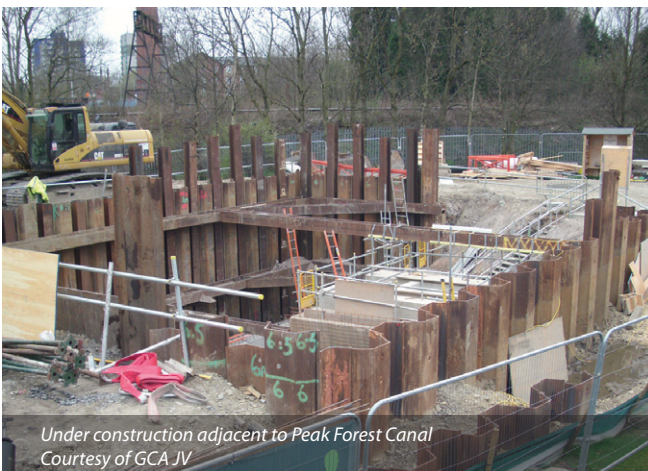
Under construction adjacent to Peak Forest Canal
Courtesy of GCA JV

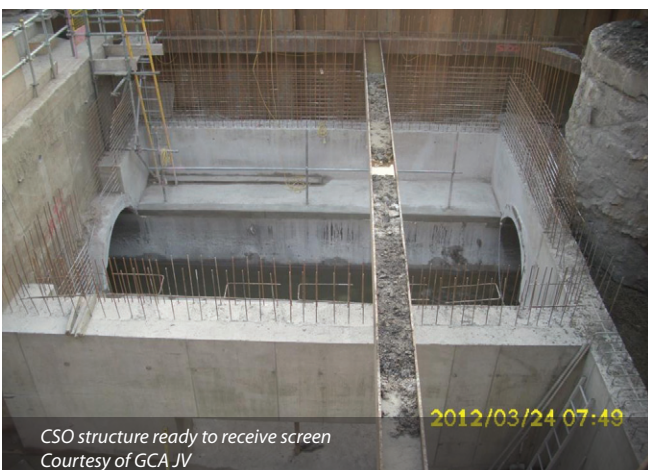
CSO structure ready to receive screen
Courtesy of GCA JV

The structure was designed and built so that the lower half was successfully completed with construction joints allowing the upper half to be built from temporary decking with the remainder of the structure completed safely after the regulatory PIU date. Because the structure had to be completed in a live environment during low
