Knightcott to Banwell (M5) Sewer Repair

collaboration between agencies to renovate strategic sewer under the M5 motorway in Somerset

by Julian Britton IEng AMICE & Daniel Humphrey MBA BSc (Hons)

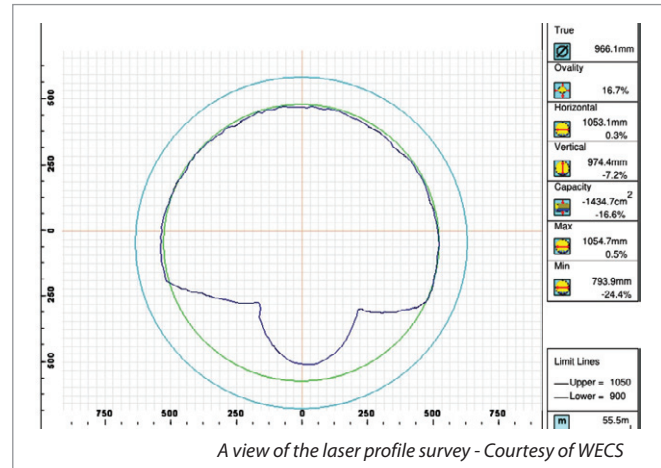
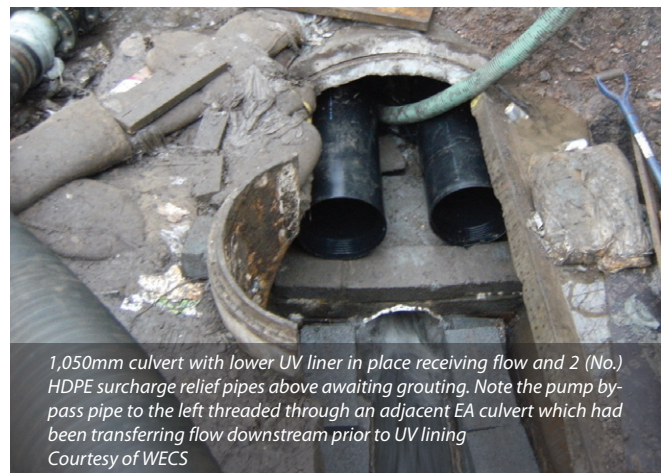
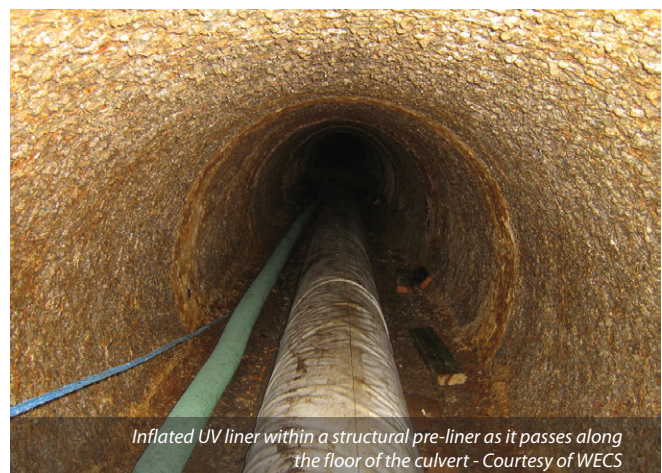
The calculations were complicated by the requirement from the hydraulics engineers to take advantage of a void by placing 2 (No.) HDPE ducts at high level above the UV liner as surcharge relief pipes. Due to the depth of the tunnel under the M5, the load due to soil burden did not significantly impinge on the new pipe/liner due to stabilisation of the existing pipe by filling with a stiff grout. Live loads from main road traffic, flowing along the motorway were negligible at this depth (less than 0.003MPa) according to the Simplified Tables of External Loads on Buried Pipelines, Department of Transport, Appendix II. The structural integrity of the corroded culvert was calculated by power washing the intrados and undertaking a laser profile to establish the degree of wall thickness diminution, all which was finally acceptable; see photograph right middle (Image and service by Exjet of Paignton, Devon).

The backgrouting pressure on the UV liner was not a real concern regarding the possibility of buckling. However, the short term elastic modulus of the plastic liner pipe was temperature sensitive and could have been affected by the heat of hydration of cementitious grout. Grouting in lifts provided the solution to minimising the heat generation effect, along with fans to pass air through the culvert and filling the annulus in three stages was required to allow the insertion of the high level surcharge relief ducts. Buoyancy of the pipes was prevented by balancing the depth of lift against the pipes temporarily filled with water during grout cure.

The renovation team worked closely with the Environment Agency to initiate a Flood Defence Consent, and they agreed use of a parallel culvert for the transfer of sewage by over pumping. To achieve this, the team butt welded a single SDR17 HDPE pipe, 80m long with a 280mm OD, and winched it beneath the motorway (E–F).
