# Blackmill Rainscape Strategy Scheme

works to prevent a poor performing CSO asset from spilling by implementing a series of surface water removal schemes and network enhancements

by Indrajith Maruthonkara MEng and Neil Campbell BEng (Hons) CEng MICE

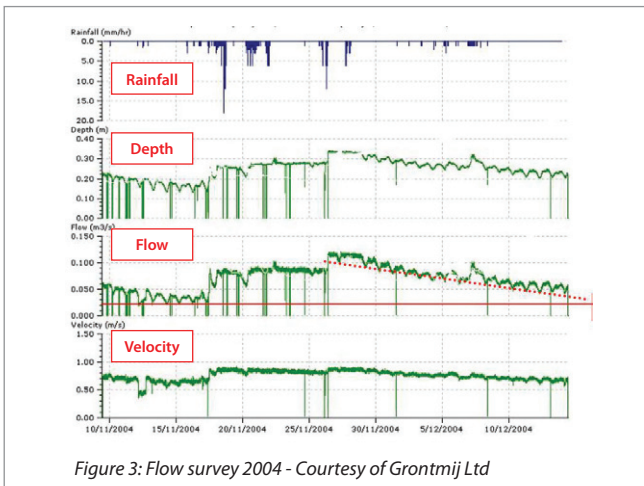
Figure 3 (next page) shows the recorded flow parameters downstream of Blackmill CSO for the survey carried out in 2004/5.

A delayed response of 17 days is evident from the end of the rainfall to the system returning to dry weather flow conditions; during that time the CSO would be operating. The AMP4 proposal was to increase the storage from 1,050m<sup>3</sup> to in excess of 18,000m<sup>3</sup> – this is neither constructible, cost beneficial nor sustainable.

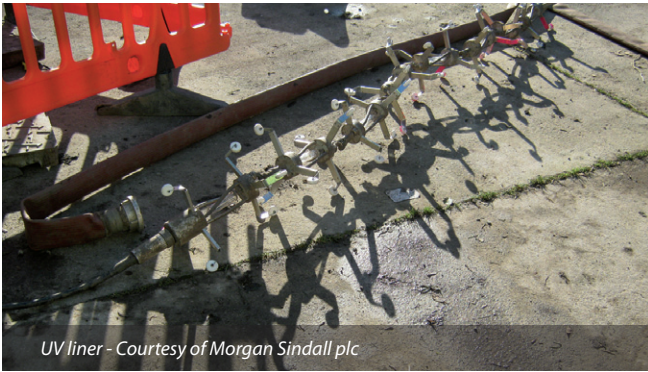
UV liner - Courtesy of Morgan Sindall plc

The lining exercise required work in and around the river, so use of hot cure lining was not advisable, due to the potential of leakage of hot, chemically polluted water into the adjacent river, as well as the removal of that water once the liner was cured. The company therefore used ultra-violet (UV) cured lining. To get the rig through the extremely difficult terrain to the sewer, they fitted the UV rig to "golf buggies" and built a temporary bridge over the Ogmere.

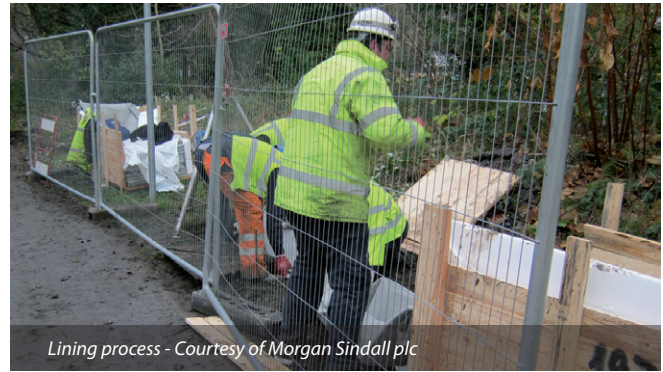
Lining process - Courtesy of Morgan Sindall plc
