Chester Brick Sewer Rehabilitation

replacement of approximately 100m of 1,240mm diameter Victorian brick sewer in the historical city of Chester, working in live flows

by David Jones HNC & Andrew Russell BEng (Hons)

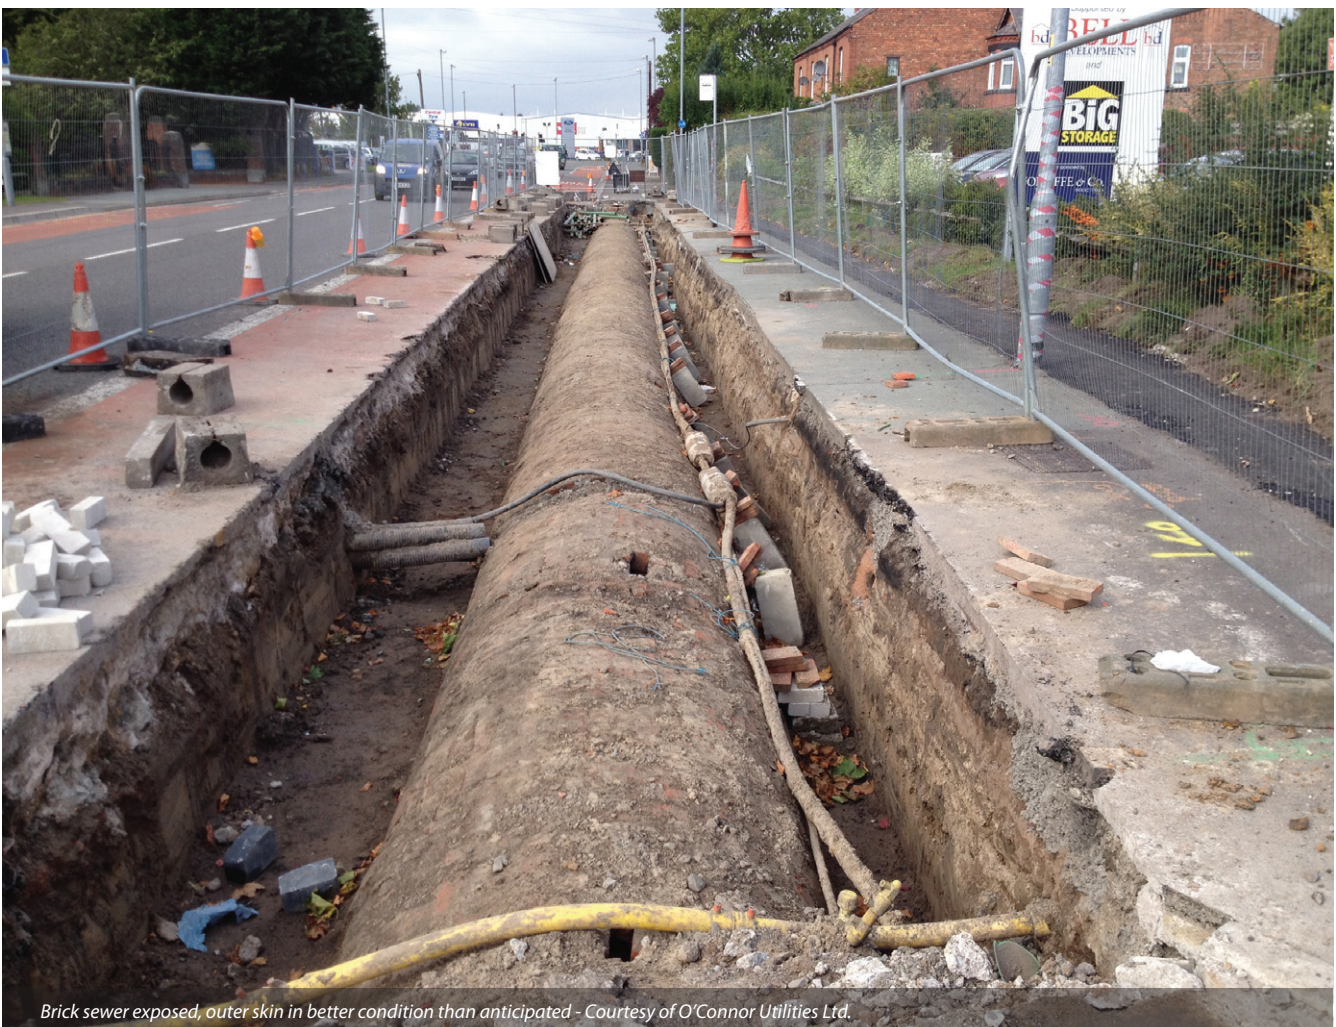
Brick sewer exposed, outer skin in better condition than anticipated - Courtesy of O'Connor Utilities Ltd.

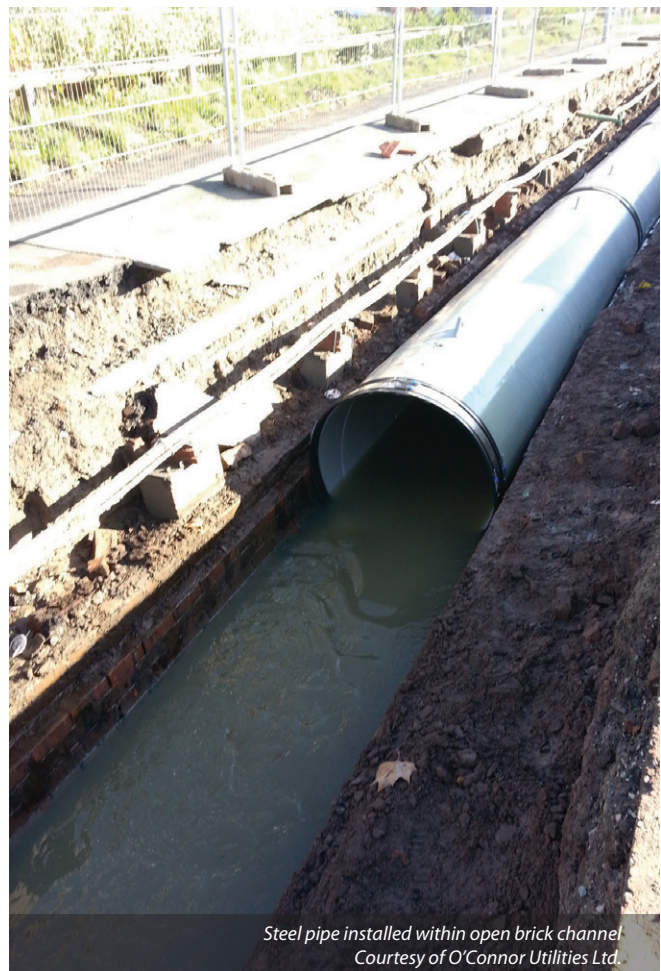
Steel pipe installed within open brick channel
Courtesy of O'Connor Utilities Ltd.

Steel was selected as the replacement pipework material and designed for a shallow depth of cover. Lifting lugs on the lengths of steel pipe were also specified to enable lifting and the lowering of the steel pipe into the brick channel.

The steel pipe featured a Scotchkote Uretane 165 HB internal coating and a Versathane external coating which facilitated sliding of the steel pipe along the brick channel. On completion of the steel pipe installation the gap between the brickwork and new steel pipe at both ends was sealed. Due to the tightness between the new steel pipe and the brickwork the annulus void was filled using a high cement content grout which also displaced any remaining sewage.
