Gorple Upper Reservoir Spillway Improvements

investigating and addressing deficiencies in the capacity of the overflow system

by Kate Speirs MEng

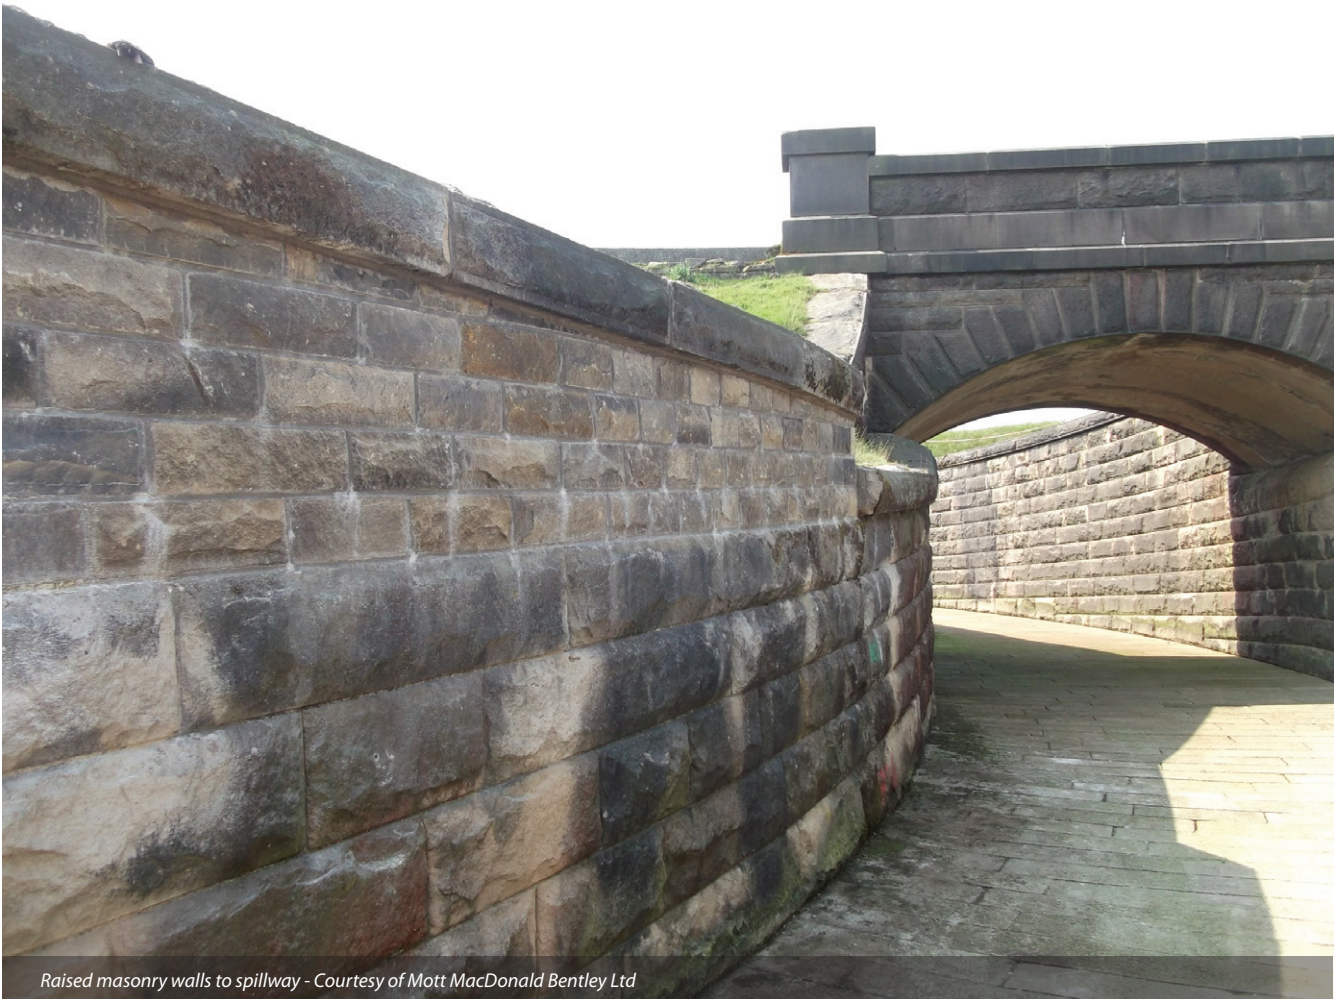
Raised masonry walls to spillway - Courtesy of Mott MacDonald Bentley Ltd

The existing masonry spillway channel was raised via a double-skinned masonry wall, with a concrete in-fill, dowelled into the top of the existing wall.

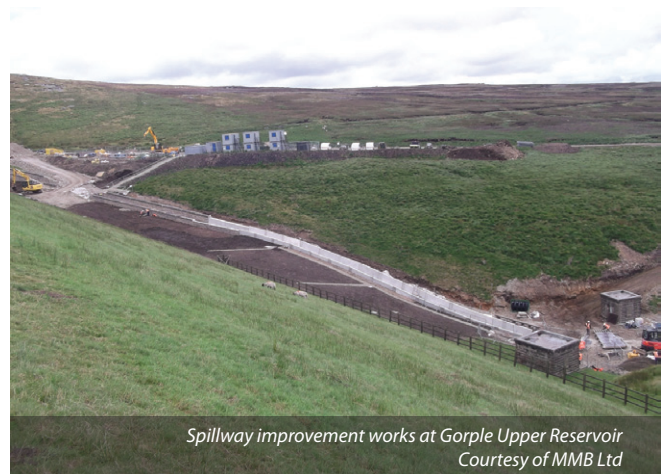
Spillway improvement works at Gorple Upper Reservoir
Courtesy of MMB Ltd

An alternative approach was therefore considered. This was to retain the existing spillway channel and simply line it with concrete in order to raise the walls and protect the existing masonry channel from high PMF flow velocities.

MMB considered a number of lining options including the use of in situ and sprayed concrete, however precast concrete wall units offered the greatest time, cost and safety benefits, and were therefore chosen as the preferred option to take forward. This utilised the standardised precast concrete wall panel product that MMB have developed in collaboration with supply chain partner Carlow Precast Concrete Engineering Ltd. It was important

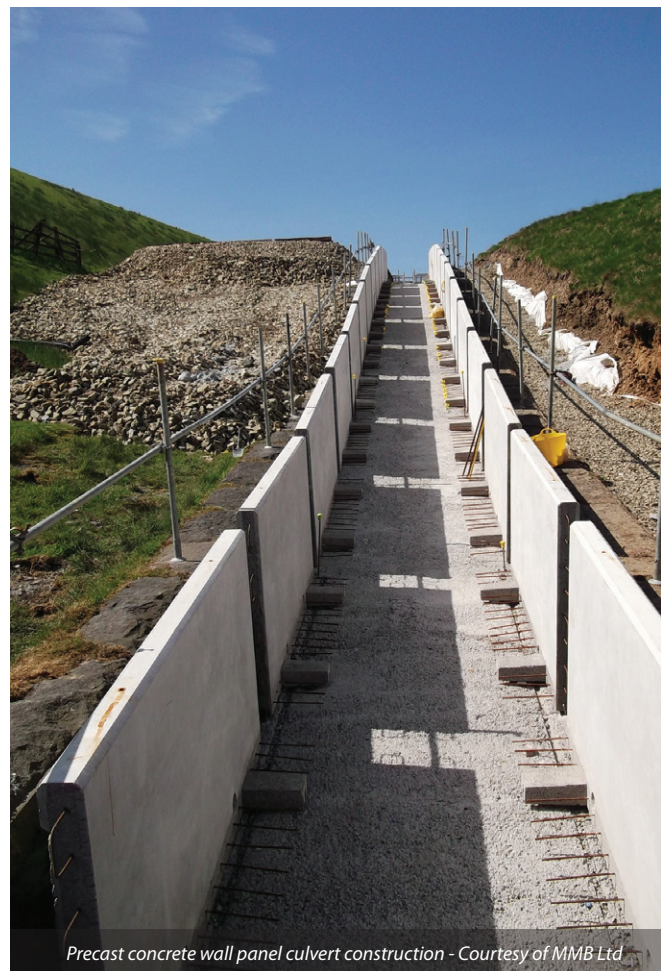
Precast concrete wall panel culvert construction - Courtesy of MMB Ltd

The model results led to the outline solution that the spillway walls required raising and the lower section of masonry spillway, where flow velocities were predicted to exceed the asset standard, required replacing with reinforced concrete as per Yorkshire Water's Asset Standard. A number of design concepts for dealing with flows overtopping the stilling basin were trialled during the physical model testing, with the most successful being the placement of a rectangular culvert in the stilling basin to direct flows to the downstream watercourse.

to maximise the channel's internal width and therefore the standard wall panel design was altered for this project by means of shortening the rear stabilising feet and lengthening the front feet so that the main body of the wall panels could sit as close as possible to the existing channel walls, without compromising the wall panel's stability during construction.

The wall panels were placed within the existing spillway channel and jointed together with minimum 400mm wide concrete infills. The channel invert was then lined with a 200mm thick in situ concrete base which covered the front feet of the wall panels. The 150mm wide void between the back of the wall panels and the existing channel walls was filled up to ground level with concrete.

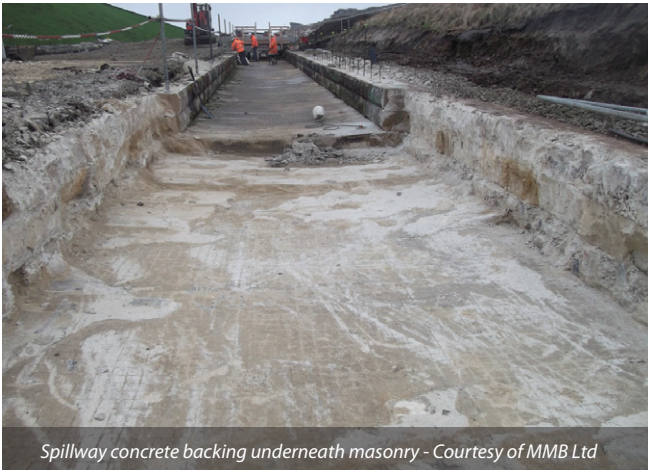
Spillway concrete backing underneath masonry - Courtesy of MMB Ltd

YWS was keen to adopt the same approach at Gorple Upper; however the spillway was too small to conduct pull-out tests. As an alternative, MMB cored through the spillway to assess the condition and depth of the masonry and concrete backing, and the bond between the two. A detailed inspection of the spillway with YWS and the QCE facilitated the shared conclusion that the existing masonry spillway was in good condition and therefore should be able to withstand higher flow velocities than specified in the Asset Standard. MMB, YWS and the QCE agreed to deviate from the Asset Standard in this case and allow the spillway to be constructed in masonry up to the beginning of the steepest section of the spillway. Beyond this point, the spillway would then be constructed in reinforced concrete.

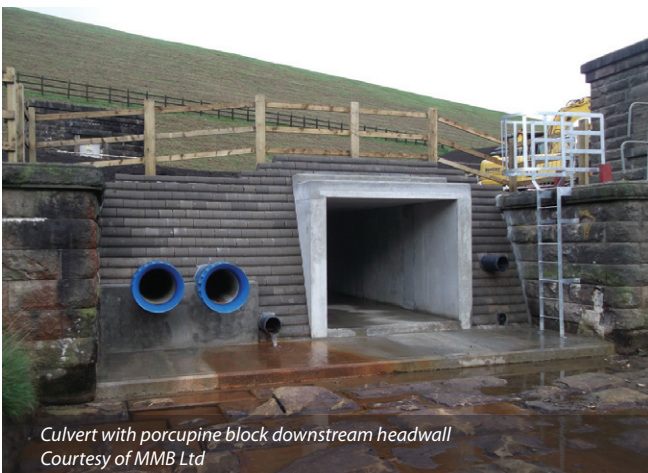
Culvert with porcupine block downstream headwall
Courtesy of MMB Ltd

As the culvert would efficiently direct flows from the stilling basin to the downstream watercourse, the remaining volume of the stilling basin was effectively redundant, except for taking drainage flows, and flows from the scour and supply mains discharging from the valve house. Therefore these pipes were extended through the stilling basin and the surplus stilling basin volume was backfilled.

To retain this backfill material a downstream headwall was required. Due to the site having difficult access routes for concrete delivery, the headwall was constructed from Porcupine blocks which provided a much more practical solution than in situ concrete. These also allowed increased drainage through the headwall compared to a solid concrete headwall.

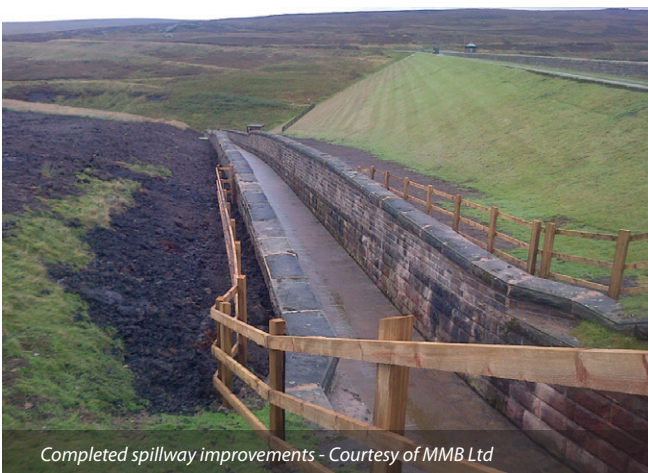
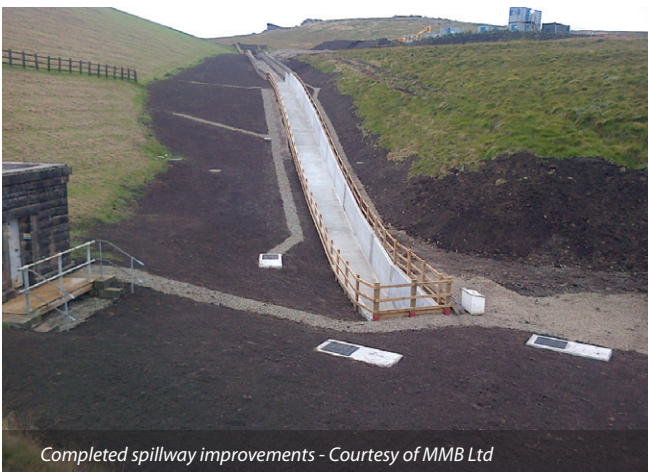
Completed spillway improvements - Courtesy of MMB Ltd

In order to minimise visual impact, the wall panels were cast with a masonry-effect form-liner finish on their outside faces for the portion that would extend above finished ground level. In addition, a 'false coping' was cast at the top of the wall panels.
