# Val de la Mare Dam

## monitoring with fibre optics

by Hugo Willson BEng (Hons) CEng MICE

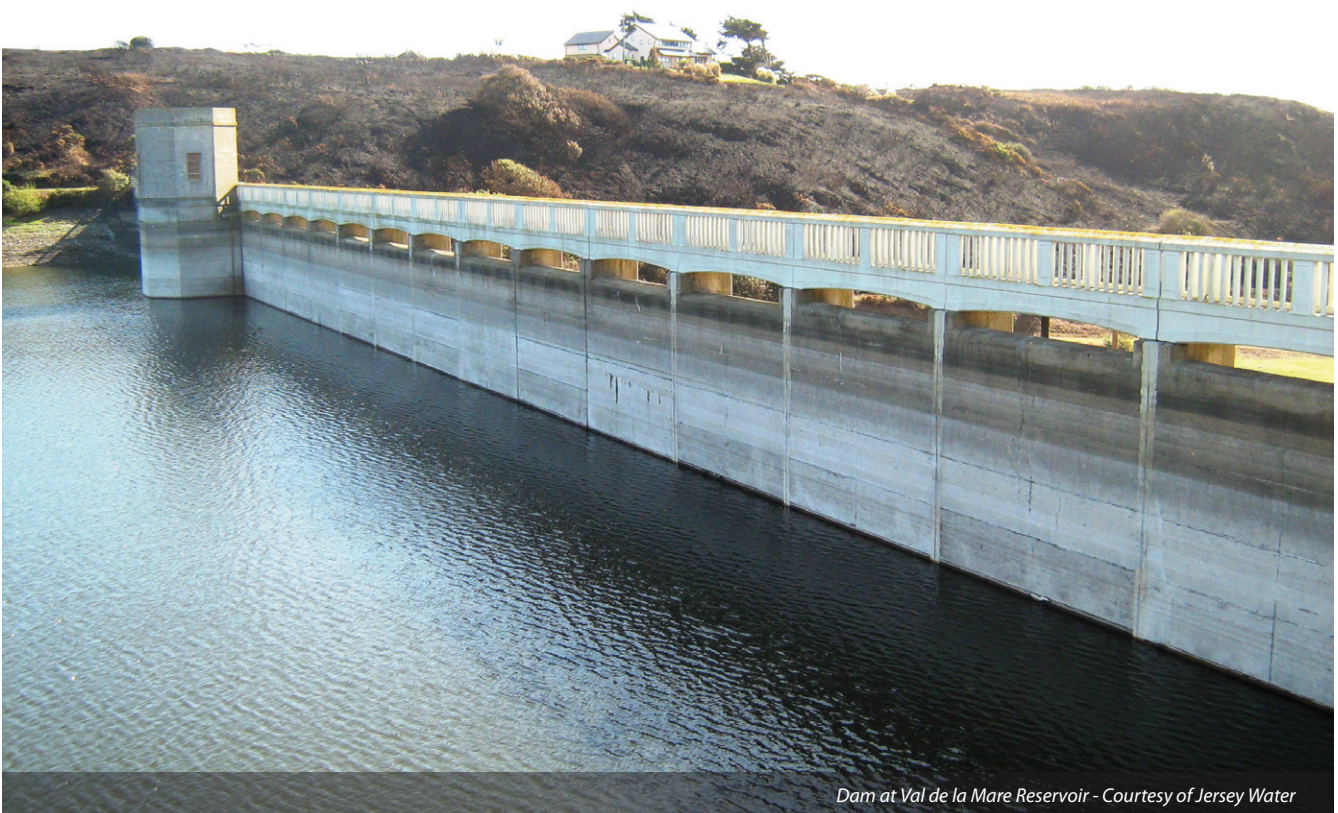
The Island of Jersey is situated in the English Channel, 100 miles south of the English coast. Jersey Water produces the Island's potable drinking water, supplying over 90% of the Island's population of 100,000 and operates six major reservoirs. Val De La Mare Reservoir has a mass concrete dam situated on the west side of Jersey and was constructed between 1957 and 1962. The storage volume of the reservoir is 938.7ML with a catchment area of 350 hectares. When full, Val de la Mare accounts for 35% of Jersey Water's available raw water storage. Crest length is 192.9m, maximum dam height is 29m above general foundation level and maximum water depth is 24.31m. The dam was constructed in 27 monoliths (blocks), each 6.7m wide formed in 1.2m lifts. The dam is owned and operated by Jersey Water.

*Dam at Val de la Mare Reservoir - Courtesy of Jersey Water*

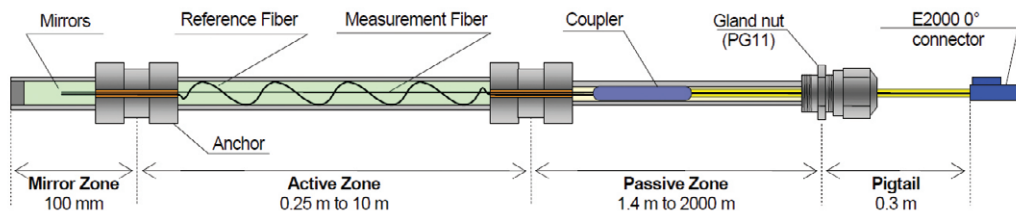
Diagram 1: Sensor configuration - Courtesy of Jersey Water

Diagram 1 (above) shows the structure of the sensors.

The sensor is composed of two main parts, active and passive. The active part contains the reference and the measurement fibres and measures the deformation between its two ends. The passive part of the sensor is insensitive to deformations and is used to connect the sensor to the reading unit.

In the summer of 2013, Jersey Water placed an order for 6 (No.) 10m long Smartec SOFO Standard Deformation Fibre Optic sensors complete with SOFO VII/MuST Universal Reading Unit. The SOFO deformation sensors are transducers that transform a distance variation into a change in the path unbalance between two optical fibres that can be measured with the SOFO reading unit.

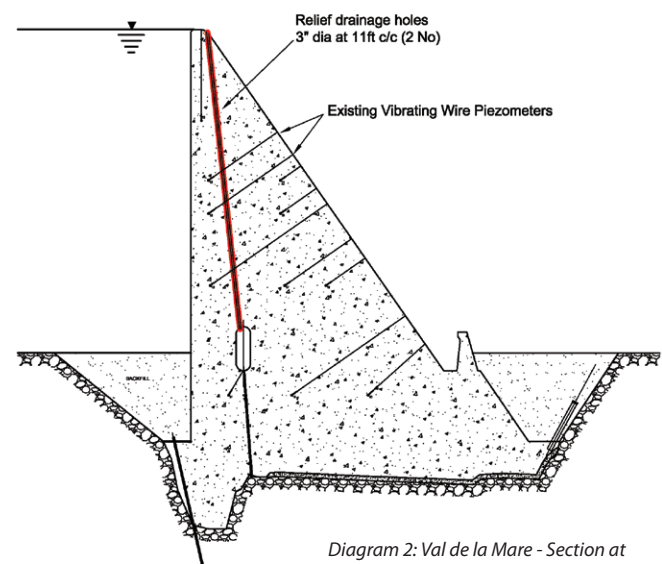
Diagram 2: Val de la Mare - Section at Block 16 - Courtesy of Jersey Water

During October 2013 Smartec engineers came to Jersey to install and commission the SOFO sensors. The sensors have been installed in pairs in three of the existing vertical drain holes. The location of the drain holes is shown in red on Diagram 2 (right).

The dam gallery runs between Blocks 10 and 19 inclusive, although blocks 10 and 19 do not contain any vertical drain holes. Drain holes in blocks 12, 13 & 14 were not suitable for use as they form the primary spillway and it was agreed that thermal effects of spilling water might not allow fair comparison of data between the blocks. The table below shows reasons behind the final choices of blocks to monitor.

Prior to the Smartec installation visit, scaffolding was erected at crest level at dam Blocks 11, 15 & 18 to allow access to the drain holes. To enable fixing of the upper tension brackets a wedge of concrete was removed from each of the 3 locations to provide a flat, level surface.

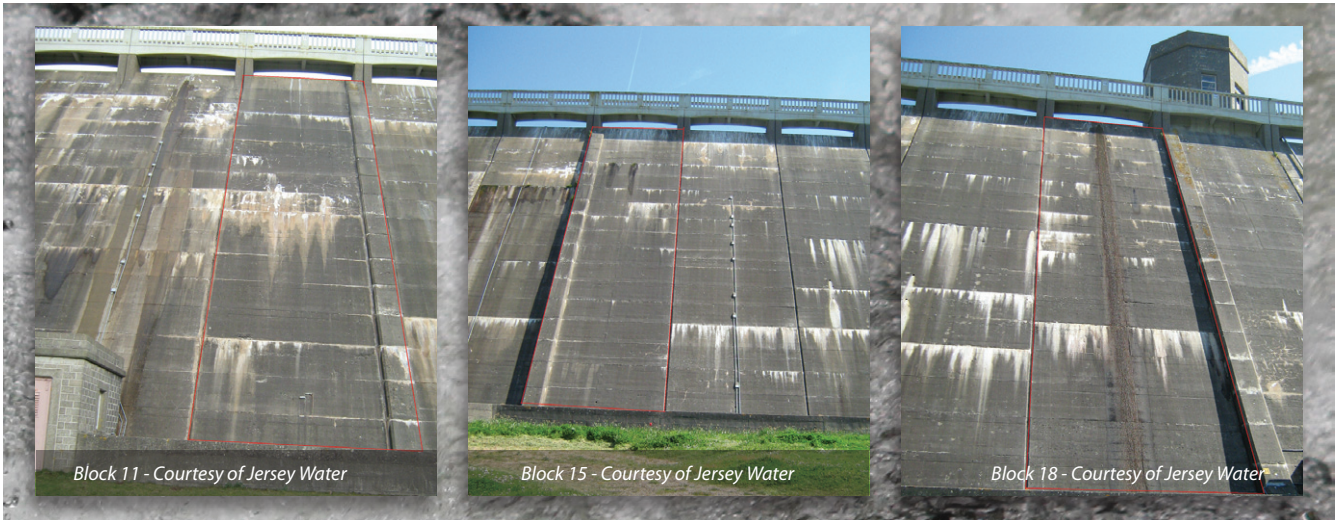
Once the sensors were installed to the drain holes, fixed and tensioned, the commissioning and training phase was able to start. The output from the Smartec reading unit has been successfully linked to the Jersey Water SCADA system to provide a visual output showing historic trends. See diagram below showing a SCADA output for Block 11.

Since commissioning at the end of October, a trend in the sensor pairs has been showing a decrease in length of approximately 1.6mm over the length of the 20 metre sensors. Readings have been taken at 4 hour intervals each day. The decrease witnessed so far can be attributed to colder weather induced contraction of the dam structure, as over the 4 weeks since installation was completed, temperatures have dropped locally by some 12°C.
