# Knitsley STW

## filter refurbishment and modification works to a medium sewage treatment works

by Grant Crawford

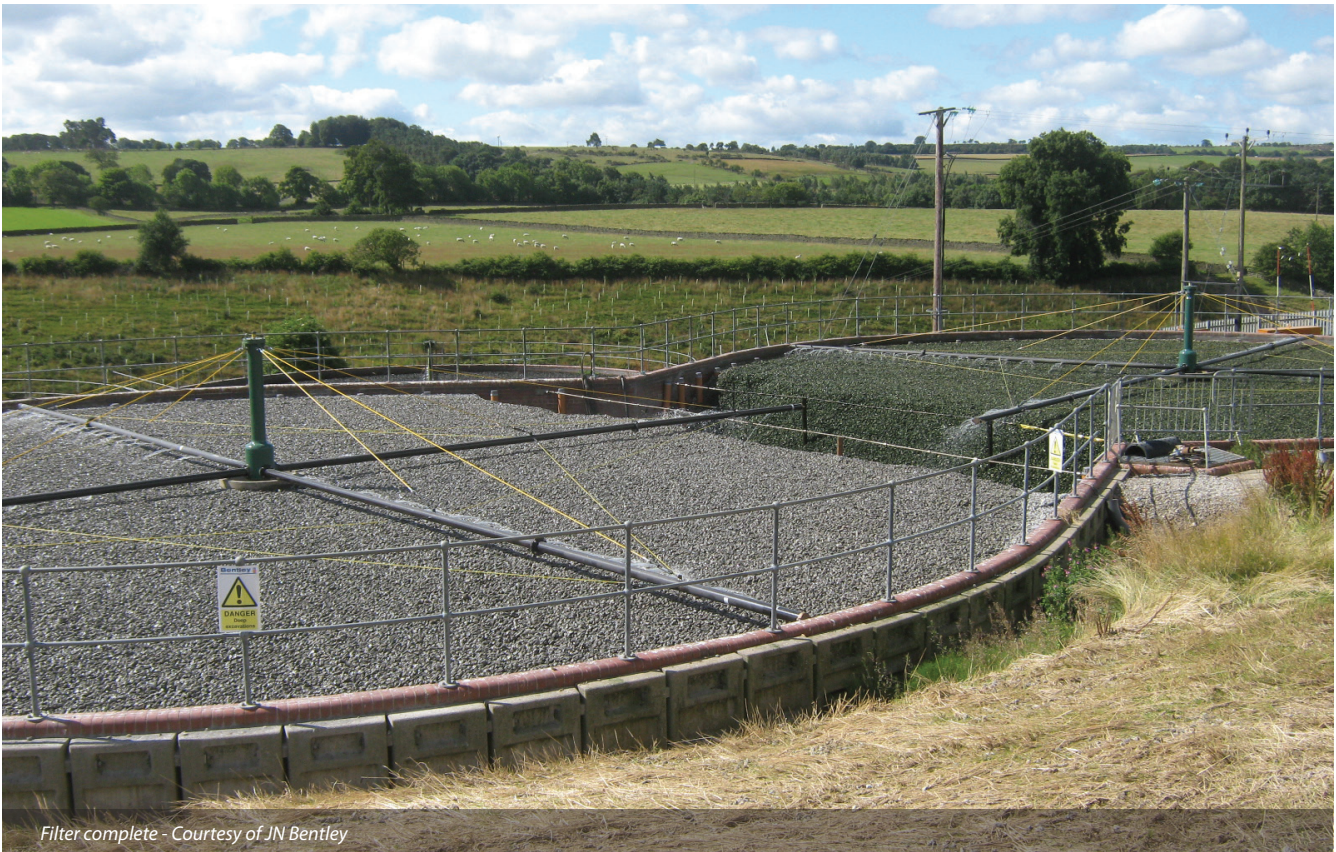
Filter complete - Courtesy of JN Bentley

Refurbishment of the three older 23m diameter filter beds included replacement of the stone media, tiles, and under-drains, installation of new distributors and local repairs to the brickwork walls.

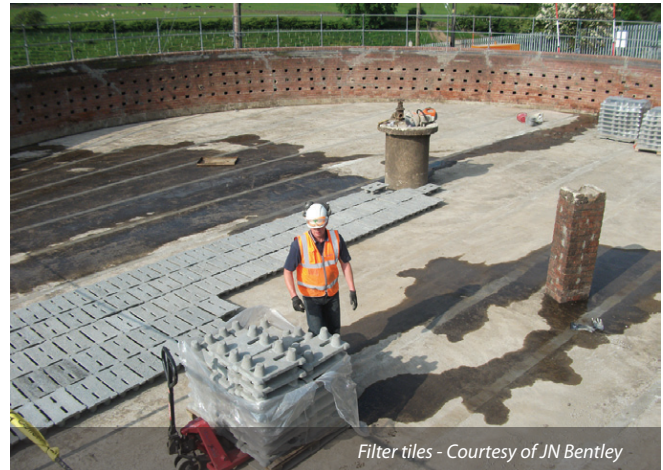
Filter tiles - Courtesy of JN Bentley

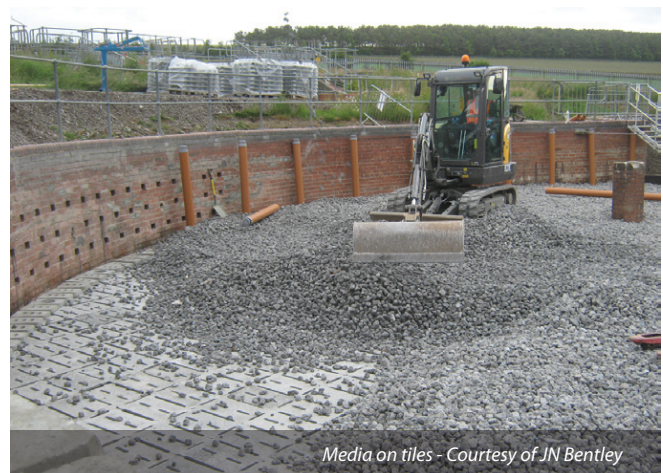
Media on tiles - Courtesy of JN Bentley

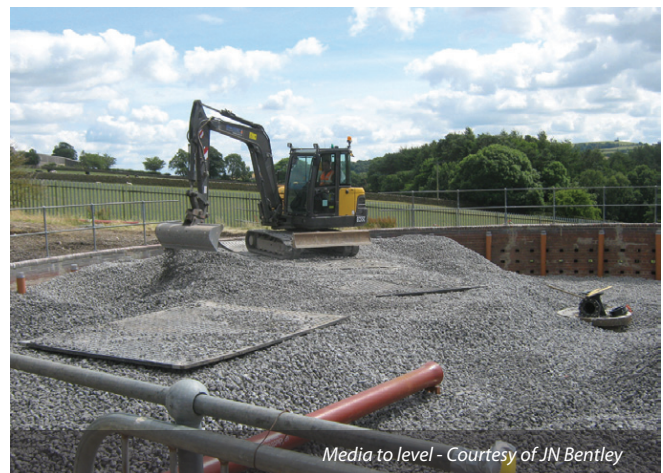
Media to level - Courtesy of JN Bentley

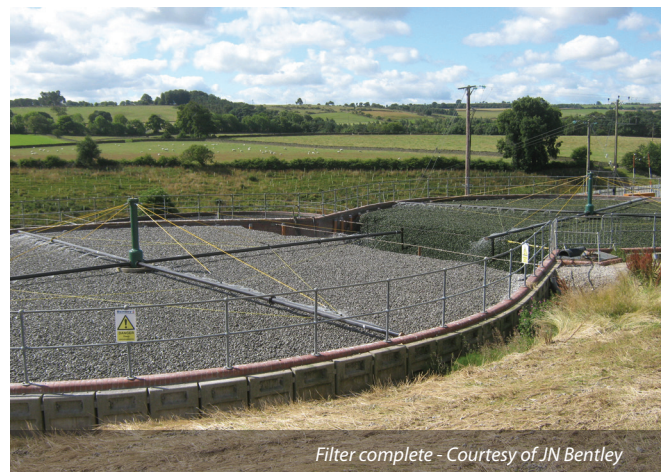
Filter complete - Courtesy of JN Bentley
