Electro Scan

a quantum leap in the identification of sewers subject to groundwater infiltration

by Julian Britton IEng AMICE & Chuck Hansen MBA (UCLA)

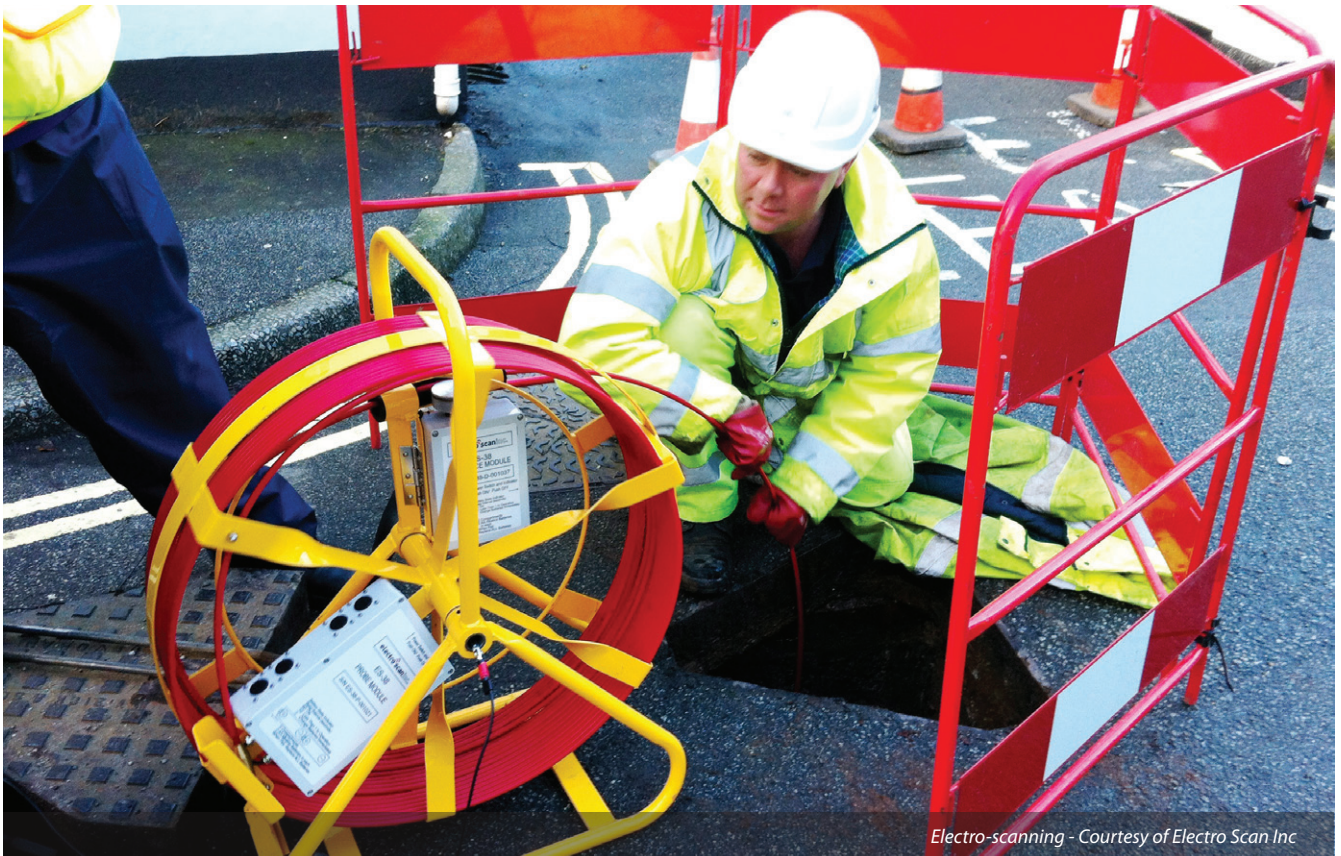
Electro-scanning - Courtesy of Electro Scan Inc

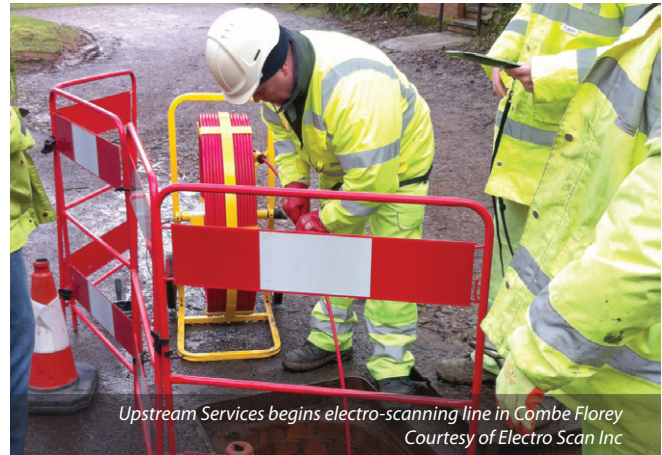
Fig 3. Typical Electro Scan trace for Combe Florey - Courtesy of Electro Scan Inc

The base line is set at 100 and results below that are discounted. You will note two longitudinal cracks at around 5m downstream are elevated at over 700, and the area under the curve gave a quantitative cumulative infiltration flow for this section of pipe of 66l/minute.

The trials at Combe Florey included undertaking the full survey with Electro Scan twice on consecutive days. This would allow us to compare the two graphs by over lay, which shows the system to be accurate and repeatable. Slight variations occur due to difference in speed of transducer transient pull through and slight reduction in the external water pressures and flows.
