Baitings Gate Bridge Refurbishment

preservation of an asset to provide a low-maintenance safe crossing of the reservoir for the public

by Paul Bennett PhD MEng

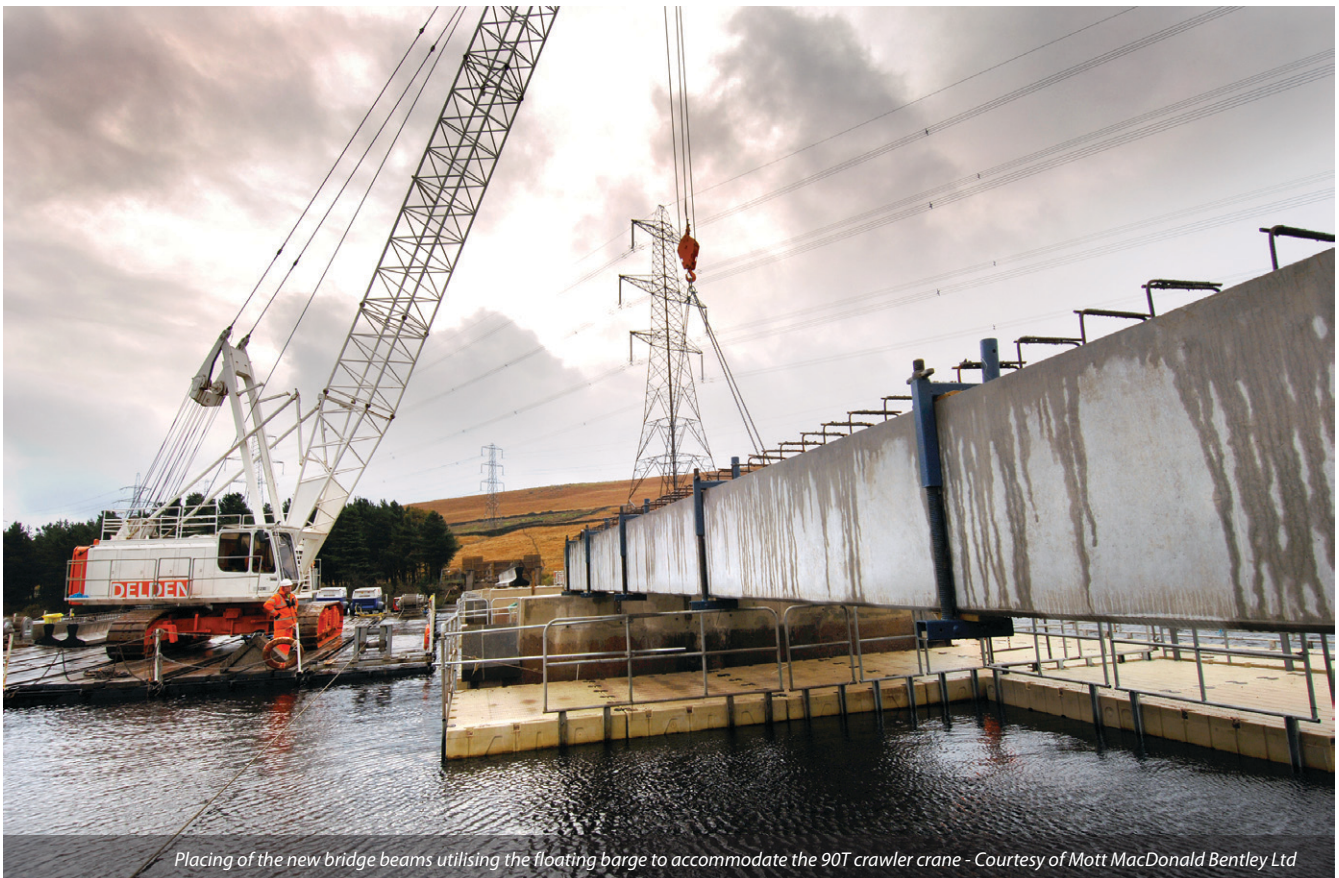
Placing of the new bridge beams utilising the floating barge to accommodate the 90T crawler crane - Courtesy of Mott MacDonald Bentley Ltd

Operational constraints on water level (0 to 2m below top water level) led the team to propose a barge and crane arrangement (both in demolition and construction). MMB worked closely with YWS to maintain the level in the reservoir both for operation and construction.

Using a crane on floating pontoons also presented new challenges as the largest crane that could safely be supported by the barge was only just within radius for the heavy beam lifts. Overhead power lines on the west side of the bridge restricted the crane to only work on the opposite side. Therefore, detailed planning of the lift sequence, barge position and amount of ballast required to trim the barge was required for all 117 (No.) beam lifts.

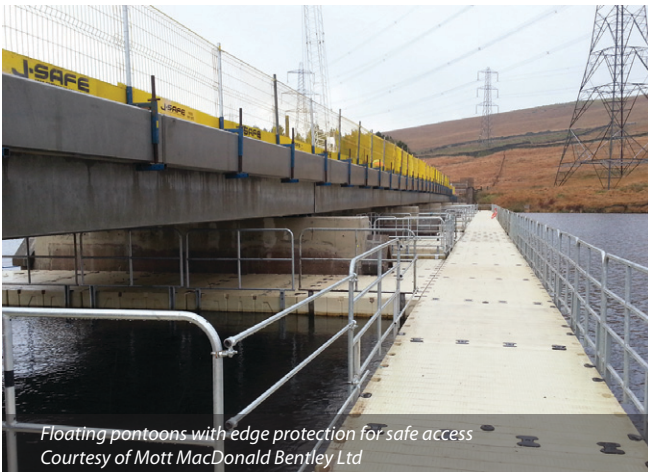
Floating pontoons with edge protection for safe access
Courtesy of Mott MacDonald Bentley Ltd

The water level also ruled out the possibility of using scaffolding during the pier refurbishment. Alternatively, a series of floating pontoons with edge protection were used to provide a safe working platform with workers wearing life jackets.

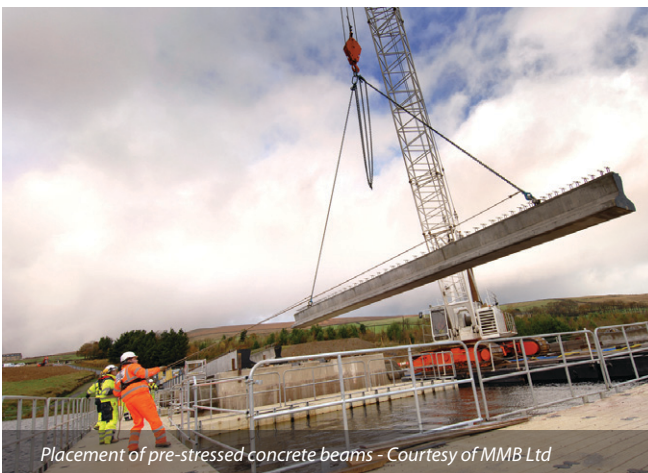
Placement of pre-stressed concrete beams - Courtesy of MMB Ltd

MMB worked in close collaboration with specialist precast concrete supplier Banaghers to utilise TY and TYE pre-stressed concrete bridge beams, providing large savings in terms of material and, therefore, embodied carbon.

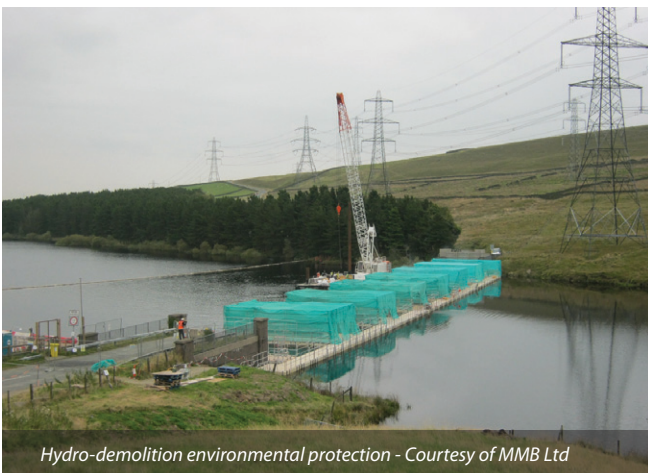
Hydro-demolition environmental protection - Courtesy of MMB Ltd

Hydro-demolition was used to remove the existing concrete from the pier tops in order for them to be repaired and re-cast. During hydro-demolition the piers were surrounded by netting to prevent debris entering the reservoir. Following hydro-demolition it was found that the existing pier reinforcement had suffered from chloride attack. Sacrificial anodes were cast in situ to protect both the new and existing reinforcement.

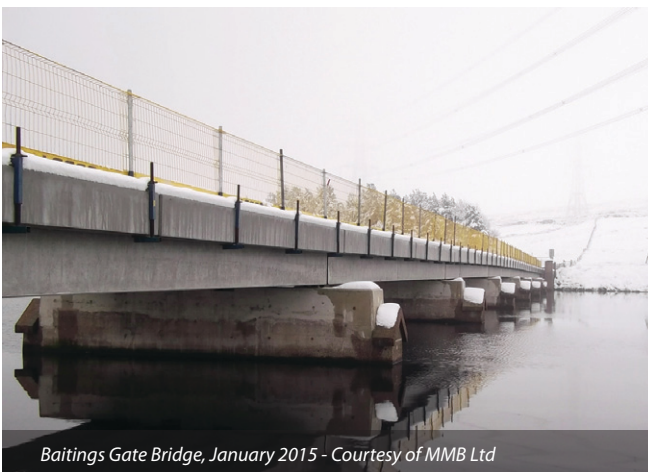
Baitings Gate Bridge, January 2015 - Courtesy of MMB Ltd

There was a need at Baitings Bridge to ensure relatively straightforward maintenance of the bridge structure and bearings. This was achieved by modifying the design to provide two bearings per bridge beam rather than the more traditional one. This allows the bridge deck to be jacked-up for bearings to be replaced as and when necessary. Another benefit of this part of the design is that it removes the need for a complete set of concrete diaphragms between the beams themselves as these would originally be used as jacking points.
