# Beaver Dyke Reservoir

## reservoir discontinuance - removing reservoir from the Reservoirs Act 1975 by excavation of over 20,000m<sup>3</sup> of embankment fill

by David Rebollo BEng MSc

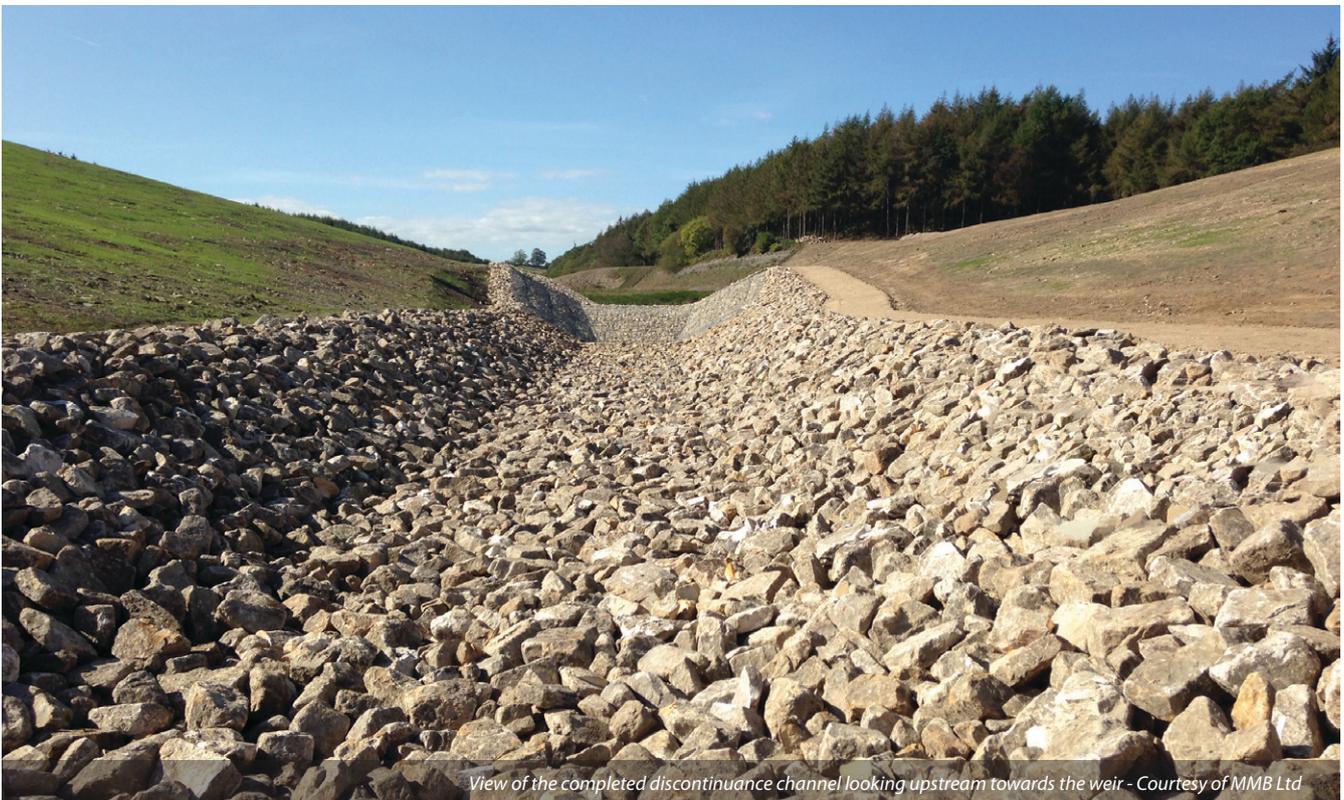
*View of the completed discontinuance channel looking upstream towards the weir - Courtesy of MMB Ltd*

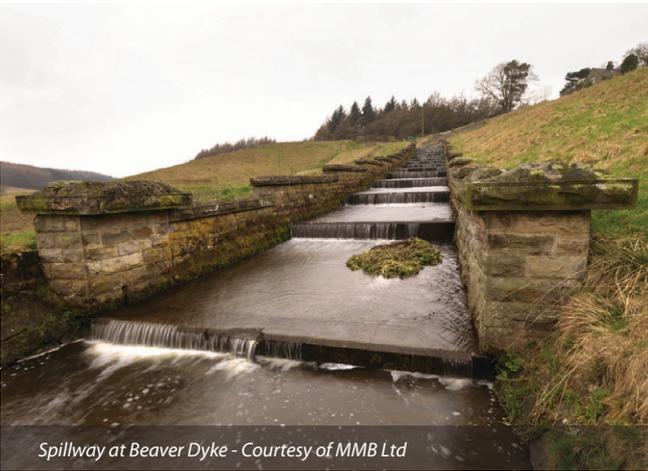
Spillway at Beaver Dyke - Courtesy of MMB Ltd

The overflow arrangement was situated at the north end of the dam and comprised of a stepped semi-circular weir, discharging into a tumble bay area followed by a stepped, masonry channel.

The 160m long spillway channel would cascade down the left mitre of the embankment (looking in the downstream direction) with the masonry overflow weir controlling the Top Water Level (TWL) of the reservoir at an elevation of 169.90m AD.

The top 85m of spillway was a rectangular channel of masonry construction whilst the remaining section was trapezoidal in section and formed from stone block work. A circular, masonry clad, brickwork valve tower was located on the upstream face at the centre of the embankment. The valve tower housed the reservoir's draw-off and scour arrangement, discharging into the scour channel at the toe of the embankment and the raw water supply main which ran alongside the scour channel before continuing down the valley to Harlow Hill WTW.

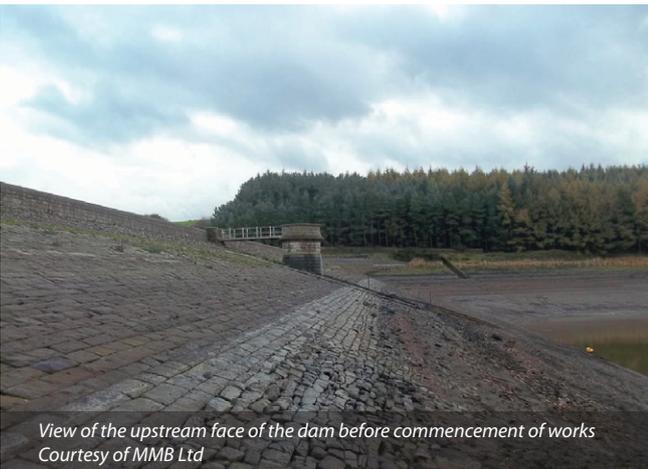
View of the upstream face of the dam before commencement of works  
Courtesy of MMB Ltd

The upstream face of the embankment was protected with masonry pitchings with a gradient of approximately 1 in 3. The downstream embankment was grass-covered and had an approximate gradient of 1 in 2. A vehicle access track ran along the crest adjacent to a 1.1m high masonry wave wall for the full length of the embankment.

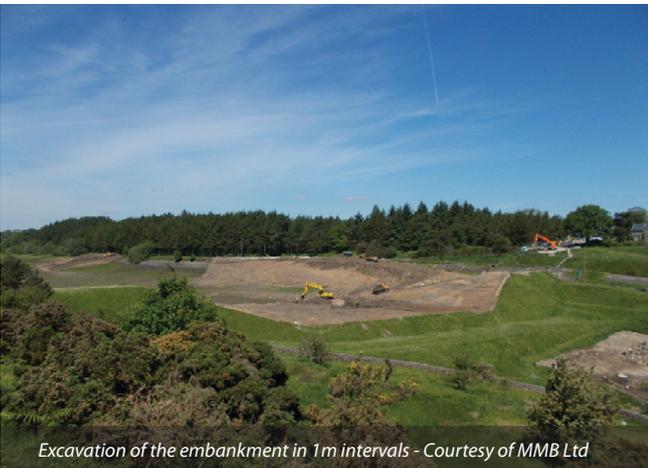
Excavation of the embankment in 1m intervals - Courtesy of MMB Ltd

The 14m deep excavation to reduce the impounding level was carried out in 1m benches, leaving a 1 in 4 slope at either side. A series of excavators and tracked dumpers worked simultaneously to progress the excavation. The use of Building Information Modelling (BIM) and 3D modelling has been instrumental in delivering this aspect of the works. The model formed the basis for setting out such that the changing working area and excavation volumes could be interrogated at each stage. This was key in programming the construction, adapting to the changing risks, and communicating with client and third parties.

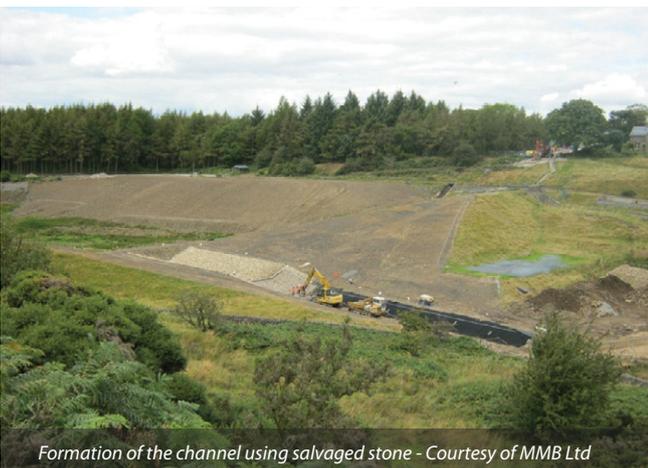
Formation of the channel using salvaged stone - Courtesy of MMB Ltd

The vertical alignment and cross-section of the channel have been designed to yield optimum hydraulic conditions for the channel to be of salvaged stone rather than concrete, masonry or other imported materials. This not only resulted in a significant reduction to the visual and environmental impacts of the works, but also provided substantial cost and programme savings to the client and consumer.

Economic sustainability has been ensured by constructing a quasi-natural channel made entirely of locally sourced stone. An impermeable liner has been used to minimise its tendency to meander and overgrow, thus minimal maintenance is expected.

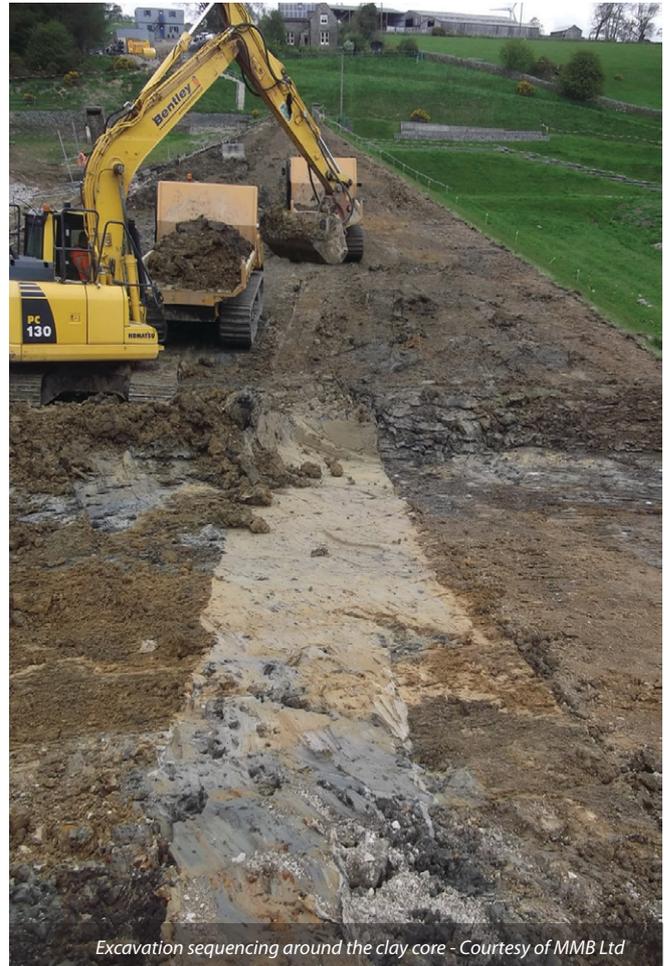
Excavation sequencing around the clay core - Courtesy of MMB Ltd

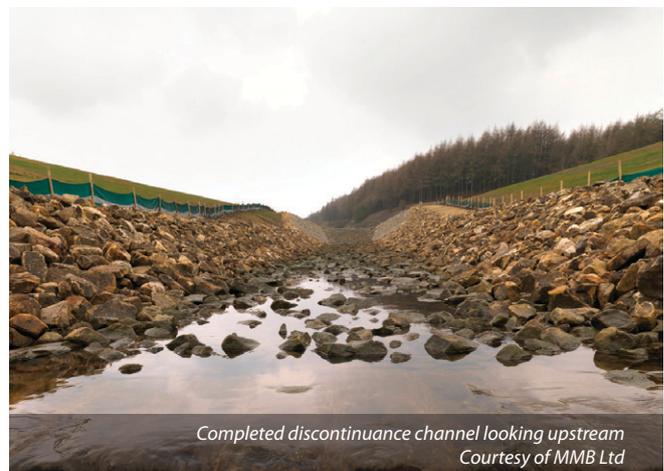
Completed discontinuance channel looking upstream  
Courtesy of MMB Ltd

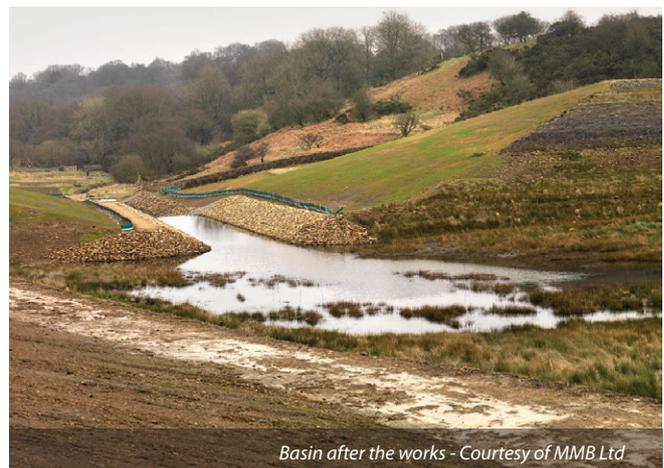
Basin after the works - Courtesy of MMB Ltd

In addition, the restoration strategy has been integral to the scheme from the early design stages. Parts of the draw-down zone have been retained to enhance marginal habitats as well as creating new habitats where fill has been placed and allowed to naturally re-vegetate. Whilst it may take longer for the ground flora to fully
