Loch Arklet Reservoir

largest anchoring scheme for Scottish Water

by Jeff Forrester

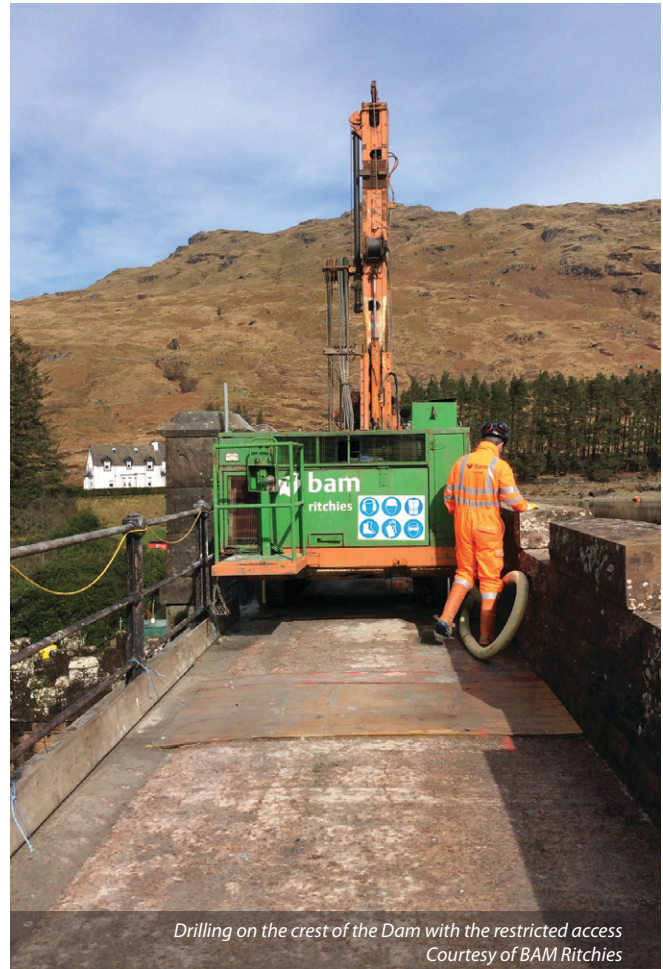
Drilling on the crest of the Dam with the restricted access
Courtesy of BAM Ritchies

The works have been completed on the top of the dam which is 2.7m, making access very restrictive and challenging, adding risks of working at height, working beside water, rotating drill rigs and plant movement.

Manhole chambers were constructed in the dam using large diameter coring and saw cutting in advance of the anchor hole drilling. Bam Ritchies' Hutte KBR 203 drilling rig with a Numa RC100 Challenger down-the-hole hammer was then used to drill the 311mm diameter anchor holes into the schist bedrock, which includes quartz veins.

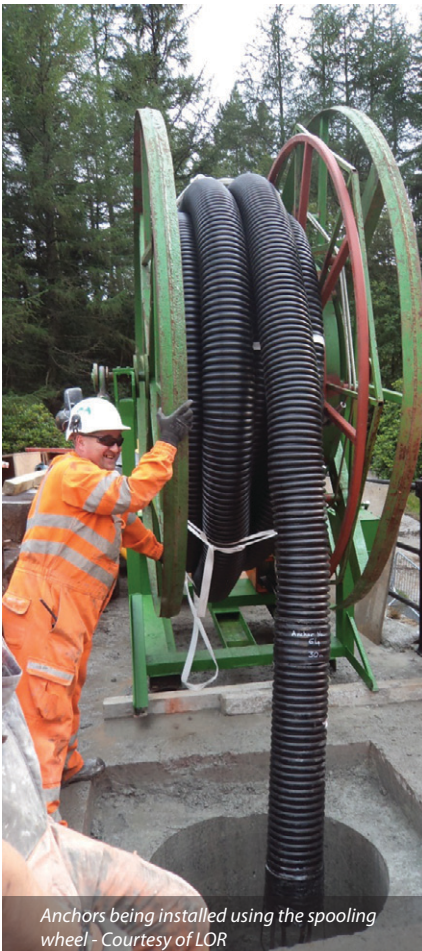
Anchors being installed using the spooling wheel - Courtesy of LOR

A protective nose cone was fitted to the base of the anchors and each was delivered to site on special ring frames, which fit onto BAM Ritchies anchor spooling wheel. Due to the narrow and undulating single track road from nearby Aberfoyle, articulated lorries could not be used, so only four anchors in their frames were delivered at a time.

Using BAM Ritchies' specialist hydraulically-powered anchor spooling device, the anchors were installed by flooding the sheathing internally to overcome buoyancy.

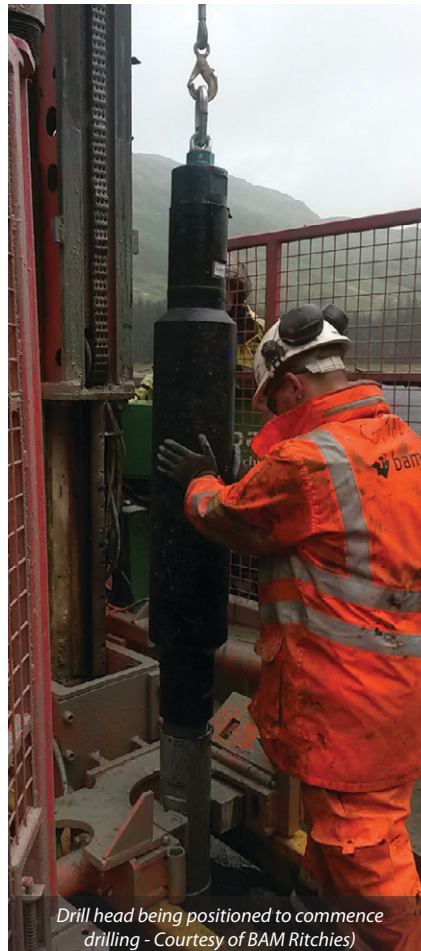
Drill head being positioned to commence drilling - Courtesy of BAM Ritchies)

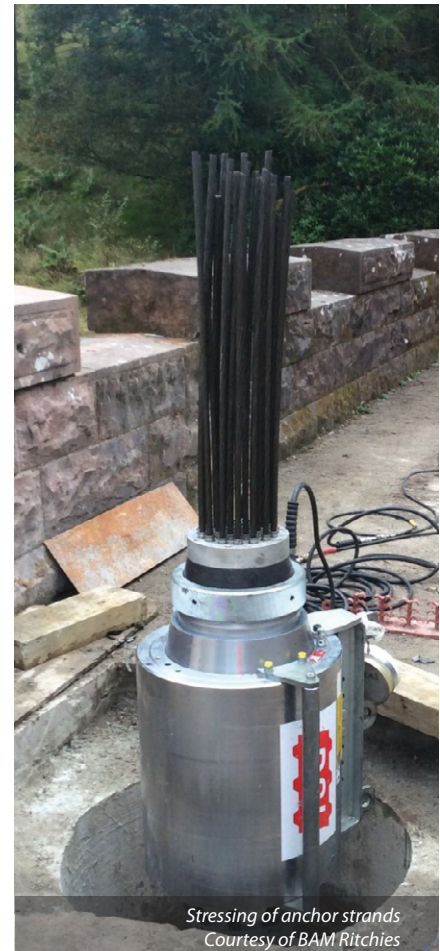
Stressing of anchor strands
Courtesy of BAM Ritchies

A 6,800kN long stroke jack with internal gripping wedges was brought in from Dywidag in Germany to test and stress the anchors, which were locked off at 110% of working load. This is thought to be the highest capacity anchor stressing jack in the UK at the moment and, since it operates differently from conventional strand anchor jacks, the site team had to develop modified stressing and testing procedures.

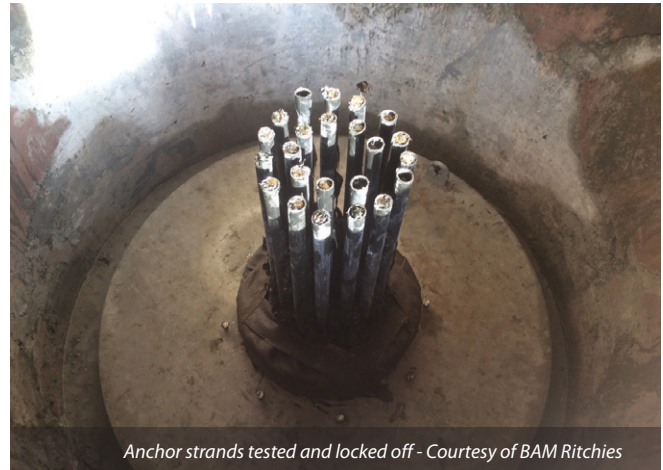
Anchor strands tested and locked off - Courtesy of BAM Ritchies

In advance of the main works, the team installed and tested a trial anchor to prove BAM Ritchies' in-house design. Three of the working anchors were also 'suitability' tested and all anchors have 'acceptance' tests at 1.5 times design working load to BS EN 1537.

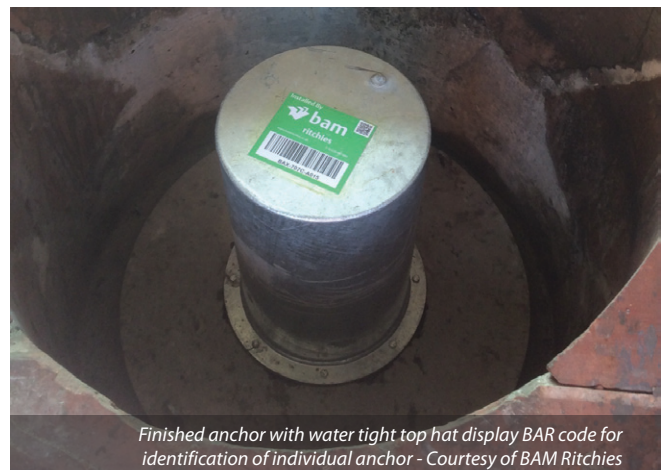
Finished anchor with water tight top hat display BAR code for identification of individual anchor - Courtesy of BAM Ritchies

All anchor heads are fitted with sealed corrosion-protected 'top hats' within the manholes. A major benefit to Scottish Water is that the anchors have re-stressable head details; in other words, long caps to accommodate 450mm protruding strands. This enables re-stressing of the entire anchor or individual strands in the future, if any drop off of load is detected.

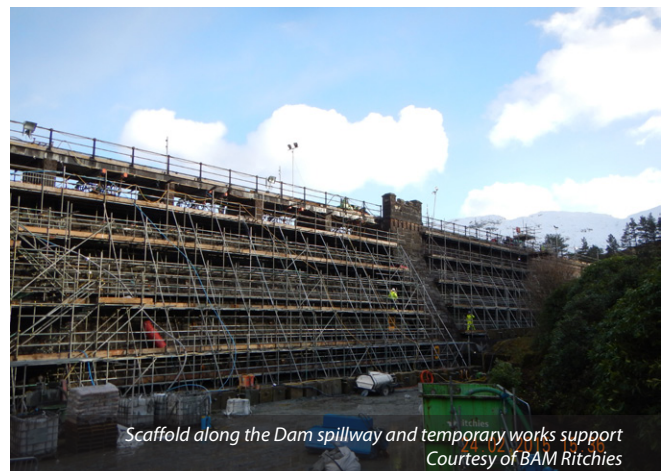
Scaffold along the Dam spillway and temporary works support
Courtesy of BAM Ritchies

- Design and installation of 64 (N0.) rock anchors from the dam crest through the body of the structure and into underlying rock foundation depths varying from 25m to 52m, including:
 - ▲ All temporary works necessary to permit the anchors to be installed and tested. (includes scaffolding and access roads).
- Replacement of span 1 of the overflow bridge and repairs to the abutment.

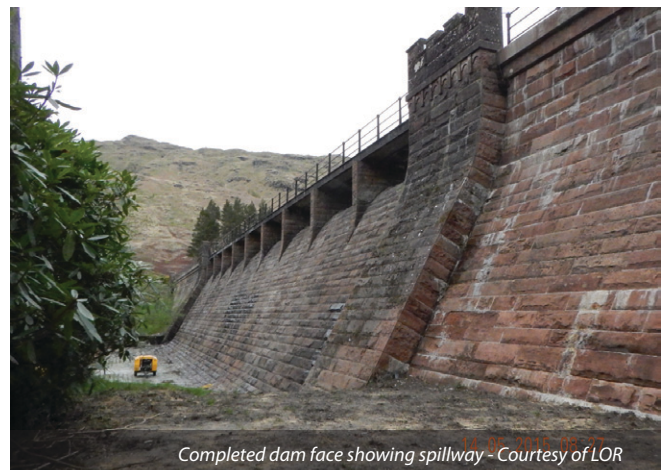
Completed dam face showing spillway - Courtesy of LOR
