Watersheddles Reservoir Spillway Improvements

innovative solutions to meet challenging site conditions
and maintain compliance with the Reservoirs Act 1975

by Kate Speirs CEng MICE

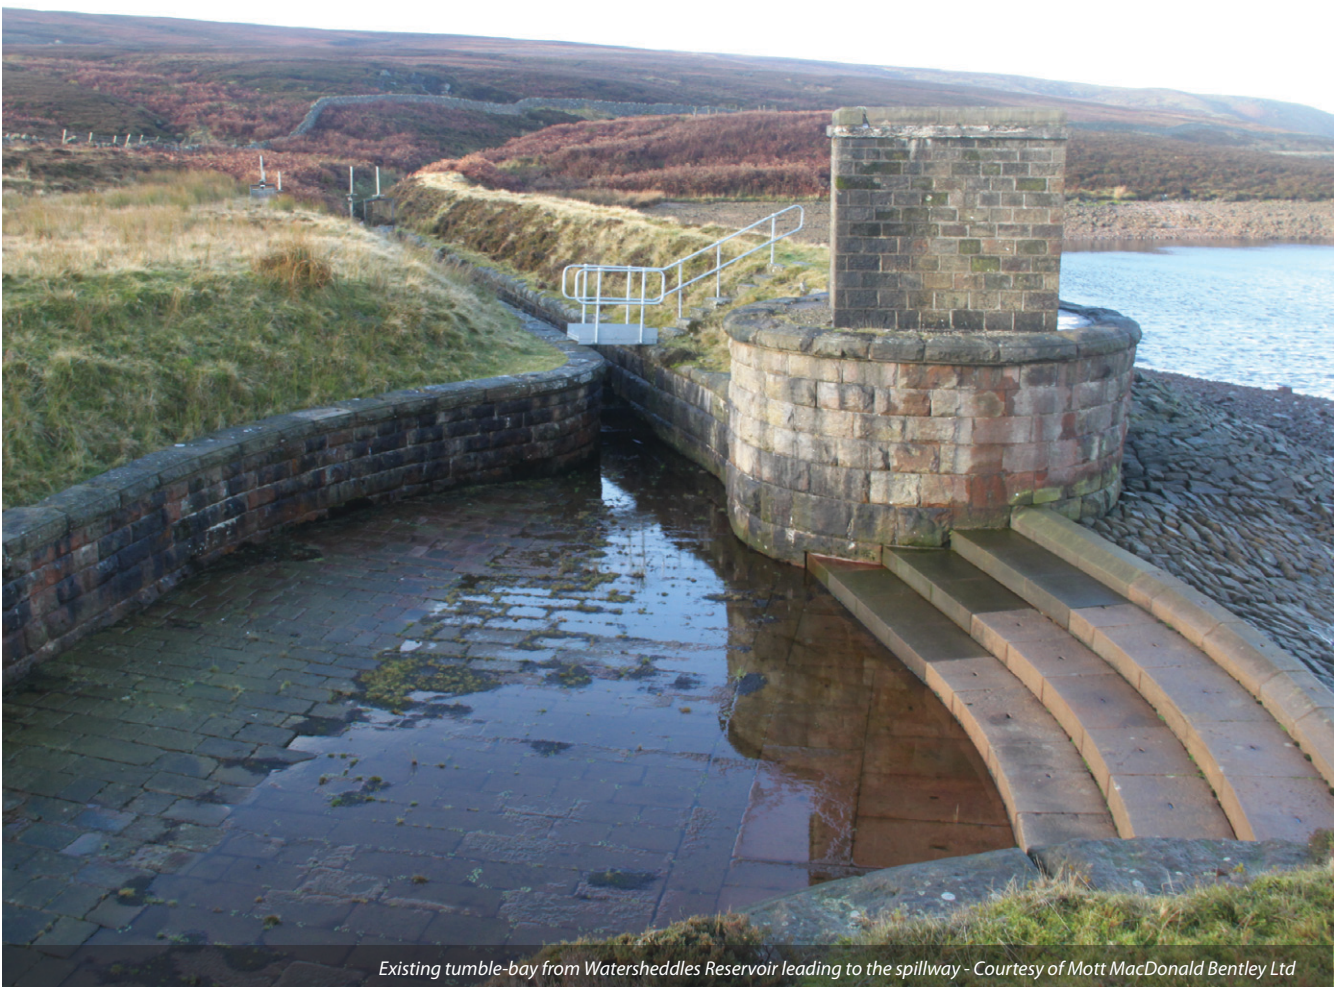
Existing tumble-bay from Watersheddles Reservoir leading to the spillway - Courtesy of Mott MacDonald Bentley Ltd

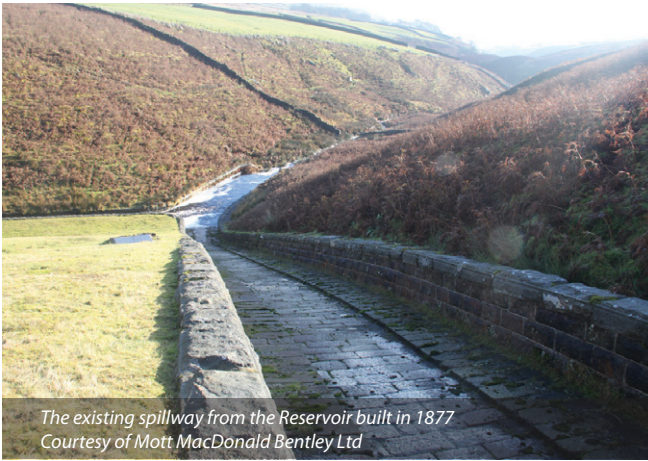
The existing spillway from the Reservoir built in 1877
Courtesy of Mott MacDonald Bentley Ltd

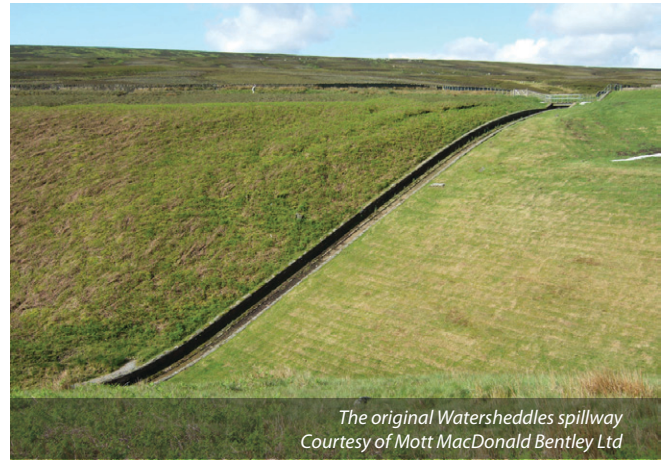
The original Watersheddles spillway
Courtesy of Mott MacDonald Bentley Ltd

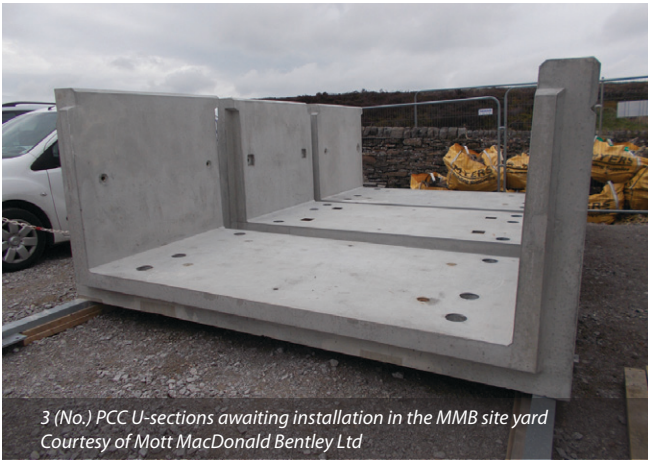
3 (No.) PCC U-sections awaiting installation in the MMB site yard
Courtesy of Mott MacDonald Bentley Ltd

In order to eliminate any in situ concrete construction on the steepest section of the spillway, the design concept behind the PCC U-sections was to use a ‘spigot and socket’ joint with an appropriate waterproof sealant - similar to a culvert unit - rather than in situ RC wet joints which would provide water retaining joints.

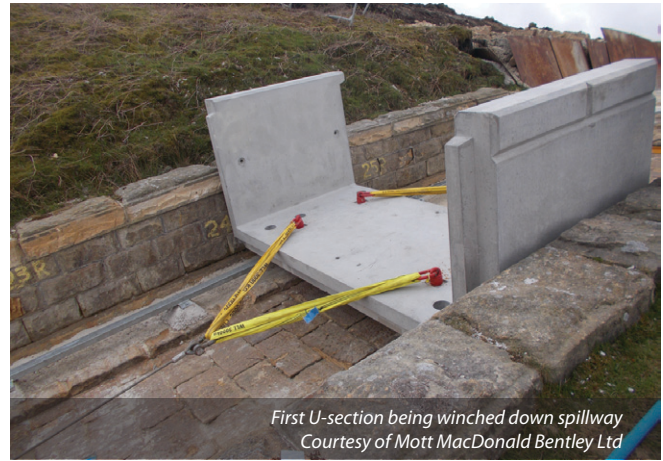
First U-section being winched down spillway
Courtesy of Mott MacDonald Bentley Ltd

A sacrificial rail system was developed to allow the units to be carefully slid into place on the steep spillway, utilising winches at the

upstream and downstream ends of the spillway. Once in position and secured to the rails underneath, the units were grouted into place to provide additional restraint within the existing spillway channel and to negate the risk of the U-sections being plucked from the spillway channel in the extreme case that a joint leaked and PMF pressures developed under the U-Sections.

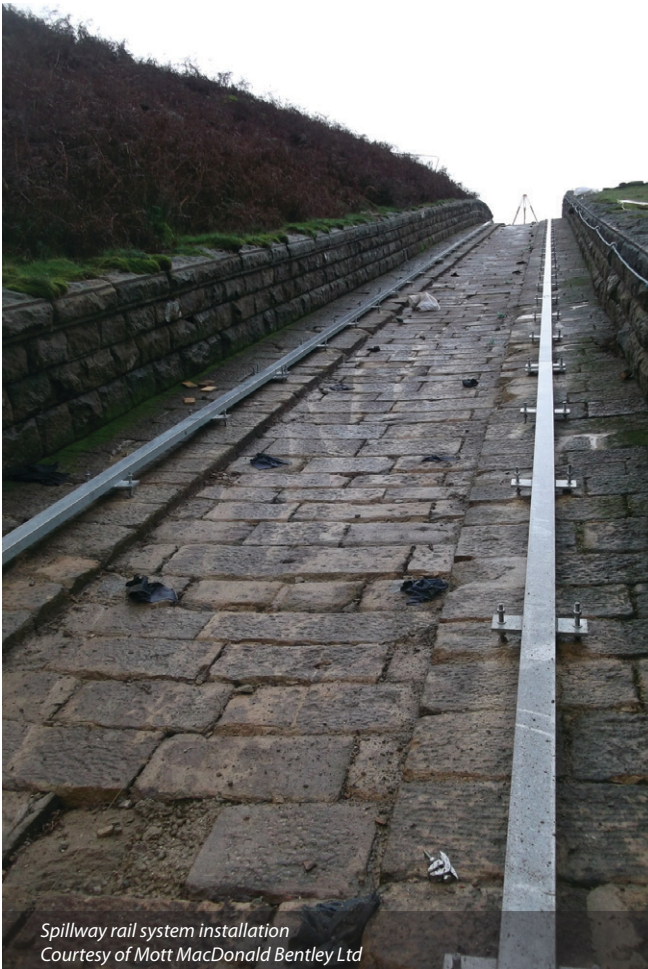
Spillway rail system installation
Courtesy of Mott MacDonald Bentley Ltd

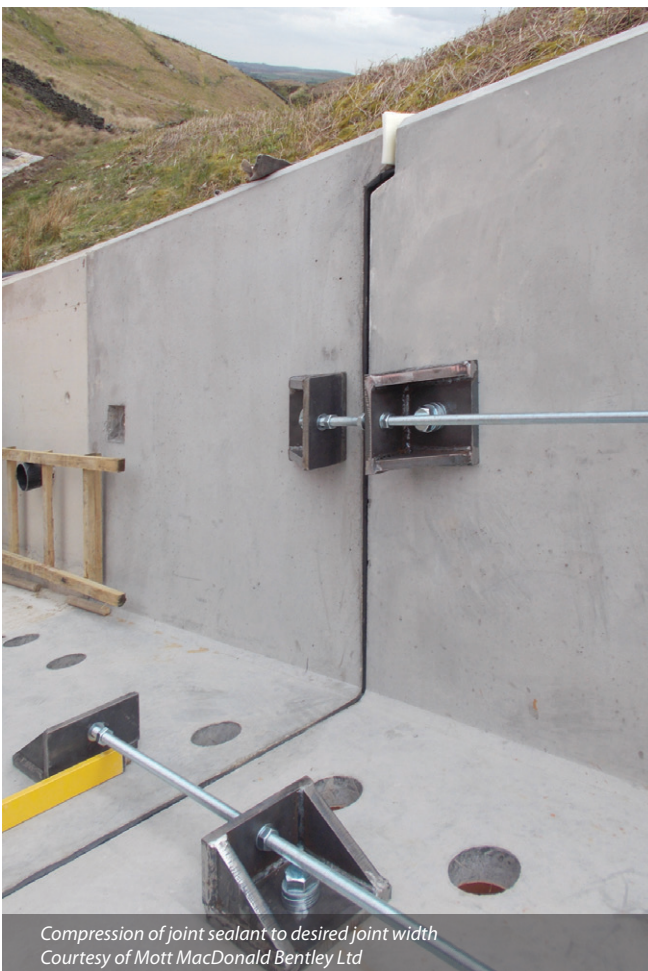
Compression of joint sealant to desired joint width
Courtesy of Mott MacDonald Bentley Ltd

As it was clear that a fully water retaining joint would be difficult to achieve, MMB, YWS and the external technical advisor agreed collaboratively that the joint would perform sufficiently if it was designed to be water-tight (i.e. no leaks) rather than water-retaining (i.e. in situ with water bars). MMB selected a suitable PCC supplier to manufacture the units and engaged their expertise throughout the design process to aid in developing a suitable joint detail.

PMF conditions - where velocities reach up to maximum of 25m/s at the downstream end of the spillway. MMB therefore arranged for the PCC subcontractor to manufacture a mock joint section and for it to be pressure tested to prove that the proposed joint design would perform to the required criteria. The joint detail surpassed the design requirements which gave YWS and the technical advisor confidence in the design.
