Sunnyhurst & Earnsdale Impounding Reservoirs

reducing the risk of failure

by Gary Harrison

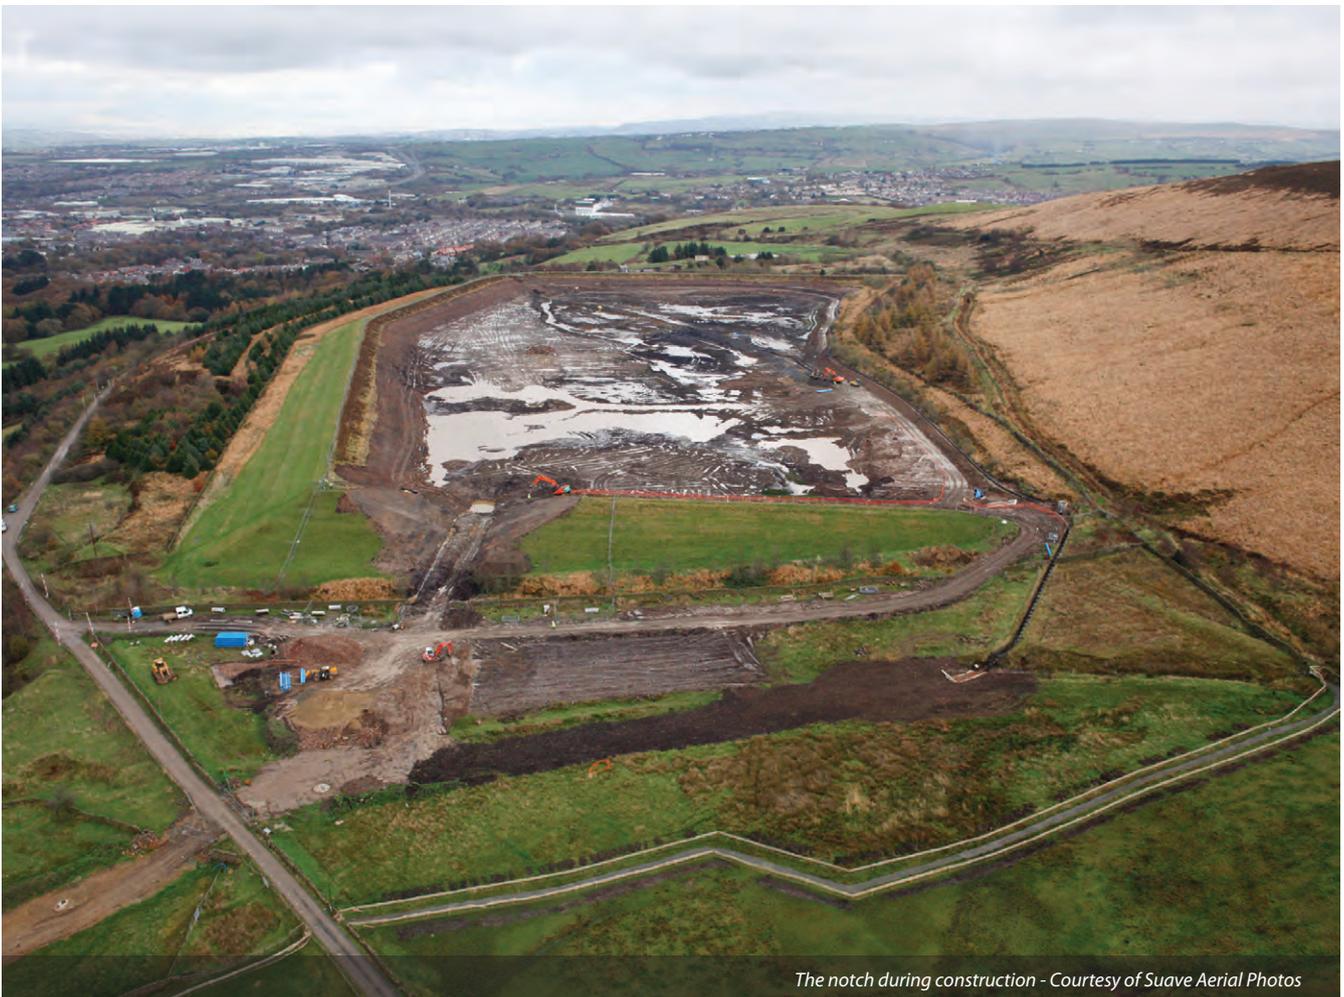
The notch during construction - Courtesy of Suave Aerial Photos

In order to remove the reservoir from the Reservoirs Act and the operational costs associated with such a designation, the stored volume needed to be less than 10ML (to capture the proposed amendments to the Flood and Water Management Act 2010). As such, the embankment was to be notched to its foundation with 1 in 3 slope gradients leading up the crest.

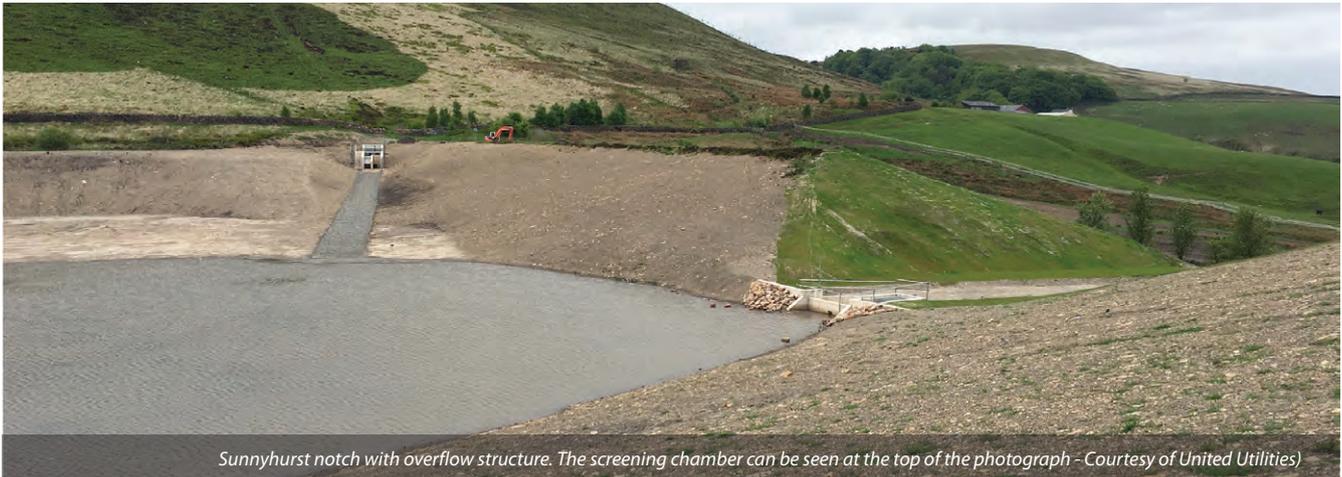
Sunnyhurst notch with overflow structure. The screening chamber can be seen at the top of the photograph - Courtesy of United Utilities

The basin was very flat and needed to be reprofiled so it gently rose away from the notch, reducing the volume retained by the weir whilst providing temporary storage, which drains through the retaining structure (with low level orifice and high level weir) into the transfer pipeline. The final solution included a low level wet land area upstream of the retaining structure to act as a silt trap and increase biodiversity potential within the basin.

The UU Asset Manager wanted the some of the supply capabilities provided by Sunnyhurst to be retained. Therefore an intake chamber to accept the current inflows into the reservoir was proposed. Sedimentation within the source water was undesirable so the solution included a stilling basin, which weared over onto a Dulas Coanda screen intake.

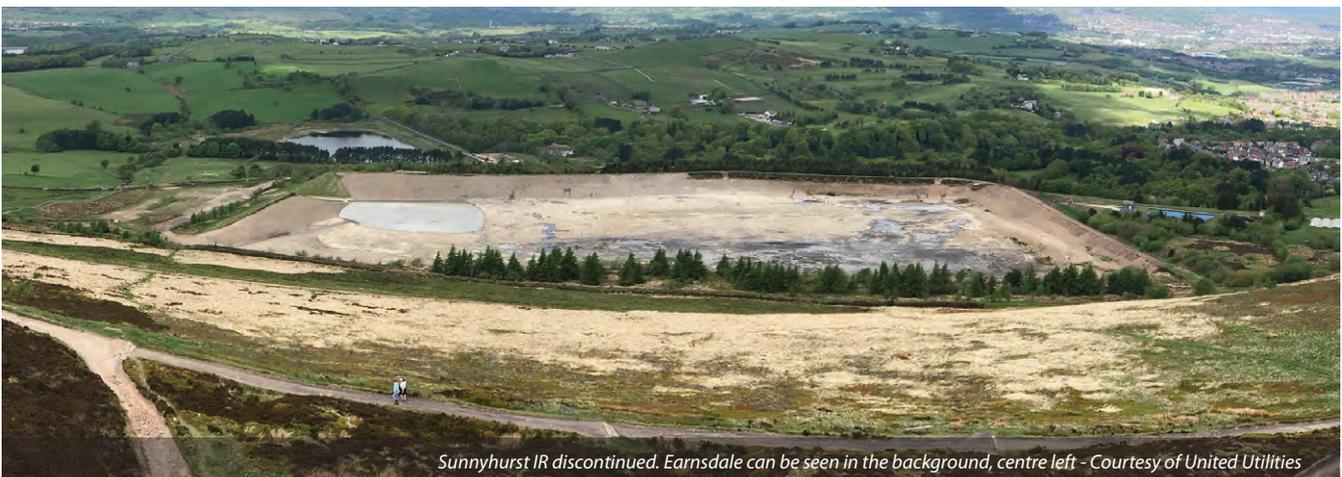
Sunnyhurst IR discontinued. Earnsdale can be seen in the background, centre left - Courtesy of United Utilities

The length of the embankments meant that these solutions were deemed cost prohibitive. The reservoirs storage capability was no longer deemed necessary due to increased network connectivity, and therefore the decision was taken to discontinue.

The discontinuance options included blading the embankment into the hillside, effectively returning the area to a pre-construction state, or by notching the embankment so it could not impound. After initial consultation with the Environment Agency it was agreed that the scheme had to be flood neutral under a 1 in 100 year storm event.

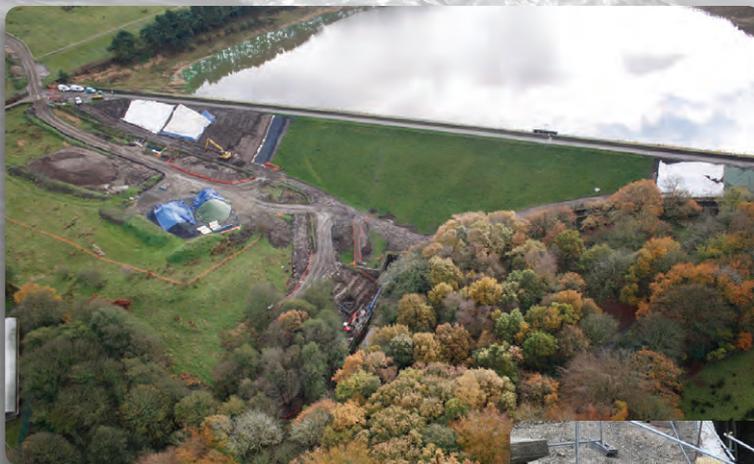
*Earnsdale during the installation of the filter and drainage layers
Courtesy of Suave Aerial Photos*

Any future potential leakage through the embankment, which could cause internal erosion will now flow through the filter and drainage layers and be collected by new toe drains. Inspection chambers on the toe drain allow flows to be monitored for any changes or any suspended solids (a sign of internal erosion), facilitating robust surveillance of the embankment over time.

Over time internal erosion can lead to 'piping' and in turn failure. The filter and drainage layers are composed of a granular material, the grading of which is determined by the grading of the embankment material, and are designed to capture small particles transported through the embankment, whilst allowing the water to pass.

The overlaid drainage layer is a coarser graded material and allows water to dissipate to the toe drains.

During construction, there were strict compaction criteria which had to be met and proven with robust in situ testing. The drainage layer was overlaid with a geotextile separator layer to prevent infiltration and contamination of the granular layers by overlying cohesive backfill and finally covered with subsoil, top soil and turf.

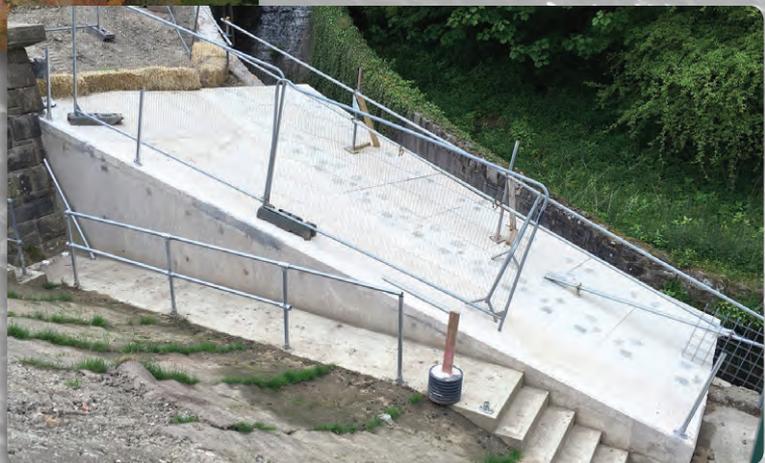
*Flow deflector and toe weight
Courtesy of United Utilities*

An additional weight, composed of granular fill and mass concrete, was placed outside of the discontinued and infilled valve house, downstream of the berm. New scour pipework was placed below the concrete cap to reduce the likelihood of leaks in the future. This included a new hydraulically actuated scour valve for downstream control, housed in secure kiosk, for ease of operation. An existing rising main between the Earnsdale scour pipe and the Fishmoor pipeline has been recommissioned to offset the loss of attenuation at Sunnyhurst.

As part of the works a physical model of the spillway at Earnsdale was built to test how it performed under Probable Maximum Flood (PMF) conditions. The model indicated that super elevated flows over topped the spillway channel walls at the toe of the embankment, increasing the risk of erosion. To remove for the potential for this occurring a cantilever slab, termed the 'flow deflector', was designed to extend over the overflow channel and become utilised during storm events greater than 19m³/s (approximately 50% PMF). The slab deflects the super elevated flows into the centre of the stilling basin to prevent out of channel flow.

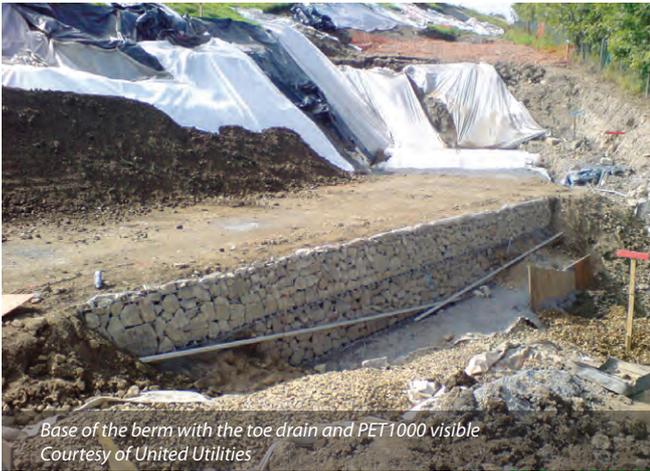
Base of the berm with the toe drain and PET1000 visible
Courtesy of United Utilities

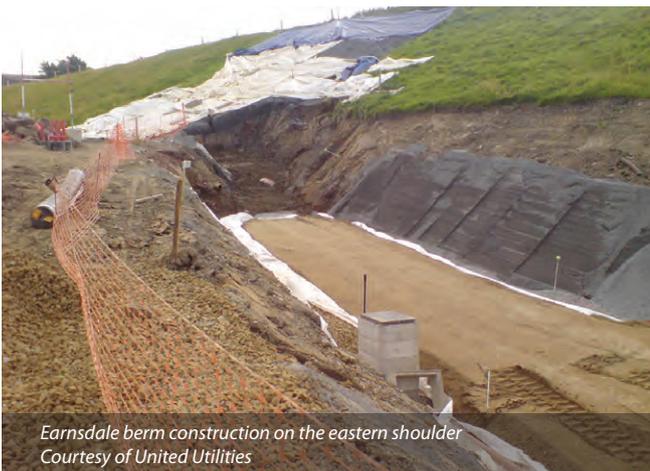
Earnsdale berm construction on the eastern shoulder
Courtesy of United Utilities

The berm is effectively a dead load placed on the toe of the embankment. The outline design by United Utilities, subsequently confirmed by the contractors geotechnical advisers, GHD Livigunn, determined that the berm needed to be approximately half the height of the embankment to ensure a minimum factor of safety of 1.5 against slips.

The berm is a structural reinforced earth structure with layers of granular material wrapped in geotextile, including a non-structural facing system comprised of stone and steel retaining cages. The backfill of the structural element of the berm is comprised of site won notch material from Sunnyhurst. The berm facing materials and geotextiles were supplied by Tencate and is the first time this product had been used at a reservoir site in the UK. Geoman Ltd completed the berm design on behalf of Tencate.

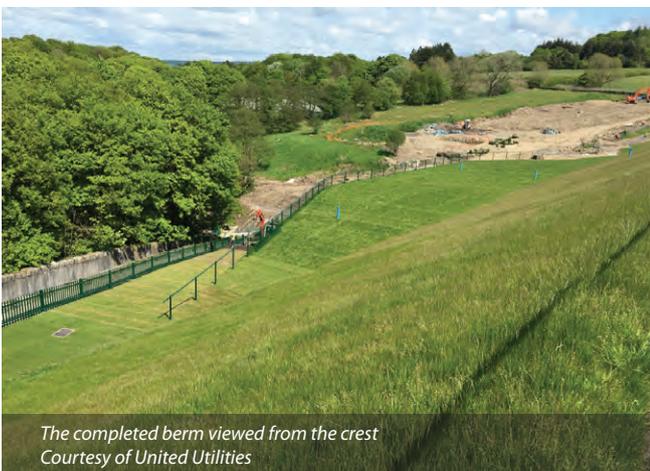
The completed berm viewed from the crest
Courtesy of United Utilities

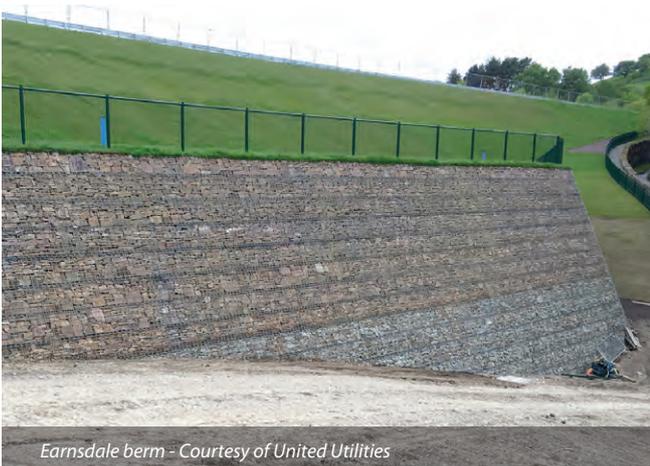
Earnsdale berm - Courtesy of United Utilities

The berms façade is 10m in height at the toe, the weight of which could lead to excessive settlement. Ground investigation determined that the underlying ground had insufficient strength to a depth of up to 7m below pre-construction ground levels. Excessive settlement also posed a risk to the scour main. The complexity of the berm design was determining how to minimise the settlement of the huge structure.

GHD Livigunn and Geoman proposed an innovative foundation solution of hit and miss deep soil mixing blocks (DSM), coupled with a load transfer mattress. DSM blends the insitu material with Portland cement, increasing the strength of the foundation material. The load transfer mattress is composed of a strong geotextile, PET1000, placed above and below the drainage layer. The geotextile can span gaps of up to 3m between the DSM cells. The design indicated that potential settlement under this solution was within the agreed parameters. The DSM cells either side of the scour pipe extended below its invert level, minimising loading on the pipe. The filter and drainage layers extended beneath the berm and interface with the embankment.
