# Fisherman's Walk Rising Main

## burst rising main repair using no-dig techniques

by Ashley Williamson BSc (Hons) IEng MICE

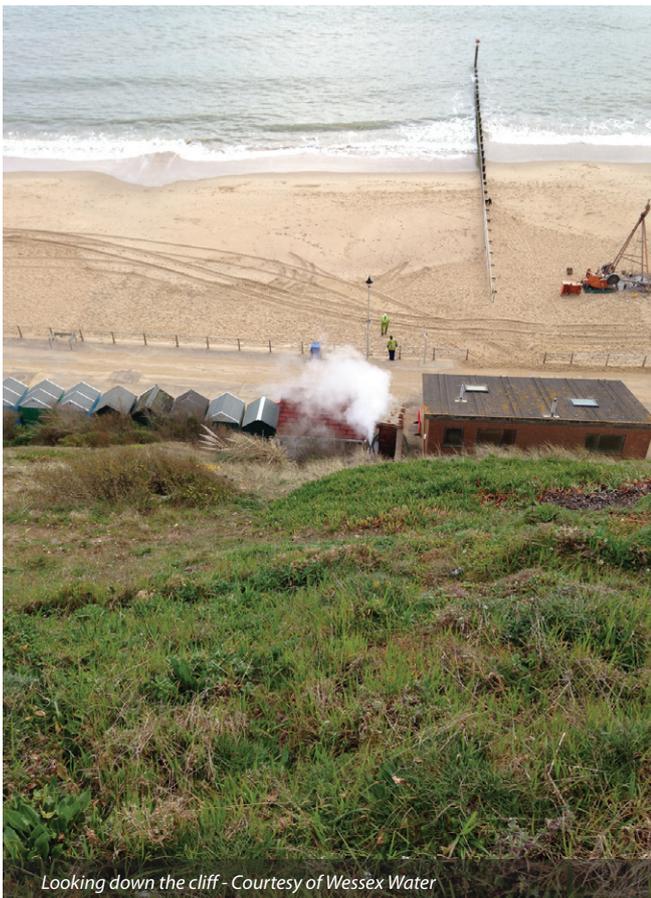
Looking down the cliff - Courtesy of Wessex Water

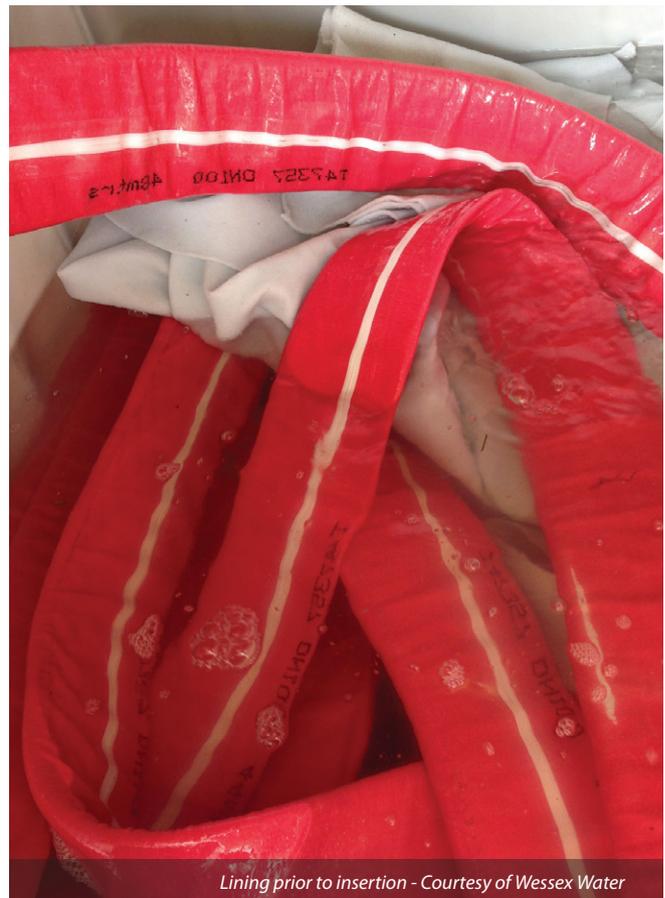
Lining prior to insertion - Courtesy of Wessex Water

The design encompassed a two-layer liner, 100mm diameter and 5.5mm thick. The innermost was 3.5mm thick and constructed of plain felt/PVC. The outer layer was a polyurethane coated glass reinforced lining 2mm thick assembled around the inner. The lining design included impregnation with an epoxy style resin to be pulled into place by a winch, within the wet well chamber. This would also require curing at 0.8 bar using steam.

The engineering and construction department removed the pipework from within the timber heading allowing the lining to be winched into place the following week. The lining took two days to install.

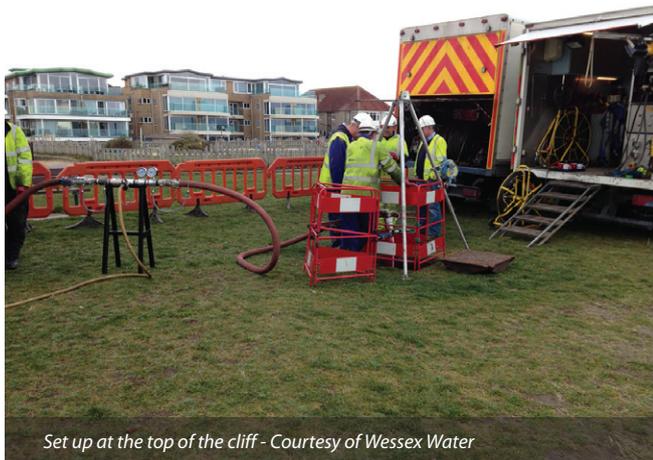
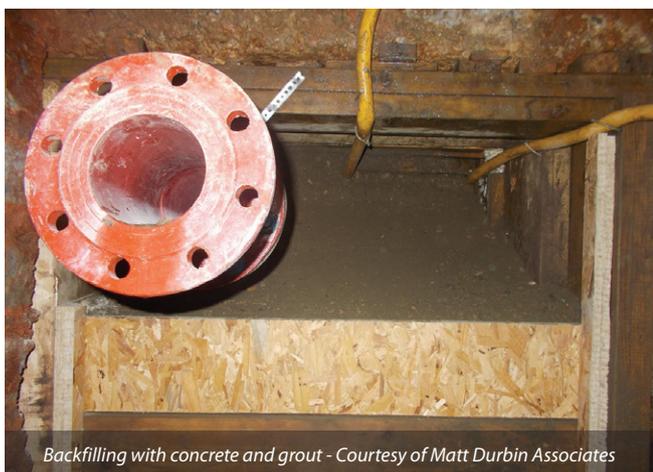
Despite the small size of the timber heading, this took five days to construct because of the complexities of dealing with very fine sands. Matt Durbin Associates confirmed the timber heading on the Fisherman's Walk project was one of the most difficult timber headings the company has encountered.

The submersible pumps, guiderails and associated pipework required removal by Northavon M&E, prior to construction works, to allow access within the wet well to erect a scaffold working platform. The scaffold working platform was level to the bottom of the timber heading.

Engineering and construction returned to install the replacement 100mm ductile iron pipework within the timber heading. This was then backfilled by Matt Durbin Associates with concrete and injected a cementous grout into any voids surrounding the timber heading. The opening of the brick wet-well chamber was rebuilt with glazed brickwork.

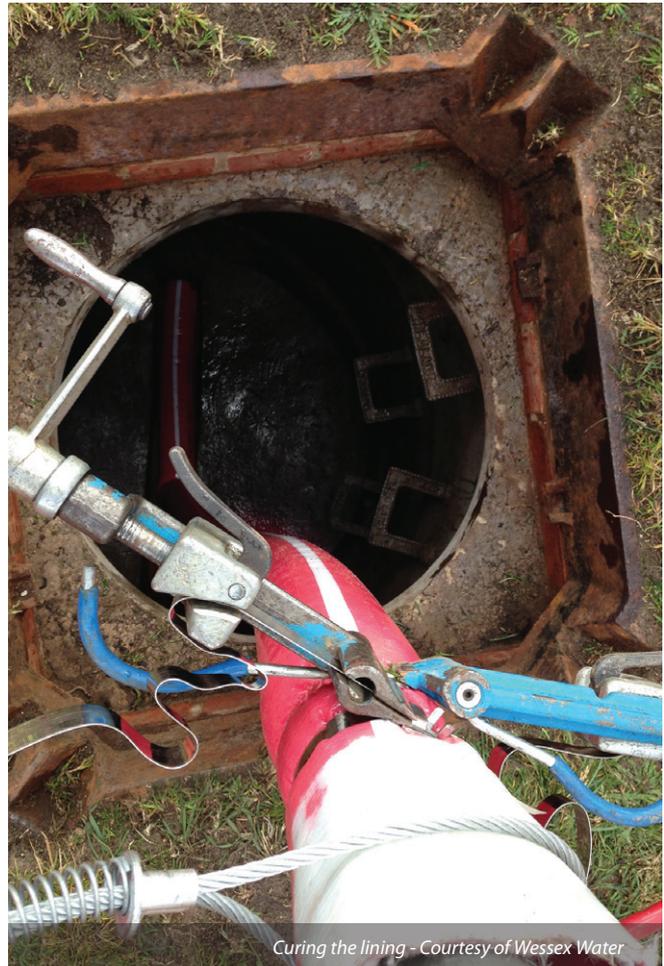
Curing the lining - Courtesy of Wessex Water

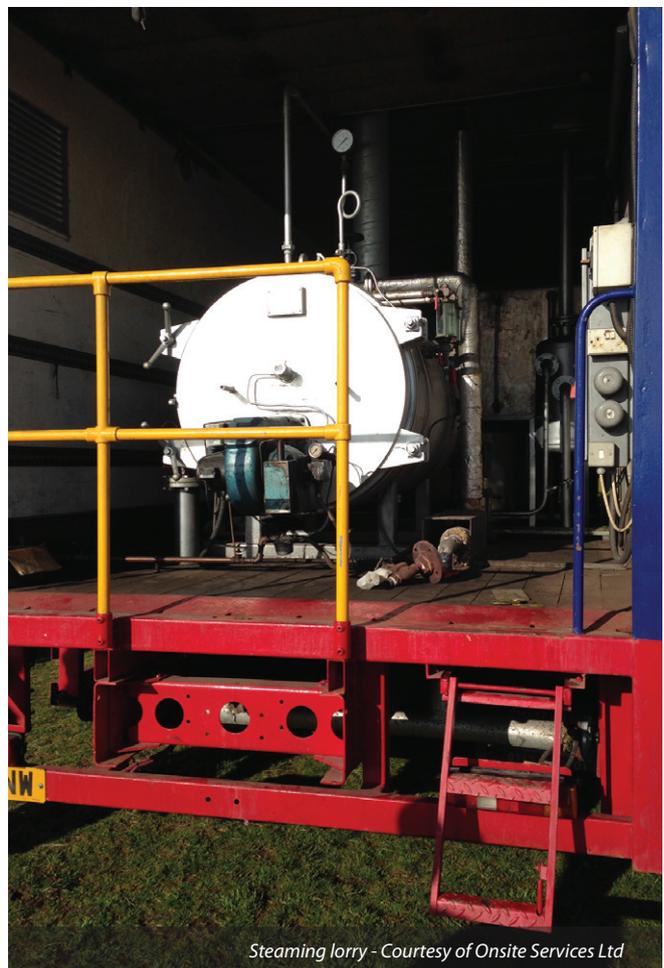
Steaming lorry - Courtesy of Onsite Services Ltd
