Bodnant Garden Water & Flood Management

the first stage of a water management plan at a National Trust property

by Mike Redding MEng (Hons) CEng MCIWEM CWEM & Raff Whitehead BSc (Hons) CEng MICE MEPS

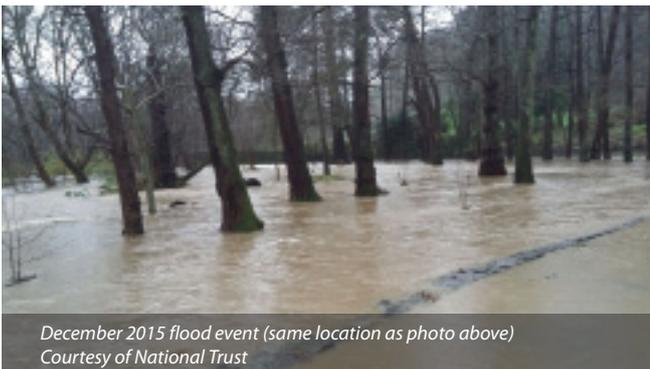
*December 2015 flood event (same location as photo above)
Courtesy of National Trust*

and responds quickly to rainfall. Whilst the Estate House is not at risk of flooding from the Hiraethlyn, past flood events have led to significant damage to the gardens. The major December 2015 flood event deposited several hundred tonnes of river gravels and sediments in the gardens and damaged footpaths and bridges. Significant costs were incurred in remediating the damage and ensuring the gardens remained safe for visitors.

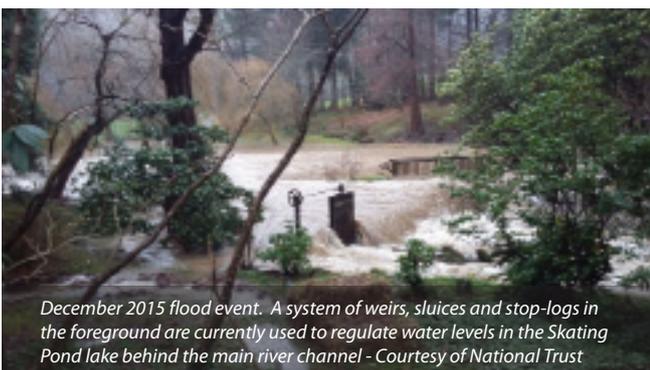
December 2015 flood event. A system of weirs, sluices and stop-logs in the foreground are currently used to regulate water levels in the Skating Pond lake behind the main river channel - Courtesy of National Trust

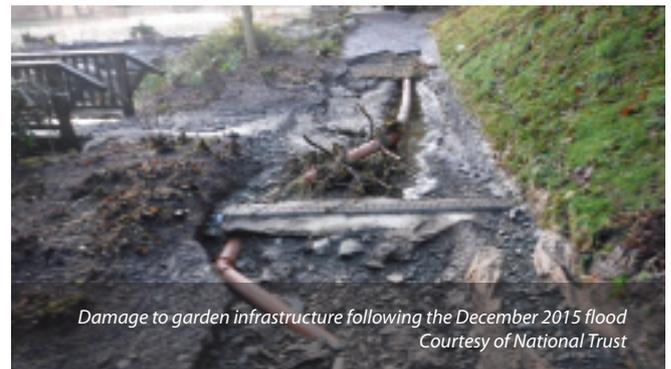
*Damage to garden infrastructure following the December 2015 flood
Courtesy of National Trust*

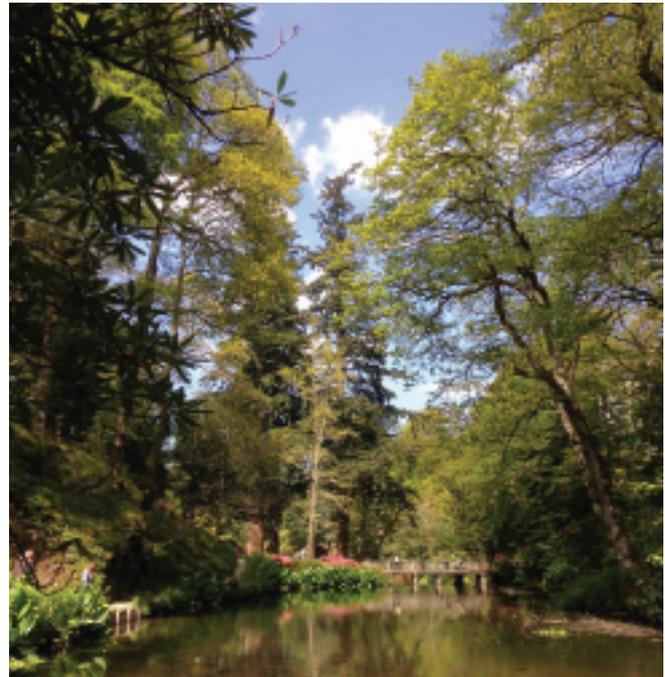
Looking down the Afon Hiraethlyn towards the Waterfall Bridge. Large quantities of gravel are deposited in the slow-moving river channel upstream of the ornamental cascade - Courtesy of Waterco Consultants

The WMP will investigate and prioritise options to improve the garden's resilience to flooding, including mapping the most vulnerable areas and managing the movement of water through the off-line lakes in the gardens. Gravel deposition is exacerbated by the historic weirs and cascades along the Hiraethlyn. Improved facilities for managing this risk will be explored, potentially including working with key external stakeholders to ensure future removal work can be undertaken efficiently and with minimum disruption to both the garden and the environment.

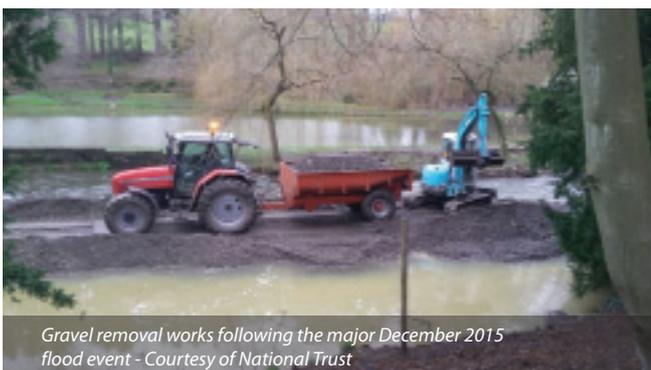
Gravel removal works following the major December 2015 flood event - Courtesy of National Trust
