# Maltsters Rising Main

replacing 500m of rising main by directionally drilling overcoming tides, difficult ground conditions, sensitive customers and significant EA constraints

by Matt Steer & Gil Clelland

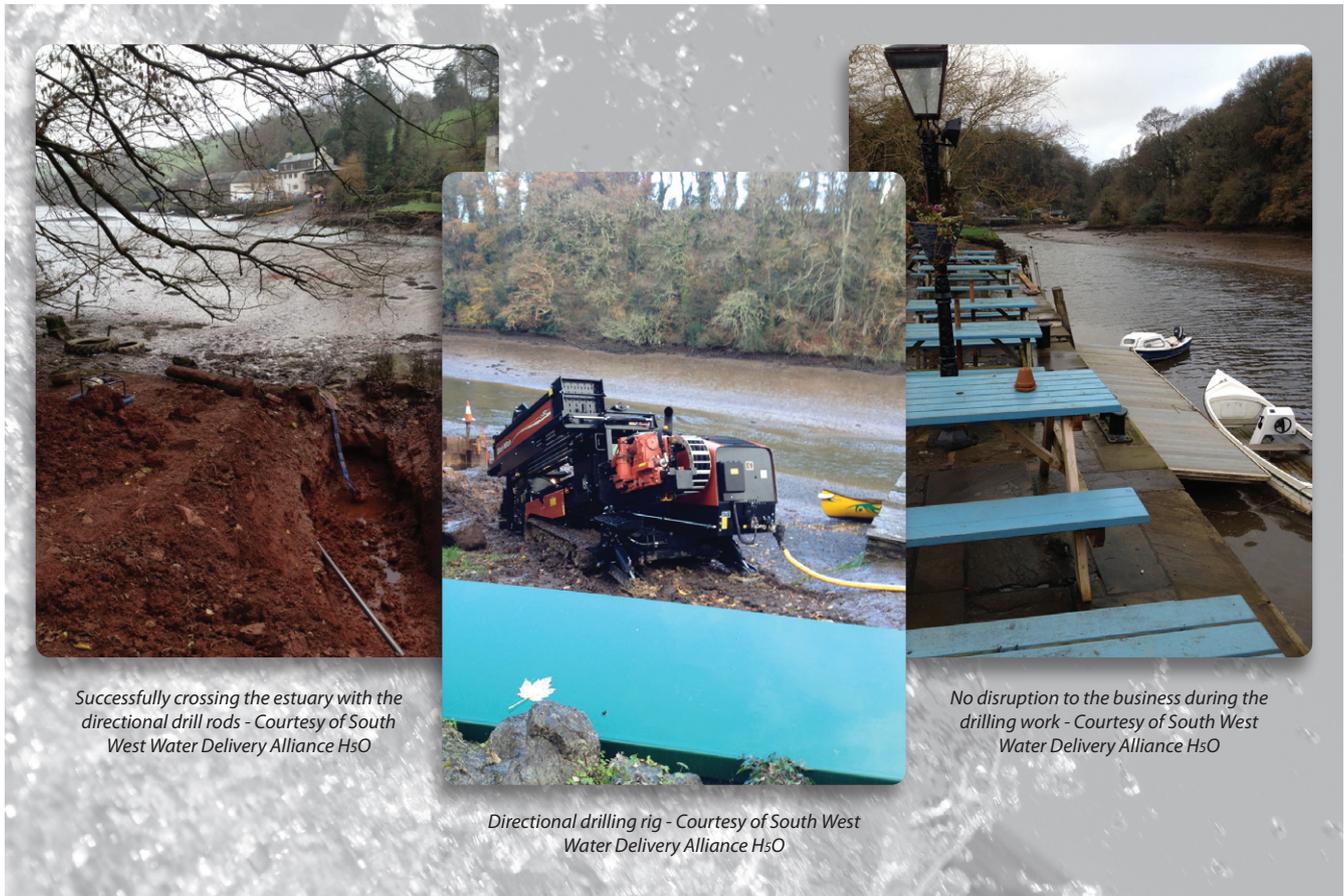
Successfully crossing the estuary with the directional drill rods - Courtesy of South West Water Delivery Alliance H50

Directional drilling rig - Courtesy of South West Water Delivery Alliance H50

No disruption to the business during the drilling work - Courtesy of South West Water Delivery Alliance H50

The team mobilised the directional drillers to site, opened up the launch and reception pits and during the following low tide begun to drill. Before they reached the low water channel they hit an outcrop of limestone and had to withdraw. The angle of the drill was moved and several different positions and angles were tried, to find a route past the rock shelf.

One of the challenges was to make regular checks as the drill progressed to ensure the Sonde was on course, which was made difficult by the consistency of the mud. A small boat was utilised to carry out the checks, and on the mud flats boards were used for the engineer to access the Sonde position and were removed as work progressed.

The team were finally able to get the rods through; however, the drill was reamed back before the tide came in, so the tidal water collapsed the void. Works started again but this time the team worked at night, taking rods off and travelling across the river to join them back on to ensure they maintained the void when the tide came in. This unusual methodology proved successful and allowed the reaming to be completed and to pull the 180mm sleeve in successfully.

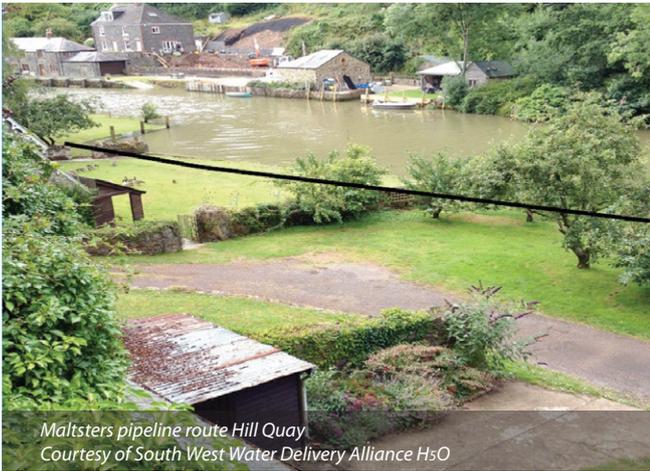
Maltsters pipeline route Hill Quay  
Courtesy of South West Water Delivery Alliance H5O

The rising main, which serves circa 430 people, flows north-west from the SPS where it crosses the Harbourne River and along a private garden and a public track, finishing at Ashprington STW - a distance of approximately 500m. The driver for the project was to rehabilitate Maltsters Rising Main to restore serviceability, reduce burst risk and provide 50-year asset life.

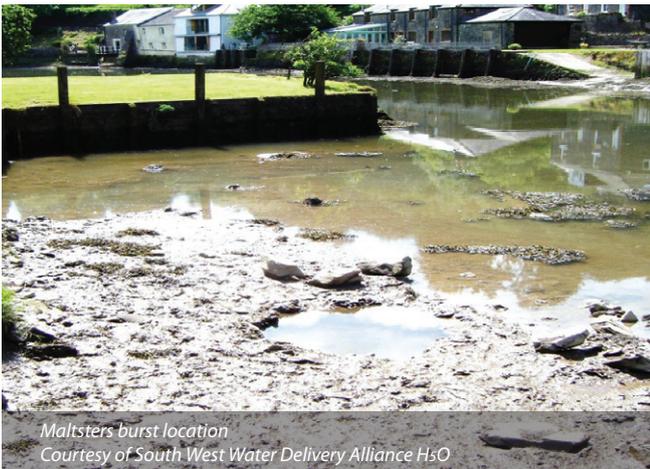
Maltsters burst location  
Courtesy of South West Water Delivery Alliance H5O

As part of the South West Water Delivery Alliance H50's capital improvements programme, the Maltsters Sewage Pumping Station (SPS) Rising Main was identified for improvement after seven historic bursts within the last two years. This rising main is situated near the picturesque village of Tuckenhay, Devon, on the Harbourne River which converges with the River Dart. These bursts had all been on a 50m section outside an idyllic rental property (Hill Quay Cottage), which was affecting both their business and that of the renowned Maltsters Public House at the opposite side of the estuary. The primary cause for the bursts was the ductile iron material of the pipe reacting to limestone in the surrounding area.

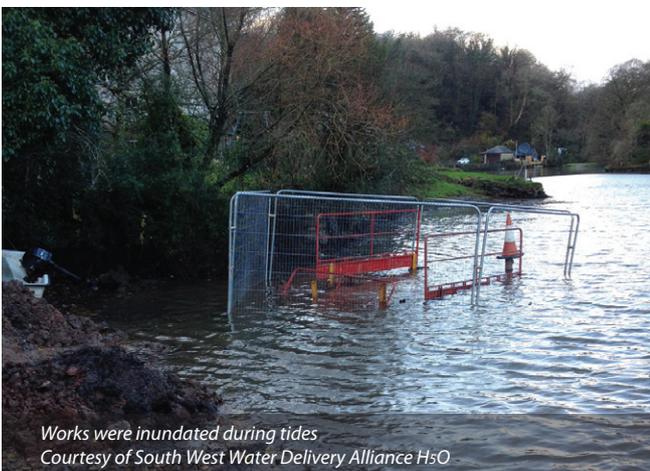
Works were inundated during tides  
Courtesy of South West Water Delivery Alliance H5O

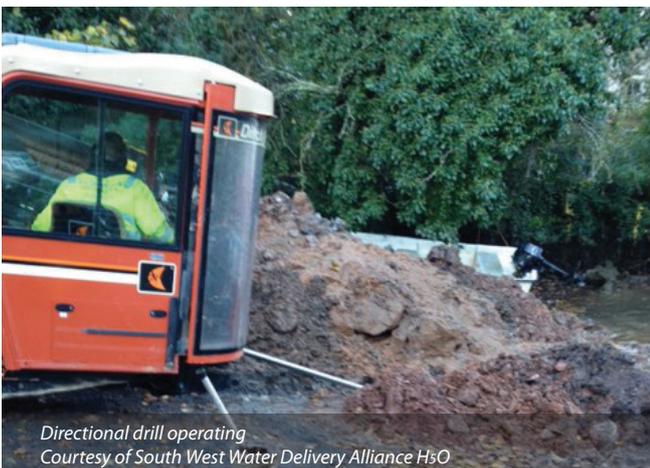
Directional drill operating  
Courtesy of South West Water Delivery Alliance H5O
