# Woolmans Wood Phase 2

£8m investment to replace water mains in parts of Chatham, Gillingham and Rochester to improve water pipes and reduce the risk of discoloured water

by Giampiero Mendola BEng MSc CEng CWEM MCIWEM

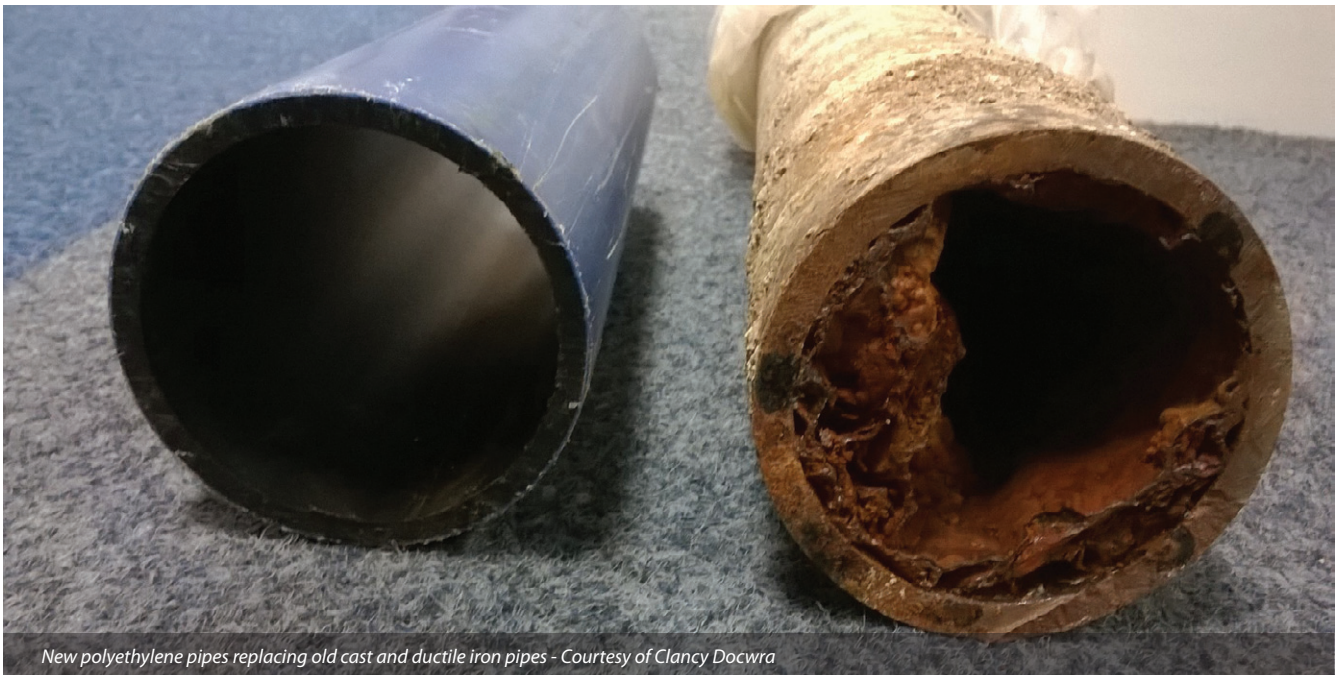
*New polyethylene pipes replacing old cast and ductile iron pipes - Courtesy of Clancy Docwra*

The pipe material specified was high density polyethylene (PE) PE100 SDR 17 with a maximum operating pressure of 10 bar. PE was chosen as it is unaffected by internal or external corrosion and allows for a fully welded system with no thrust blocks requirements. Using PE also meant that trenchless technologies could be adopted to provide additional benefits such as quicker installation with reduced traffic disruption, less ground works and, in particular, allows the use of pre-chlorinated coils to minimise service interruption time.

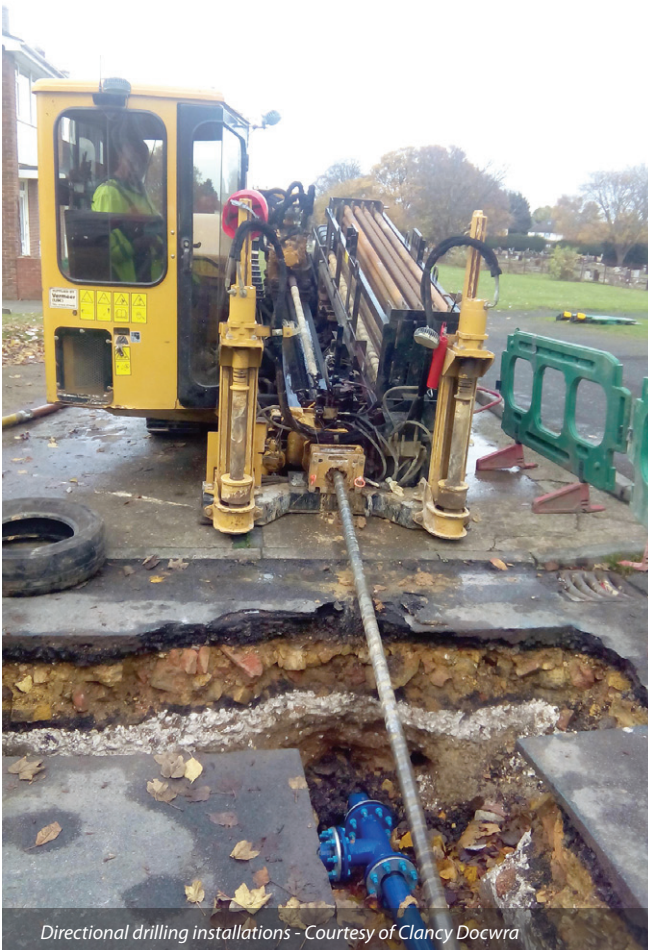
Directional drilling installations - Courtesy of Clancy Docwra

Despite the high numbers of underground services and many other constraints typical of the urban environment, the predominant installation method used on the scheme was horizontal directional drilling with approximately 76% of replacement mains installed using this method.

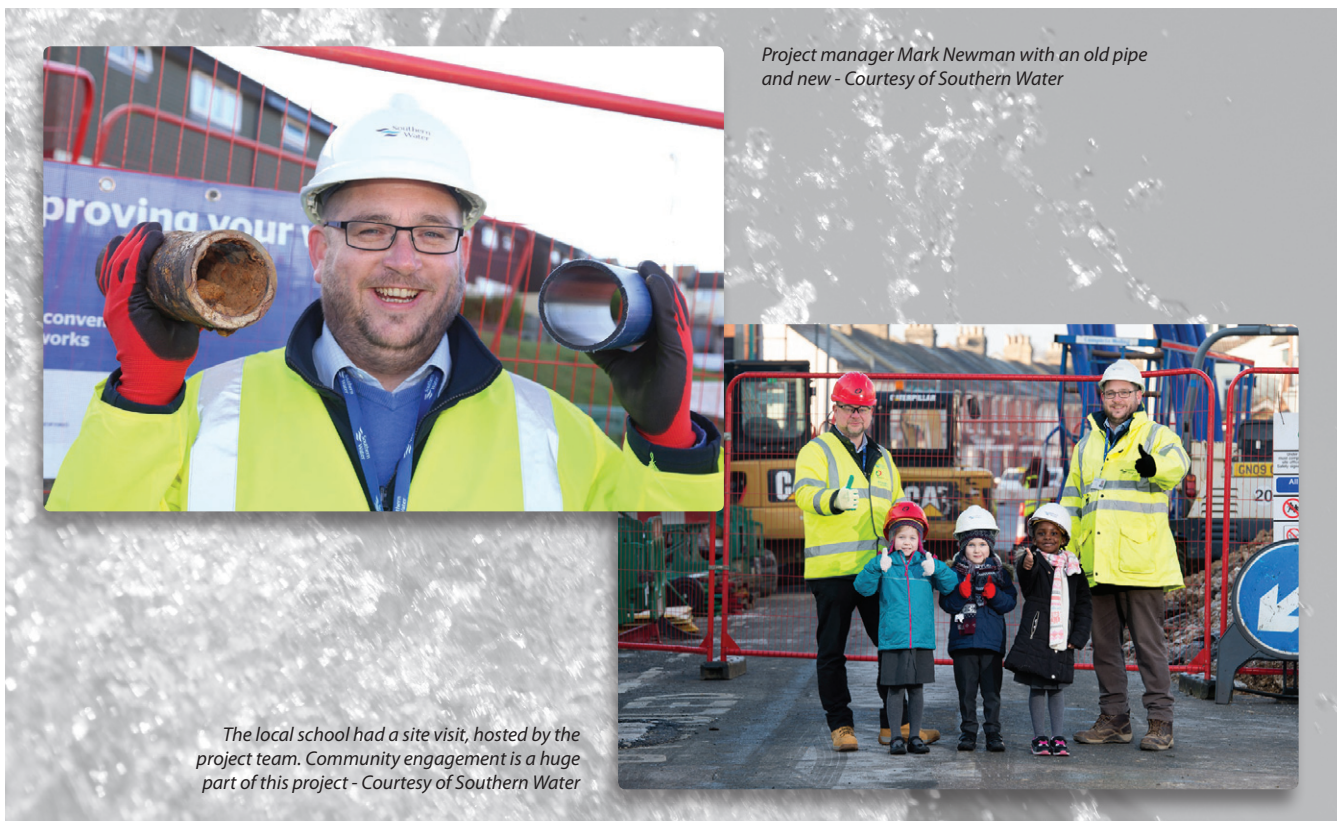
*Project manager Mark Newman with an old pipe and new - Courtesy of Southern Water*
