# Malpas Service Reservoir

## adding years to the useful life of a century old asset

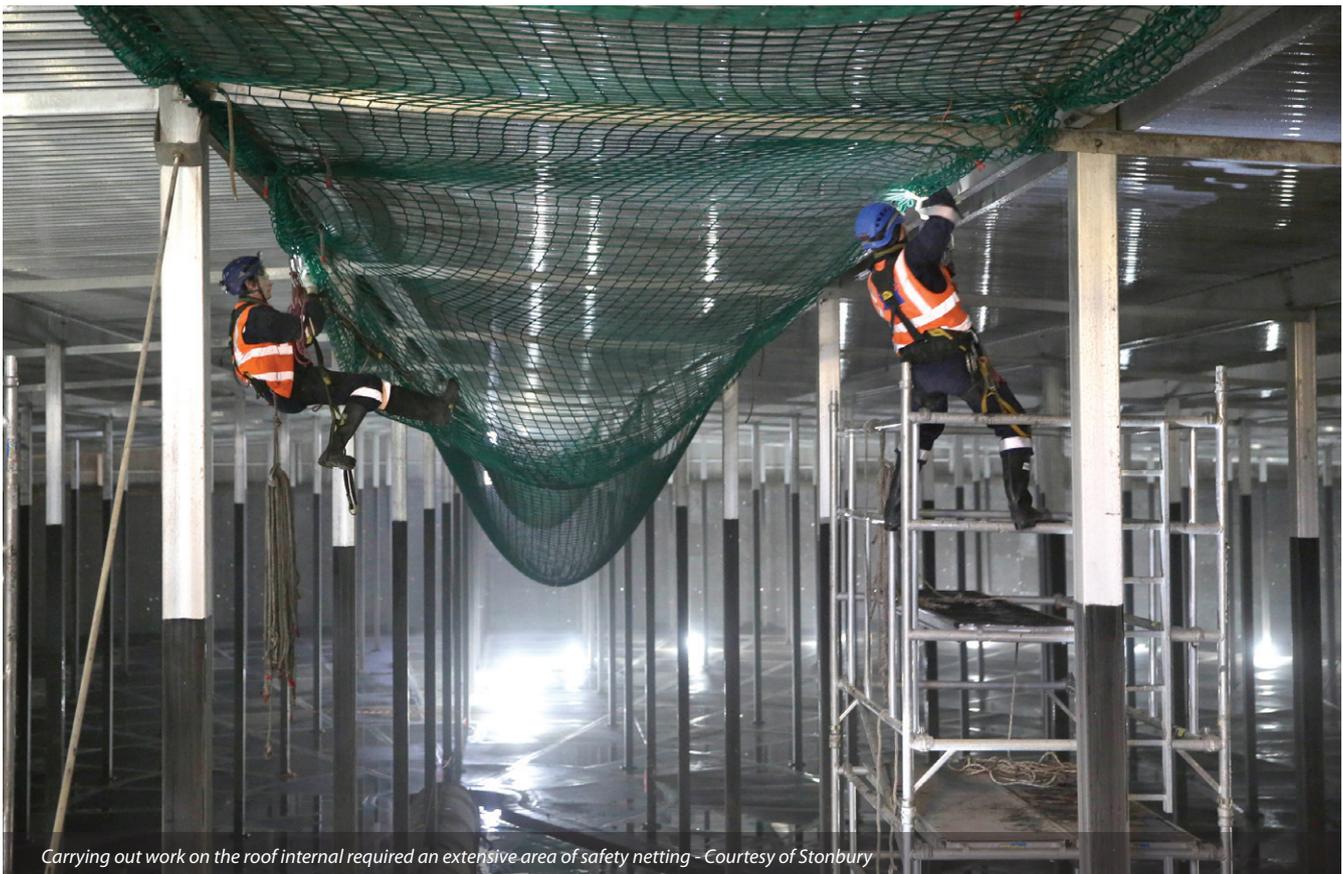
Carrying out work on the roof internal required an extensive area of safety netting - Courtesy of Stonbury

The project came with a number of challenges – not least carrying out work on the roof internally, where roof vents were allowing in rainwater. This required erecting scaffolding and an extensive area of safety netting. External access to the roof also posed safety risks as the roof had a low load bearing capacity.

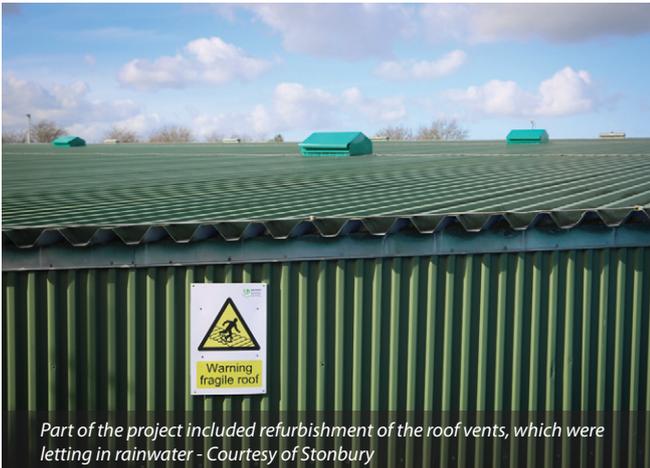
Part of the project included refurbishment of the roof vents, which were letting in rainwater - Courtesy of Stonbury

A team of specialist engineers then undertook a detailed survey of the roof vents (which had been allowing in rain water) and the grating to the floor channel to determine the scope of work required, while the blasting grit was removed from the reservoir floor by another team.

With the roof vents fixed in place, a Davit Arm and an SS ladder were introduced; and these, together with the scaffolding, provided safe access for the internal steel surfaces in the roof to be coated.

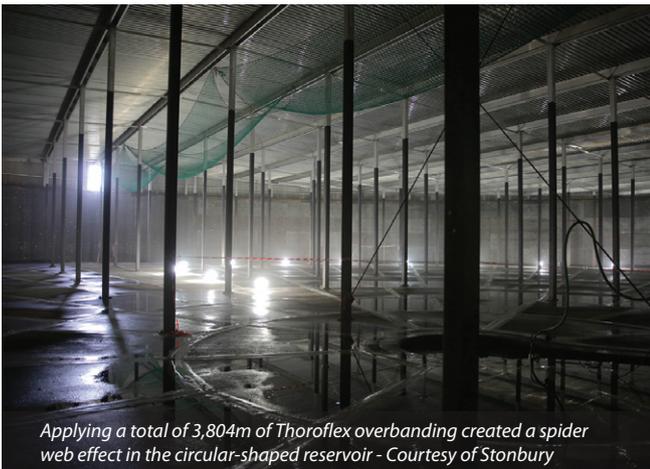
Applying a total of 3,804m of Thoroflex overbanding created a spider web effect in the circular-shaped reservoir - Courtesy of Stonbury

The project commenced with Thoroflex overbanding to the floor joints, applying the longer lengths first while keeping the joints clean ready for the welding. Ultimately, some 3804 metres of overbanding were required to cover the 3849m<sup>2</sup> of flooring creating a spider web effect in the circular-shaped reservoir.

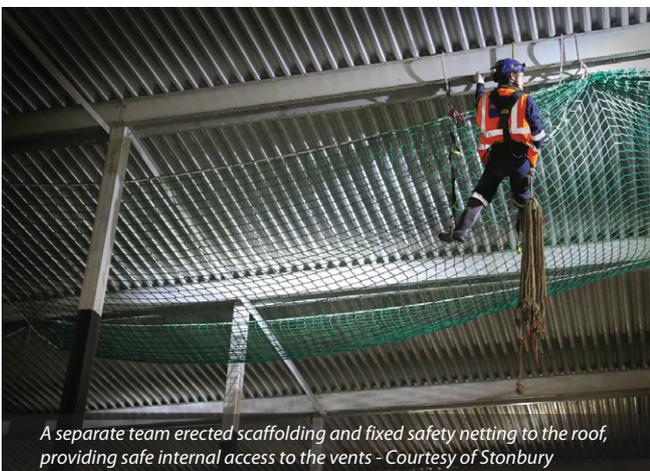
A separate team erected scaffolding and fixed safety netting to the roof, providing safe internal access to the vents - Courtesy of Stonbury

During week 9 of the contract, a separate team erected scaffolding and fixed safety netting to the internal roof, providing safe internal access to the vents. During this week, steel fabrication contractors also came on site to install a series of channel covers inside the reservoir.

Because the metal roof would not safely withstand the weight of people working on it, scaffolding was erected in several places over the top, together with a series of safety lines to provide safe external access to the vents.

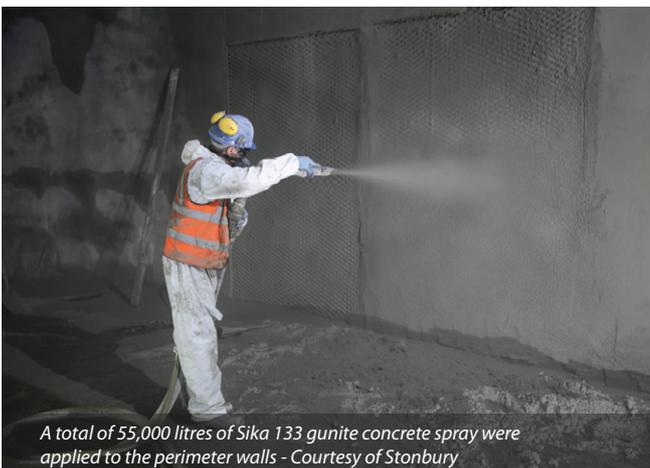
A total of 55,000 litres of Sika 133 gunite concrete spray were applied to the perimeter walls - Courtesy of Stonbury

Fixing the mesh, which ultimately took a total of 15 days, created a suitable surface for the Sika 133 gunite concrete spray to be applied. In total, 55,000 litres of concrete spray were applied to the perimeter walls.

Timber screed rails were then fixed into place and spraying of the reservoir walls began in week 5, once the mesh had been applied in the first few bays.

To stay in line with the contract schedule, a target of completing the spraying of one bay a day was set, while mesh fixing continued on the remaining bays. Progress was slowed somewhat with numerous spray pump breakdowns, putting the concrete spraying two days behind schedule at one point, requiring weekend working to regain time. Work on the grating was completed in week 7 to cover the outlet channel.

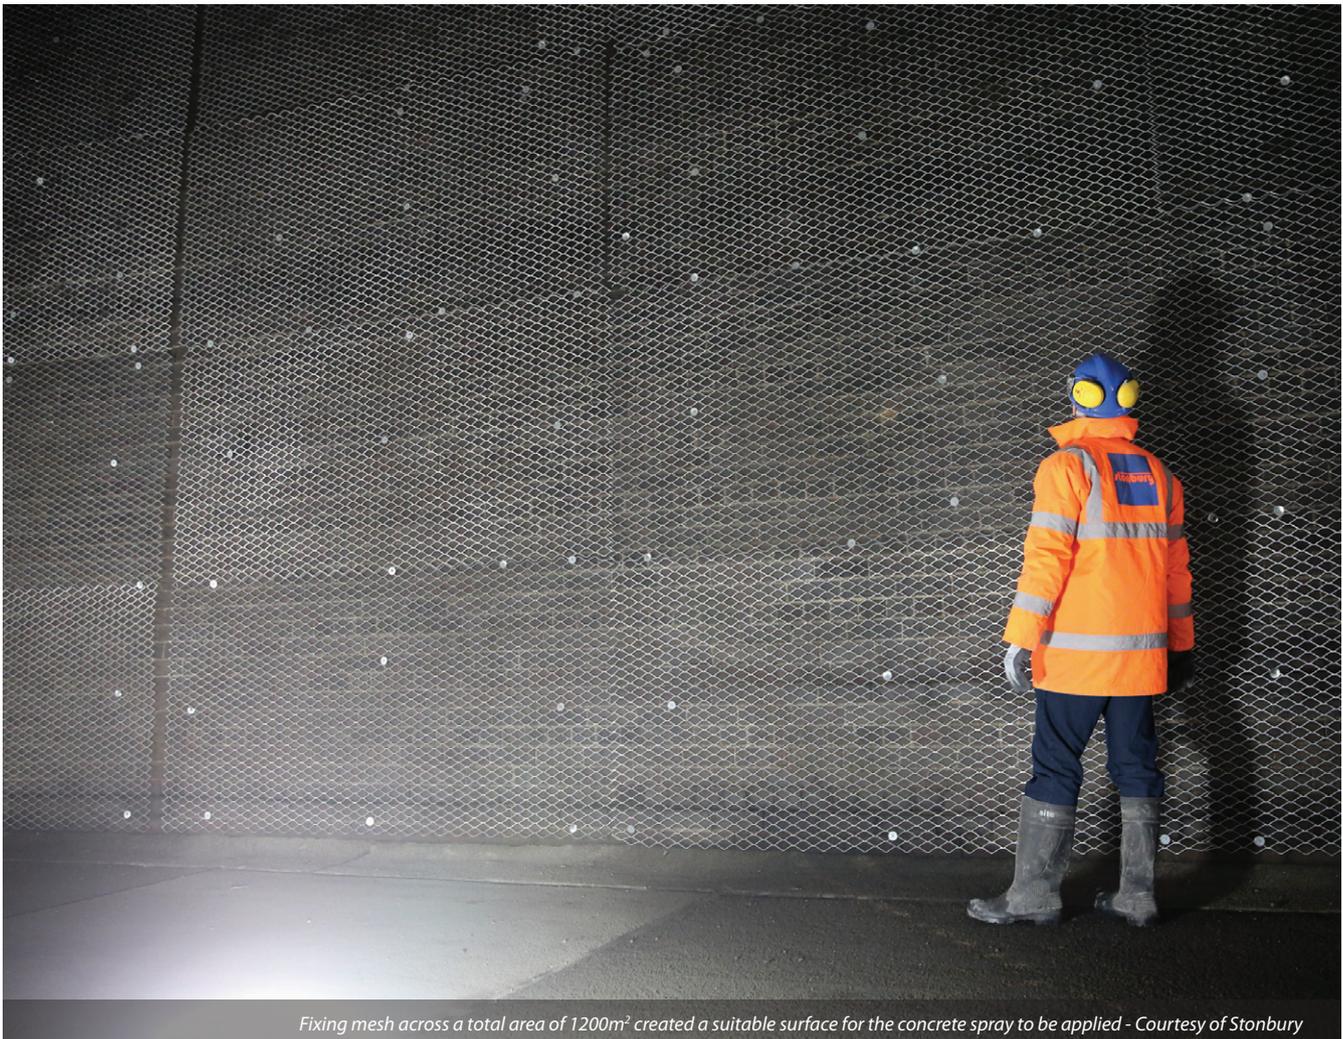
*Fixing mesh across a total area of 1200m<sup>2</sup> created a suitable surface for the concrete spray to be applied - Courtesy of Stonbury*

By week 6 of the project, the overbanding to the floor of the reservoir had been successfully completed, and the internal surface of the reservoir walls, comprising Staffordshire blue engineering bricks, had been sufficiently prepared for mesh to be fixed to the walls across 24 bays and a total area of 1200m<sup>2</sup>.
