# Springs Impounding Reservoir

## risk reduction via portfolio risk assessment identified works

by Paul Bennett MEng PhD, Pam Rigby BSc MSc & Ian Scholefield BEng Hons

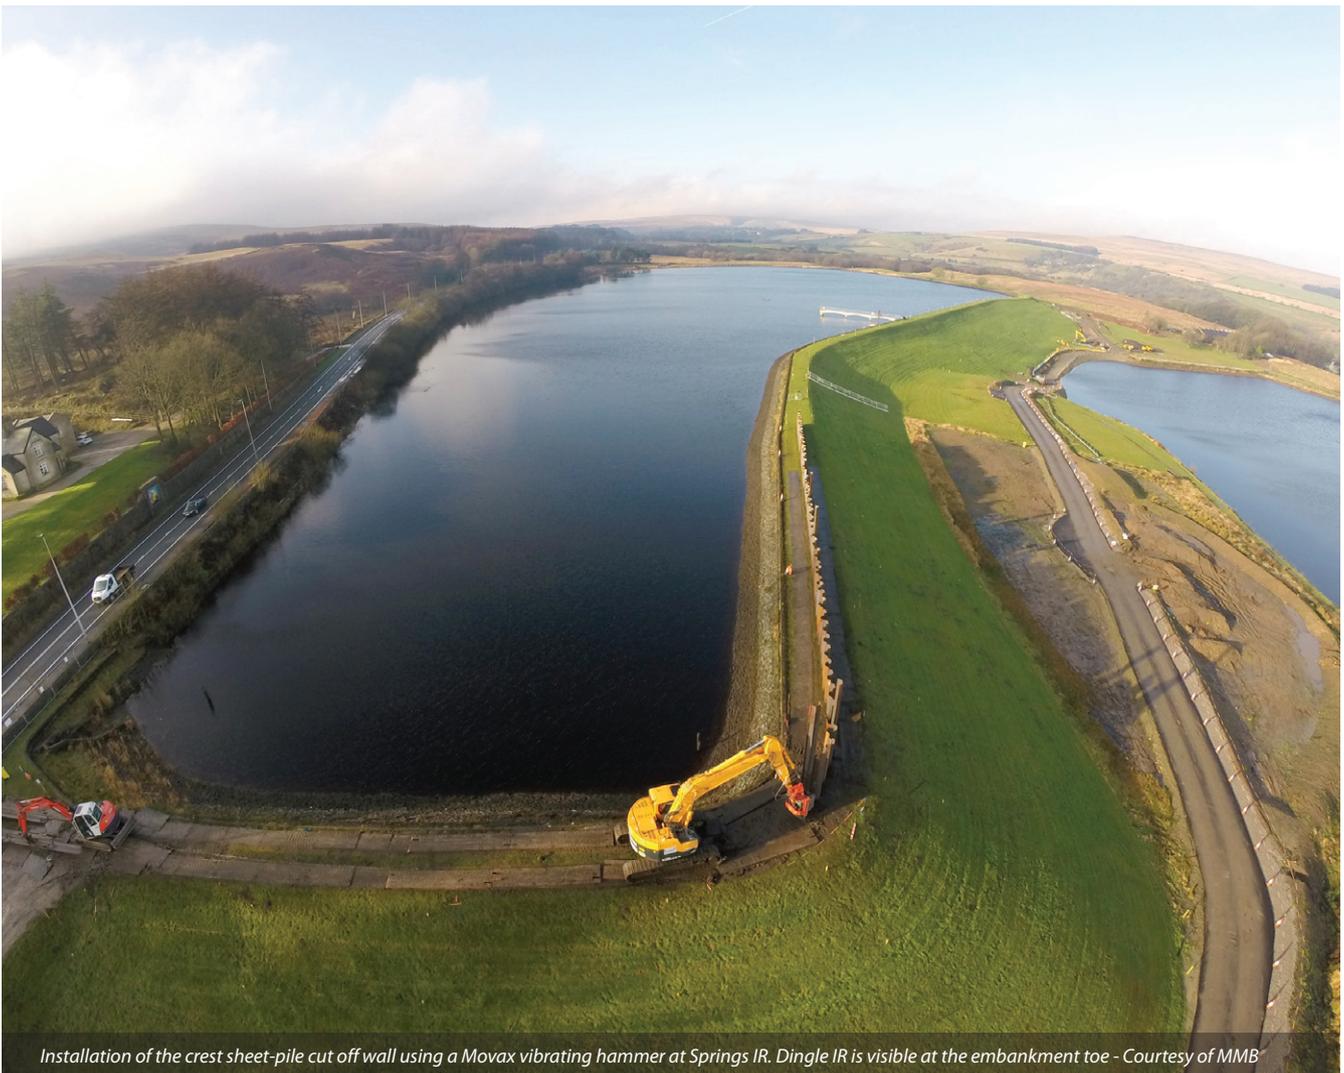
Installation of the crest sheet-pile cut off wall using a Movax vibrating hammer at Springs IR. Dingle IR is visible at the embankment toe - Courtesy of MMB

PU18-1 steel sheet piles with a Waddit interlock sealant were chosen to provide a watertight barrier, adequate section modulus for driveability and sacrificial thickness to ensure a 100 year design life. The piles have been driven to depths of between approximately 6m and 8m below the probable maximum flood (PMF) level.

Due to the constraints of the site, different sheet-pile installation methods were investigated. Although initially favoured, silent-piling techniques were discounted due to access restrictions and difficult retrieval of plant from the embankment crest.

A Movax vibrating hammer (mounted on a 25T) excavator was selected. However, this method failed to achieve design depth (approximately 2m short of the required level). The likely reason for this resistance was the presence of cobbles/boulders or a stiffer layer of material. This was overcome using an air hammer. The combination of the two techniques greatly reduced the noise pollution from this operation.

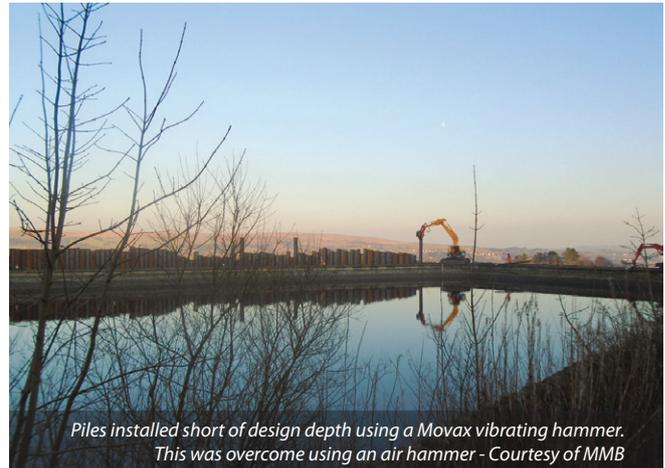
*Piles installed short of design depth using a Movax vibrating hammer. This was overcome using an air hammer - Courtesy of MMB*

On site challenges relating to the driveability of piles were overcome with the use of an air hammer following the initial installation of the piles with an excavator-mounted vibrating hammer attachment.

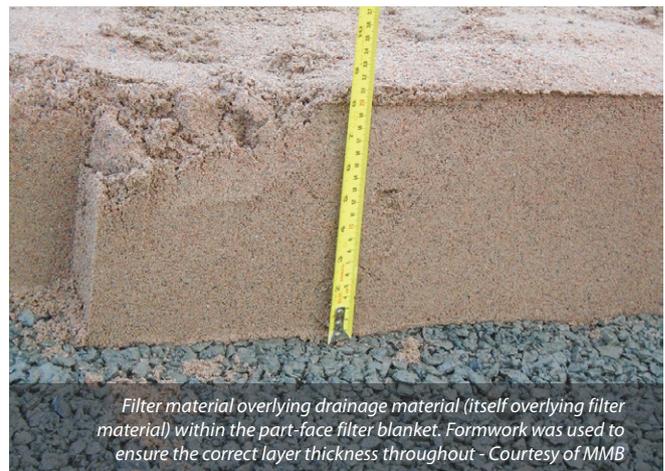
*Filter material overlying drainage material (itself overlying filter material) within the part-face filter blanket. Formwork was used to ensure the correct layer thickness throughout - Courtesy of MMB*

The filter blanket itself comprised three layers of media: 250mm filter media, 250mm drainage media and 200mm filter media, all overlain with topsoil. The filter drains into an integral toe drain. A stringent inspection and testing programme was implemented on site to ensure that the filter material fitted with the design grading envelope, inclusive of on site grading checks.

To avoid material cross-contamination on site, discrete material storage bays were utilised. The use of temporary formwork in conjunction with levelling techniques ensured that the layer thicknesses were controlled. In addition, nuclear density testing was undertaken to ensure compaction was achieved per layer/bay.

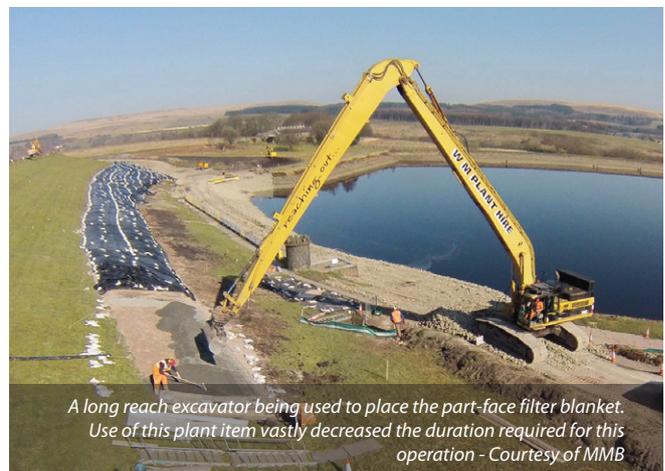
*A long reach excavator being used to place the part-face filter blanket. Use of this plant item vastly decreased the duration required for this operation - Courtesy of MMB*

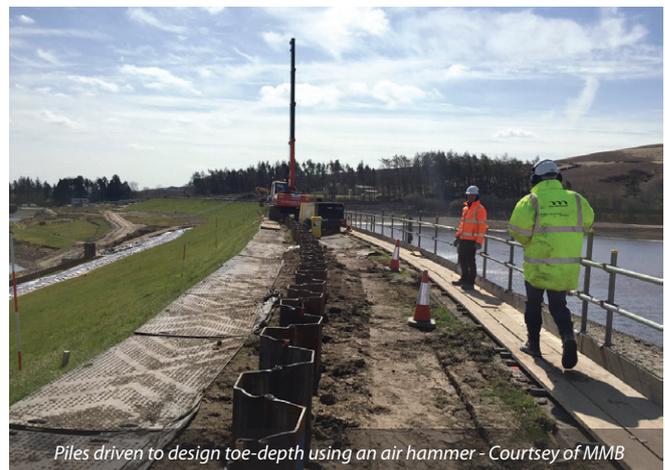
*Piles driven to design toe-depth using an air hammer - Courtesy of MMB*

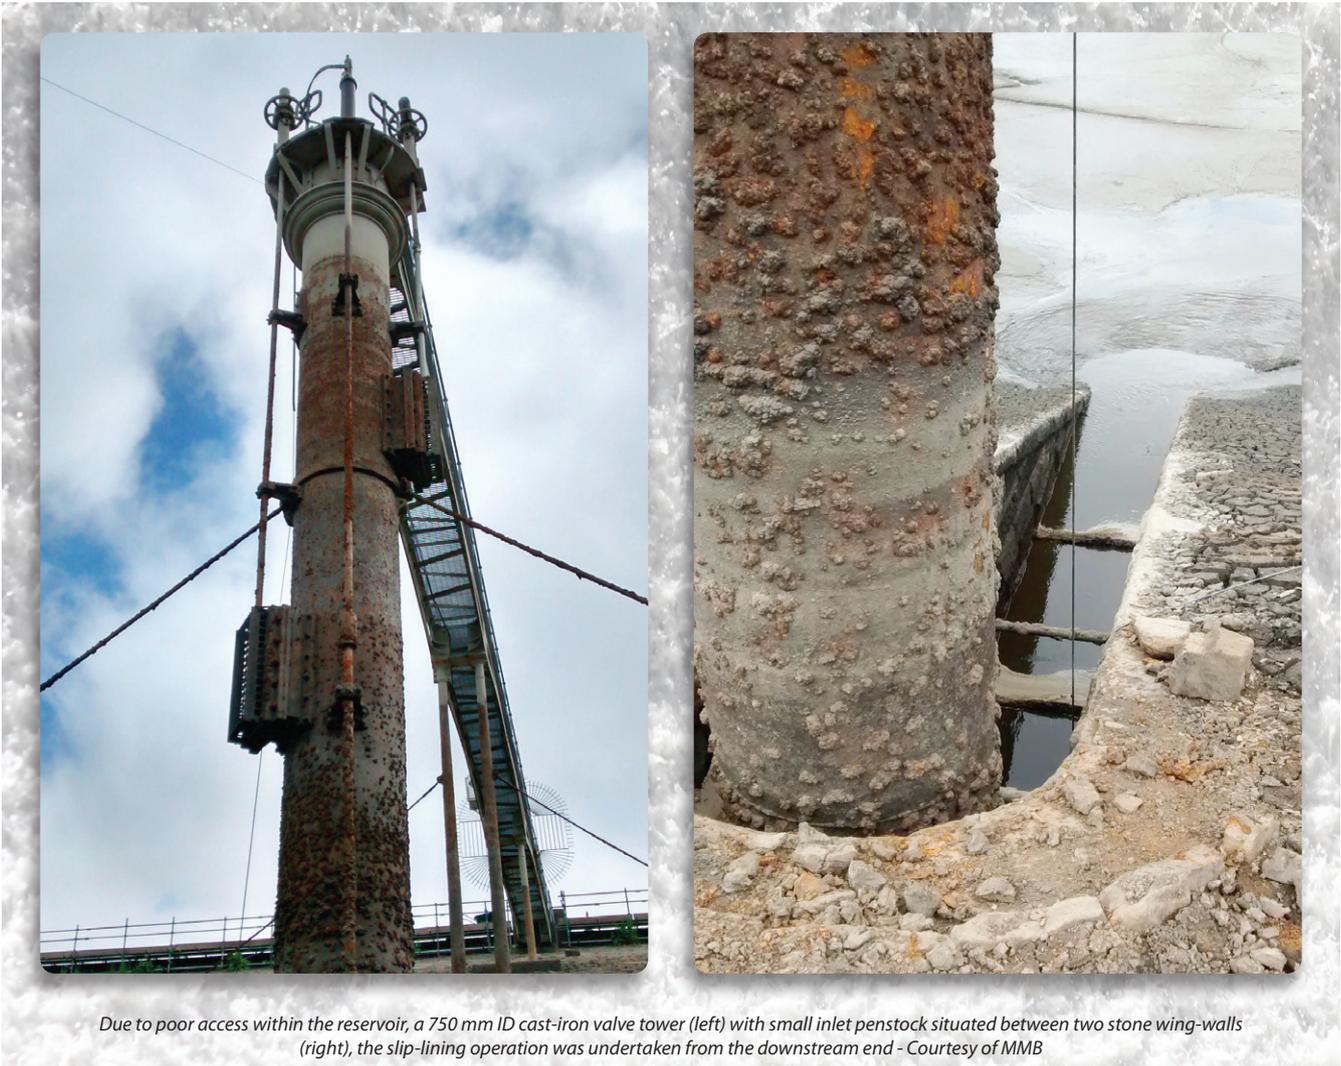
*Due to poor access within the reservoir, a 750 mm ID cast-iron valve tower (left) with small inlet penstock situated between two stone wing-walls (right), the slip-lining operation was undertaken from the downstream end - Courtesy of MMB*

The existing cast-iron scour main was slip-lined using 225mm diameter HDPE (SDR11) after extensive CCTV surveying and the removal of obstructions/deposits by robotic cutting. Due to the poor access (a 750mm ID cast-iron valve tower and similarly small inlet penstock) at the upstream end of the scour main, 6m lengths of HDPE were inserted from the downstream end using a 7T excavator.

Lengths were butt-fusion welded and then inserted once the necessary quality assurance checks had been undertaken. Once in place:

- The annulus between the host and product pipe was grouted using a high-flow grout.
- Breather pipework was placed at the soffit of the host pipe at its upstream and downstream ends.
- Further breather pipework was installed with small valves within the embankment tunnel.
- Grout was then injected from the downstream end at the invert of the host pipe.

Grout was witnessed at each of the breather pipe positions before finally flowing from the upstream end, confirming the annulus was completely full. On completion of the slip-lining operation, the tunnel was in-filled using a lightweight engineering fill.
