Butterley Spillway Improvements Works

improvement works to the only Grade II listed spillway in the United Kingdom at Butterley Impounding Reservoir in Marsden, West Yorkshire

by Rebecca Dresser MEng

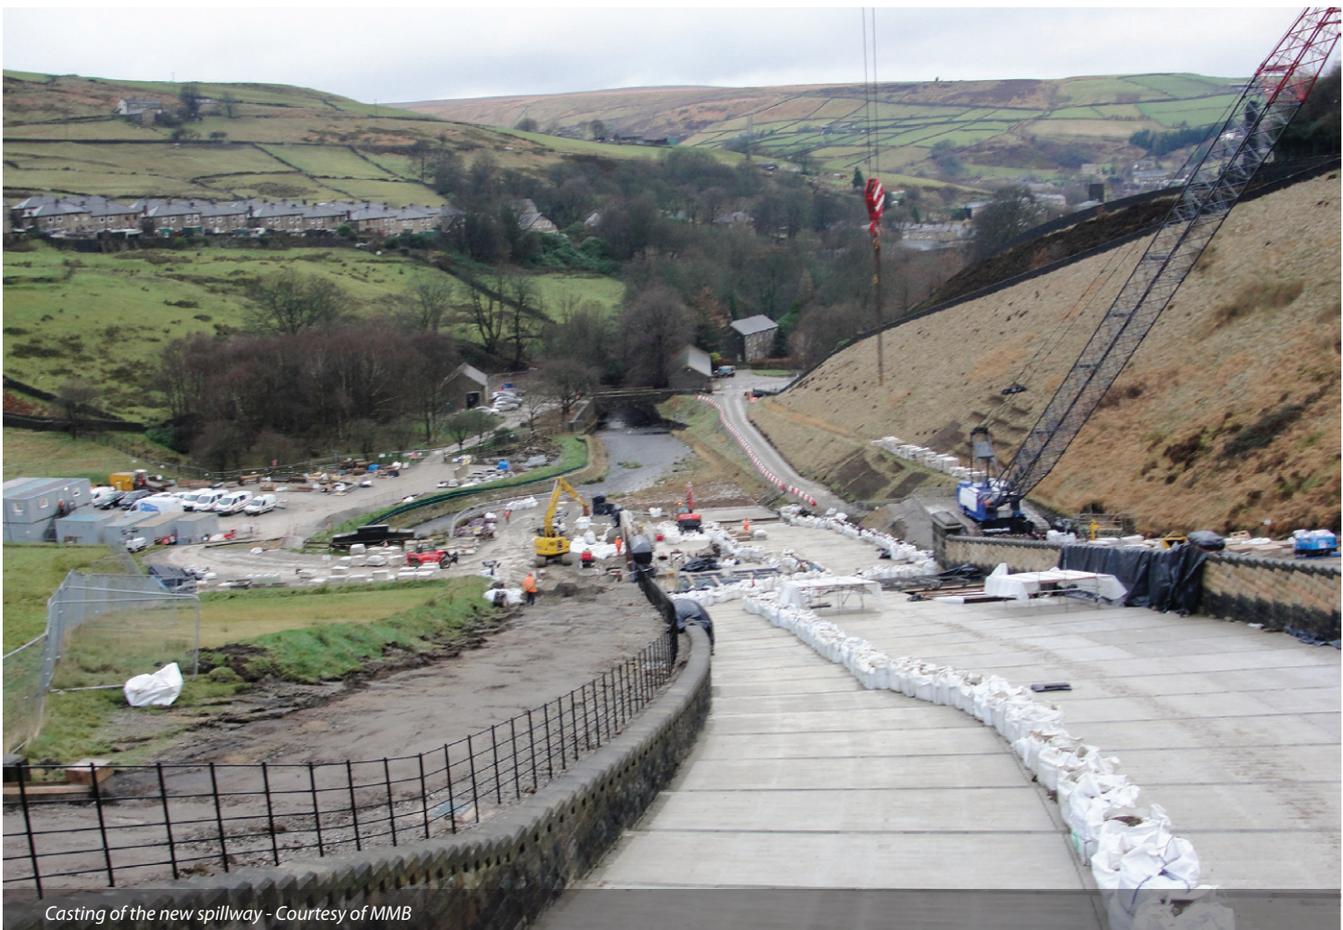
Casting of the new spillway – Courtesy of MMB

Fibre concrete has been utilised at Butterley to simplify the concrete works. In order to retain as much of the existing spillway profile as possible, the stone invert steps have been recreated in reinforced concrete. Two thirds of the spillway invert are solely reinforced with fibre to eliminate the need to install steel, with the remaining third of the invert being a combination. The use of traditional steel and fibre reinforcement concrete has simplified the steel arrangement by eliminating the need to step the steel to follow the invert profile.

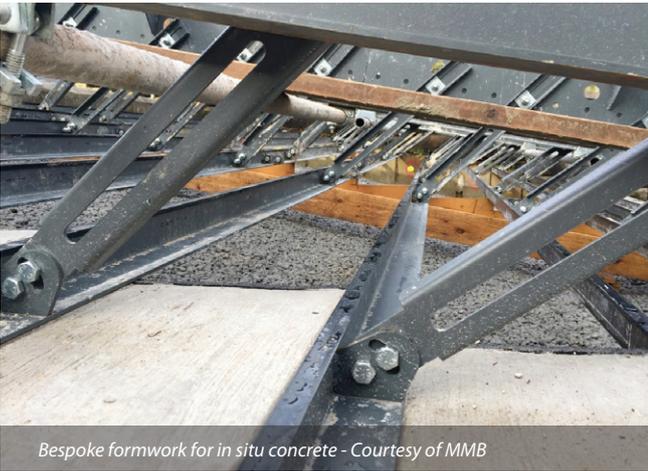
Bespoke formwork for in situ concrete - Courtesy of MMB

Due to planning complexities, there was a safety drive to accelerate the delivery programme without compromising on quality. Working in collaboration with our concrete subcontractor, bespoke steel formwork was designed and manufactured to assist the casting of the new stepped concrete invert.

The existing invert steps had a typical going of 360mm and typical rise of 65mm; added to this the curvature of the existing spillway meant that each invert concrete pour would be marginally different. The formwork was designed with bolted connections so that it could be adjusted to allow for accuracy on site during the set-up, to ensure that the new slabs blended into the existing. Retaining the 'white water' effect of the spillway caused by the stepped invert was important to the local community.

Using reinforced concrete within the footprint of the existing spillway required innovation, working in collaboration with the supply chain. Coupled with the use of fibre reinforcement, the steel formwork reduced the time taken to set up, pour and strip to 2 days, ensuring an excellent delivery of the new stepped concrete invert.

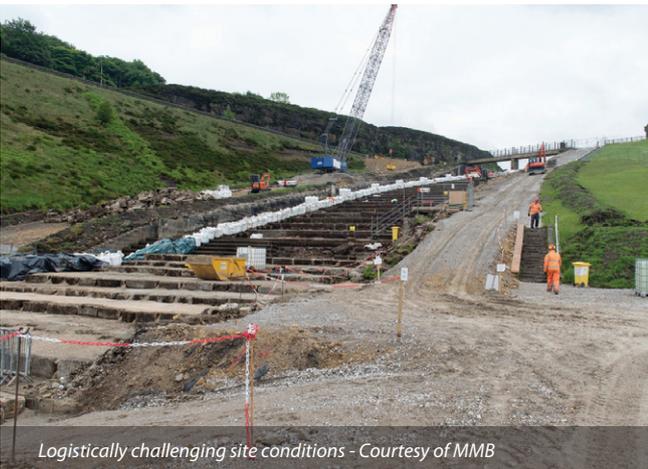
Logistically challenging site conditions - Courtesy of MMB

Access for construction works at reservoir sites is often challenging due to their location and topography. Butterley was no exception, especially for the installation of the 2 (No.) 100t crawler cranes required to service the spillway works. 3D modelling of the existing land profile to the right-hand-side of the spillway was completed to confirm that the area could be re-profiled to allow the cranes to safely be delivered, tracked into position and rigged.

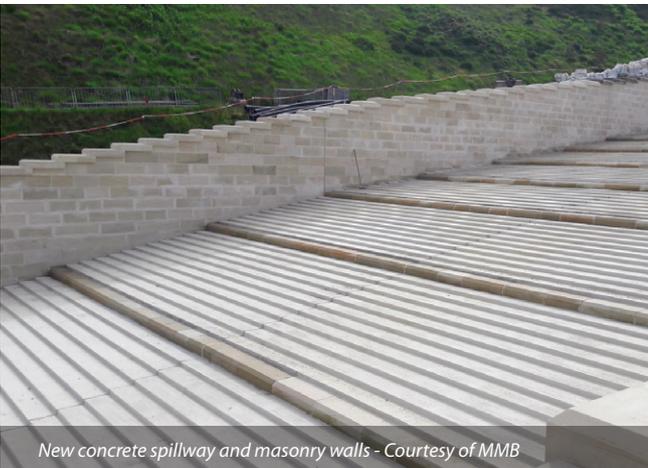
New concrete spillway and masonry walls - Courtesy of MMB

As much of the existing structure was to be retained and incorporated into the new spillway as possible; creating a suitable joint between the existing masonry and new concrete to ensure an integrated structure required some innovative thinking.

Construction joints were customised depending on their location within the spillway. In best practice, spillway joints are water retaining, at Butterley however this was not possible. As such, internal under drainage was incorporated in the form of a no fines concrete layer to eliminate flotation risk and structural damage.

To adhere to the listed building requirements, all new spillway walls and raised sections of existing walls had to be clad in sandstone, blending with the existing. To ensure that the newly-clad sections of wall matched the existing, a detailed masonry schedule was required.

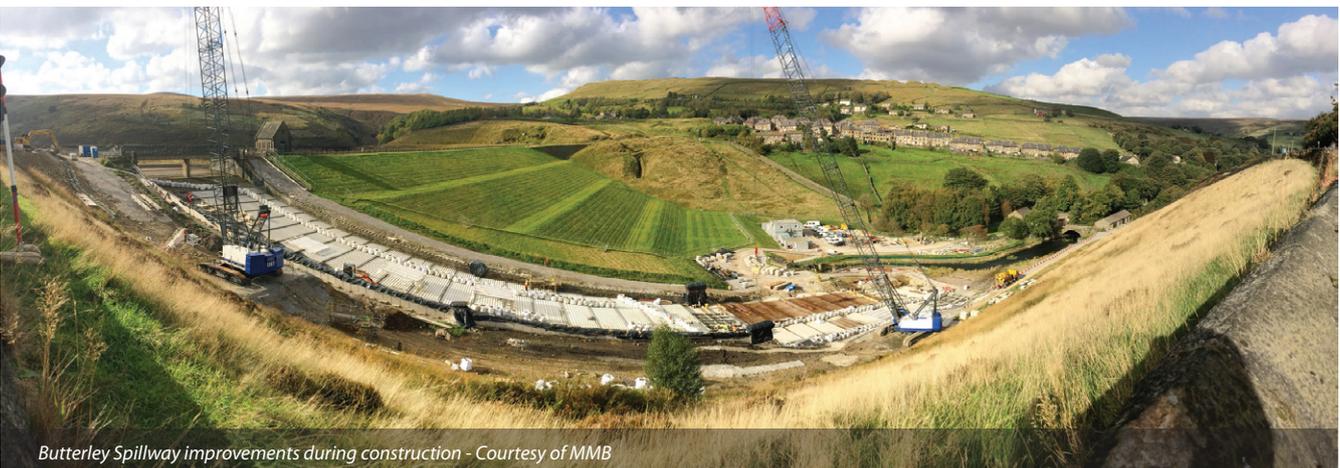
Butterley Spillway improvements during construction - Courtesy of MMB

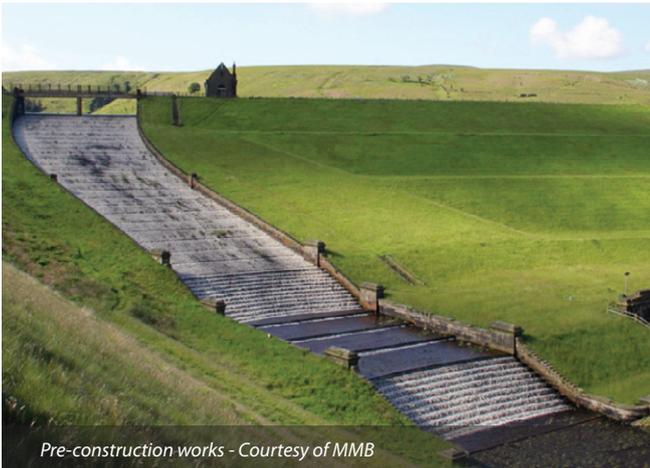
Pre-construction works - Courtesy of MMB

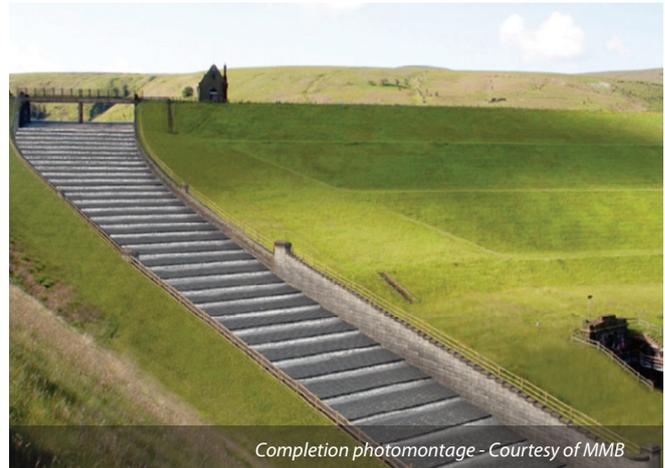
Completion photomontage - Courtesy of MMB

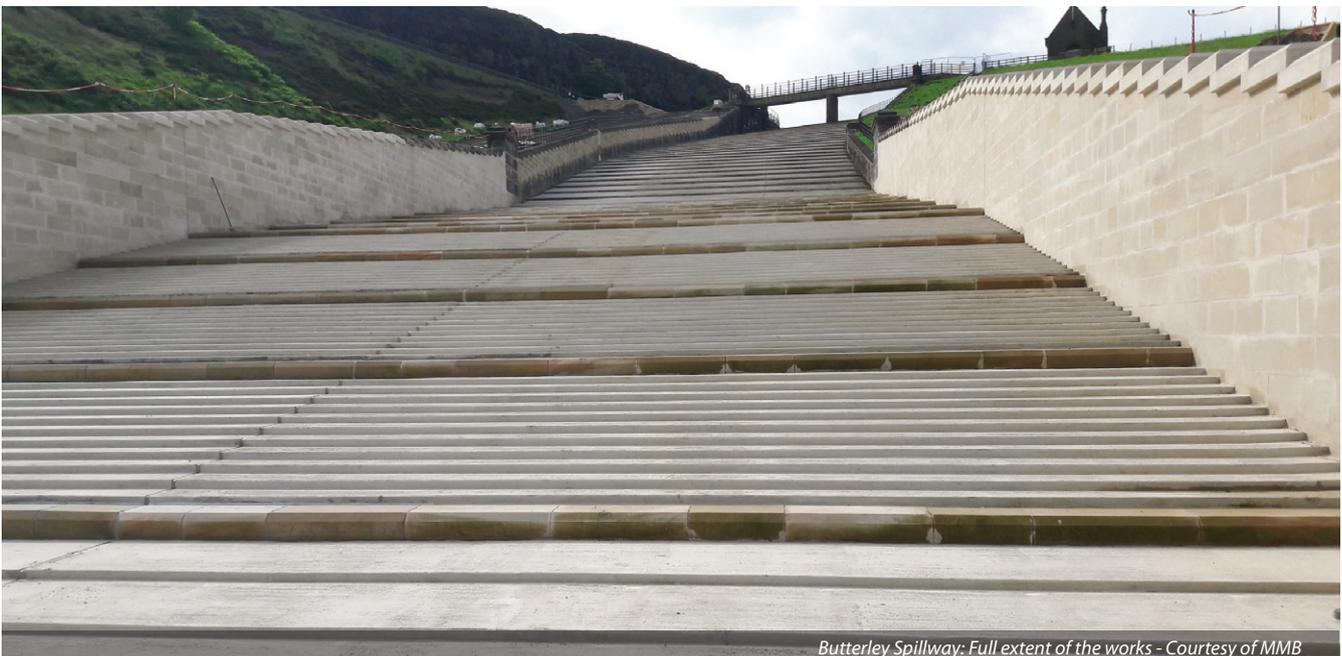
Butterley Spillway: Full extent of the works - Courtesy of MMB
