Island Barn Reservoir Remedial Works

reinforcement of 110-year old earth-filled embankment reservoir with minimal impact to service
by Amit Chakraborti

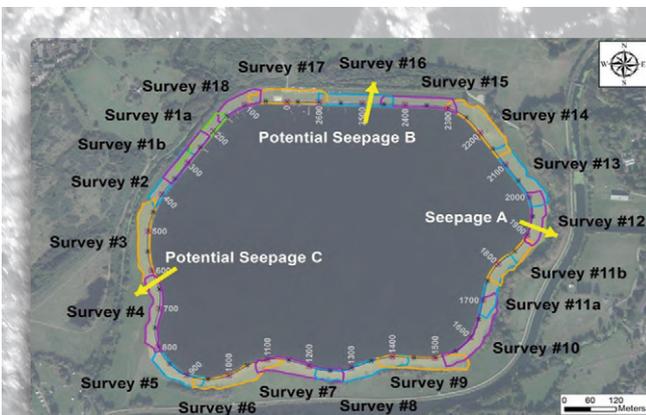
Surveys and coverage - Courtesy of Willowstick Surveys

A Willowstick survey (geophysical survey technology that scans electrical current flows between electrodes to sense water flow paths) was undertaken in 2015. It was found that there were three defined areas of seepage below the clay core that forms the waterproofing core of the embankment.

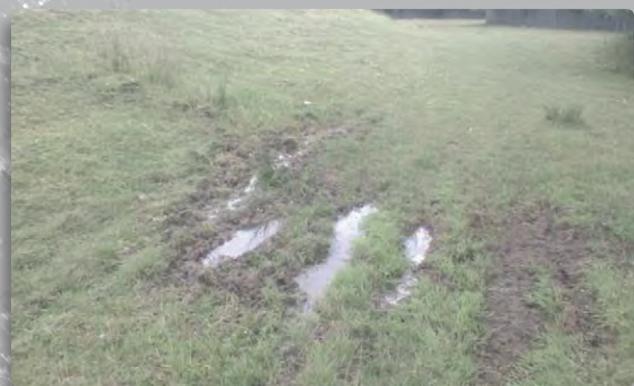
Leakage at toe - Courtesy of eight2O

For several years there have been signs of leakage through the embankment of Island Barn Reservoir. There were visible wet patches at the bottom of the embankment and restrictions operated on the reservoir.

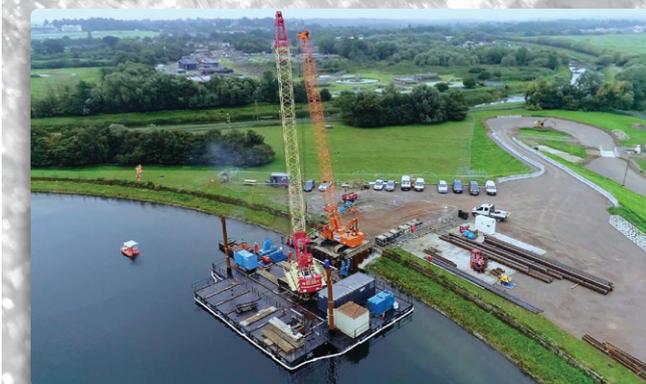
Loading of piles at new jetty - Courtesy of eight2O

To get heavy construction plant down from the crest/wave wall, to the water, special arrangements were required. A piled jetty was

constructed to the south west corner of the reservoir at a level that would allow plant to track down and onto pontoons.

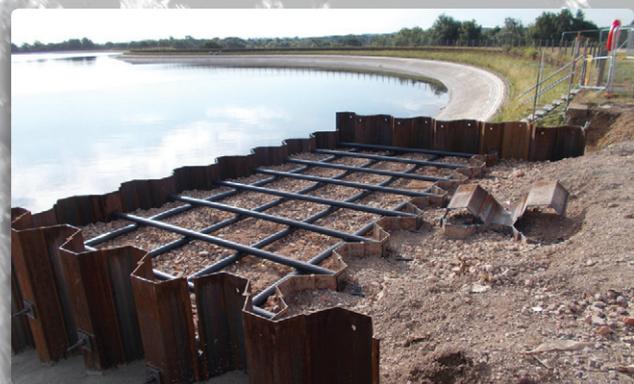
New jetty in construction - Courtesy of eight2O

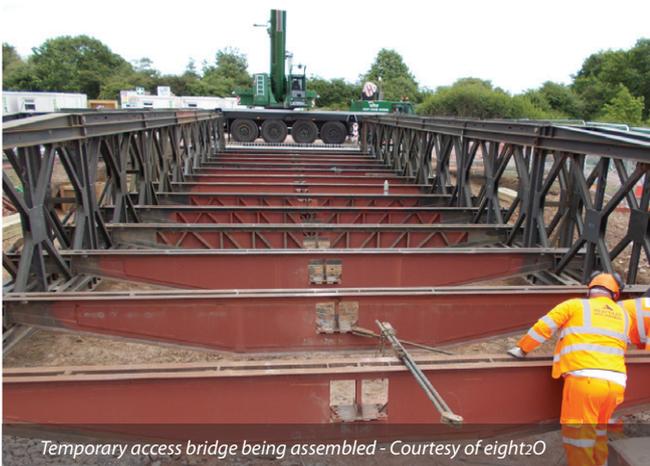
Temporary access bridge being assembled - Courtesy of eight2O

There were three areas where the access ways were traversing vulnerable mains. In particular there were some shallow potable water mains that had known leakage and a history of bursts. In one area a temporary bridge (27m span) was placed between concrete foundations that were founded onto competent ground on either side of the services.

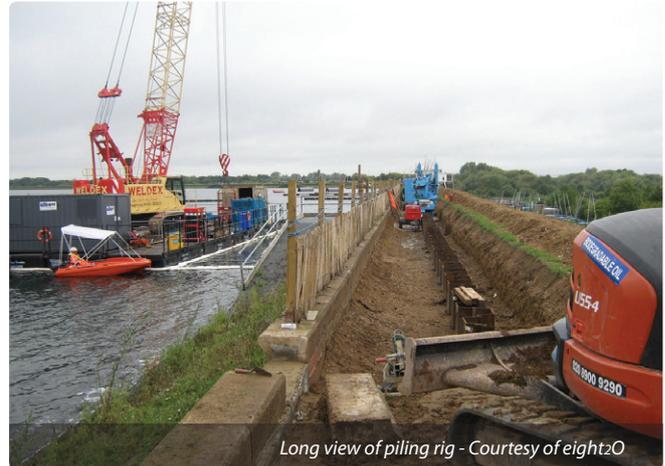
Long view of piling rig - Courtesy of eight2O

It was also planned that the piling equipment would be mounted on a pontoon system placed within the reservoir. This saved having to do a large strip of the embankment to enable heavy equipment to safely bear down.

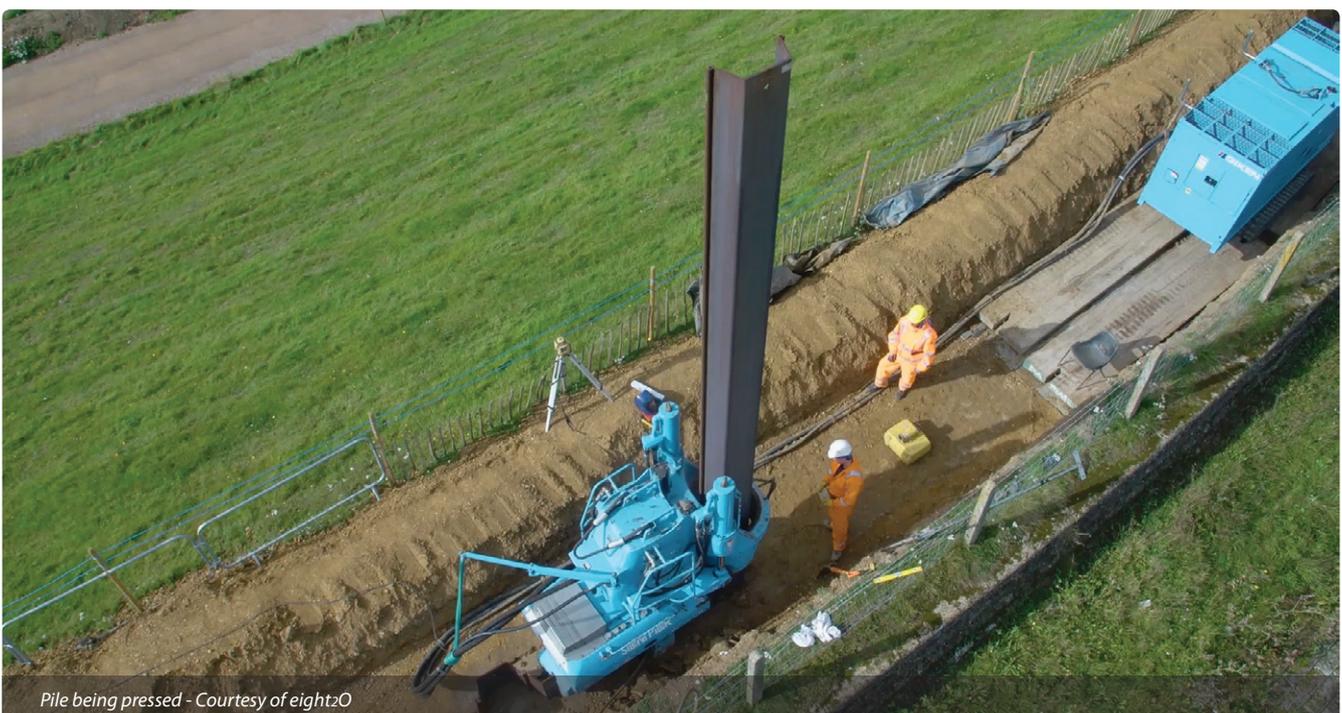
Pile being pressed - Courtesy of eight2O

The particular method chosen was GIKEN (silent piling) where piles are pressed in. Traditional methods of hammering or vibrating piles into place would have risked damaging the embankment.
