Garreglwyd Raw Water Supply Main

ensuring Welsh Water customers an uninterrupted supply during harsh weather extremes in challenging terrain

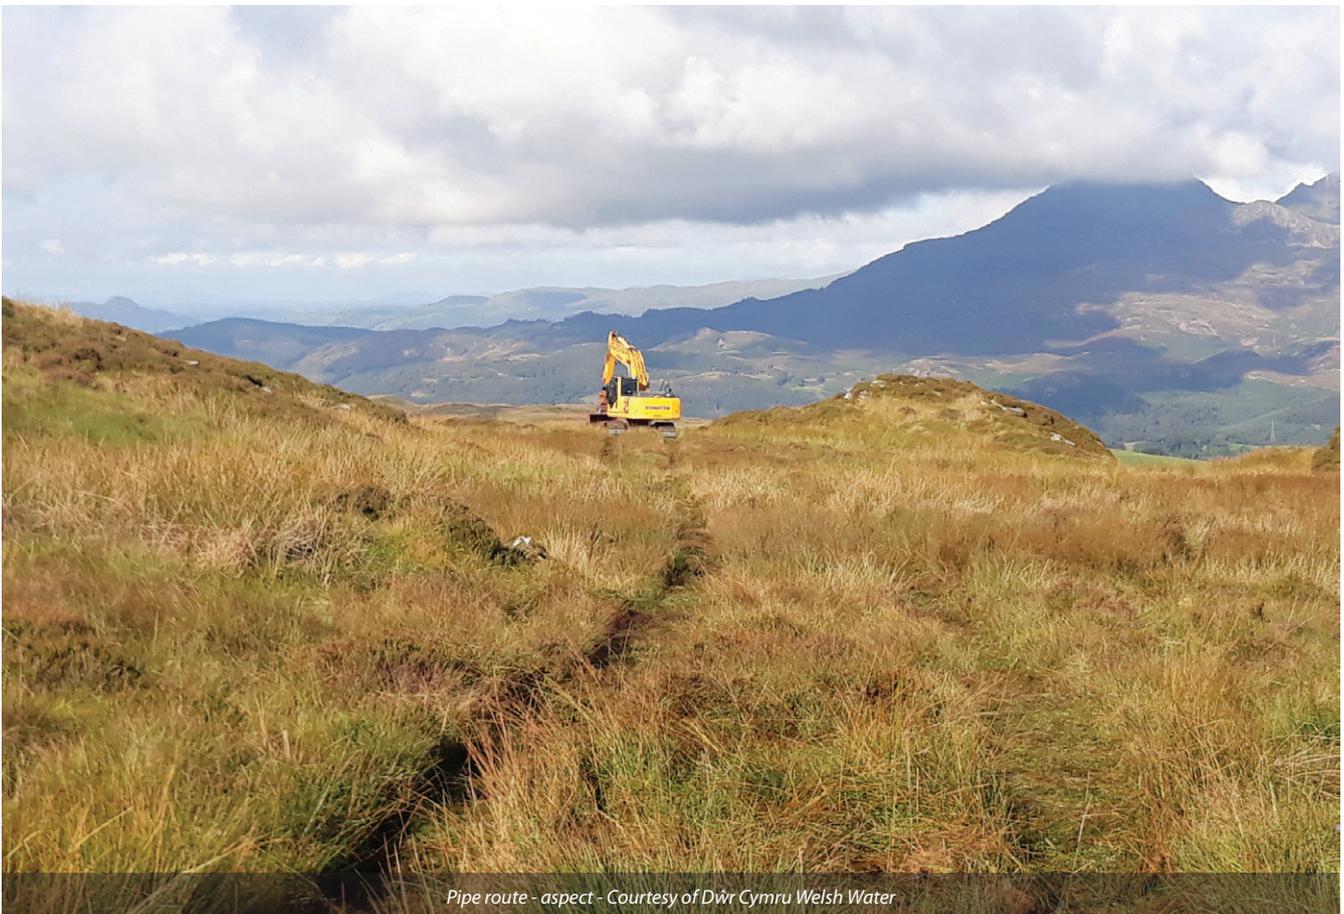
Pipe route - aspect - Courtesy of Dŵr Cymru Welsh Water

The route of the existing raw water main crossed rough mountainside open fields, passed through a disused quarry and crossed several dry-stone walls and stock proof fence field boundaries, as well as watercourses. A site walkover was carried out to view the existing route and determine potential issues with the route being partially through Crown property together with a SAC and SSSI.

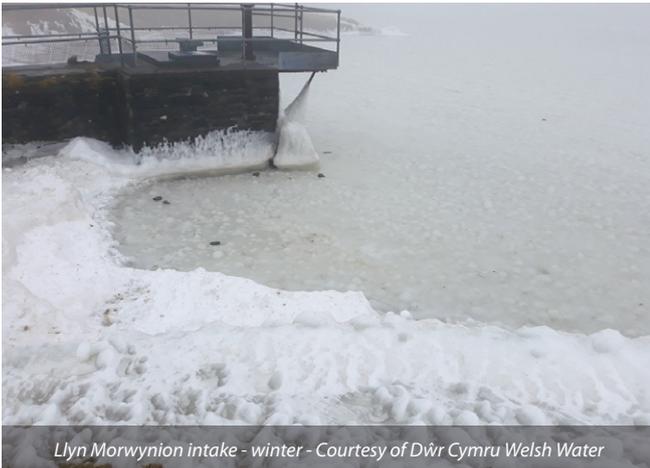
Llyn Morwynion intake - winter - Courtesy of Dŵr Cymru Welsh Water

Divers were used initially to confirm the intake within the reservoir was clear. Incremental testing was then carried out to locate the flow restriction. It was concluded that this was attributable to severe tuberculation in some 450m of the 8" cast iron raw water main. Records showed this had been the reason for the earlier replacement section of 250mm MDPE. Inspection of the MDPE pipeline showed it to be in good condition; the material being less susceptible to tuberculation.

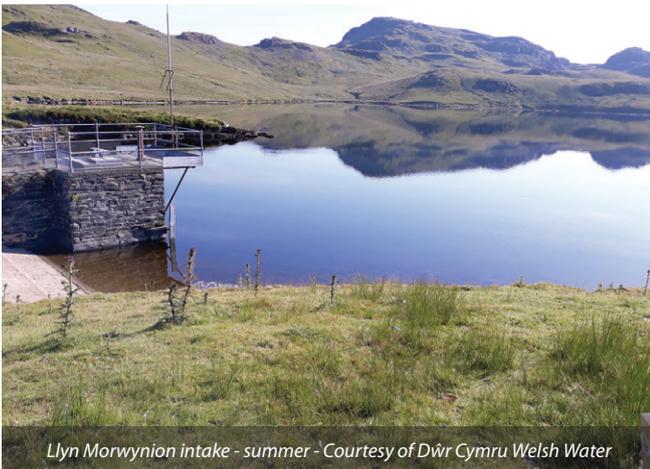
Llyn Morwynion intake - summer - Courtesy of Dŵr Cymru Welsh Water

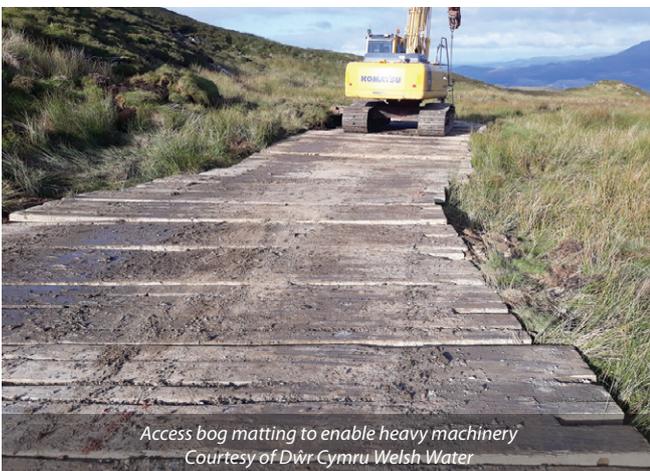
Access bog matting to enable heavy machinery
Courtesy of Dŵr Cymru Welsh Water

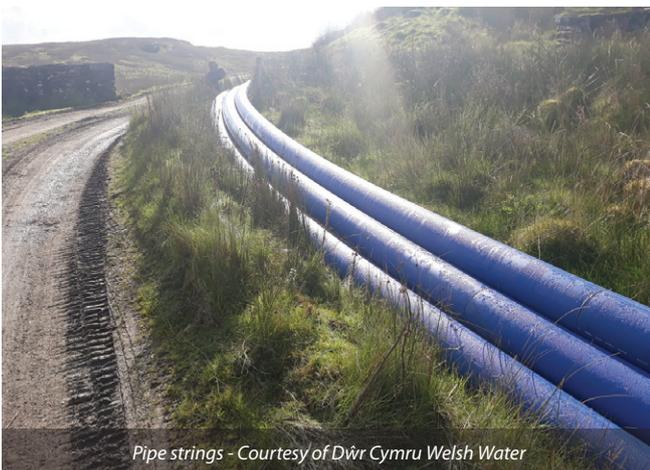
Pipe strings - Courtesy of Dŵr Cymru Welsh Water

Waterco undertook the calculations and modelling and confirmed the hydraulic adequacy of 250mm MDPE for future supply requirements on the proposed extended route. The agreed solution was therefore to replace 550m of 8" cast iron with 250mm PE100 SDR11. Waterco prepared legal notices of entry for Welsh Water to issue to private landowners and to submit applications for the works to Natural Resources Wales (NRW) and Gwynedd County Council.

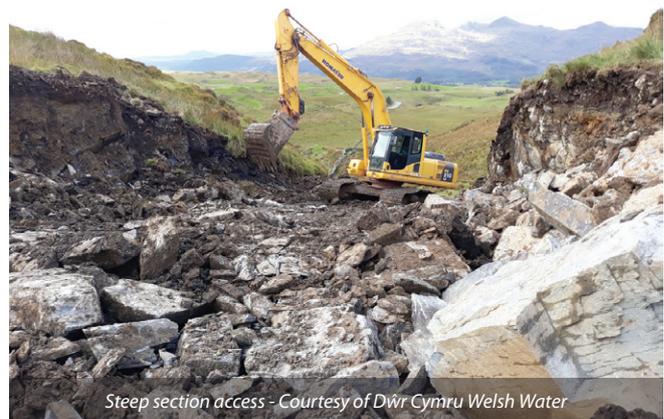
Steep section access - Courtesy of Dŵr Cymru Welsh Water

The OCU site team dealt with some extremely challenging terrain by open cut methods and worked long hours to deliver the scheme two weeks ahead of programme, with the new pipeline section replaced and commissioned by Welsh Water in October 2018.

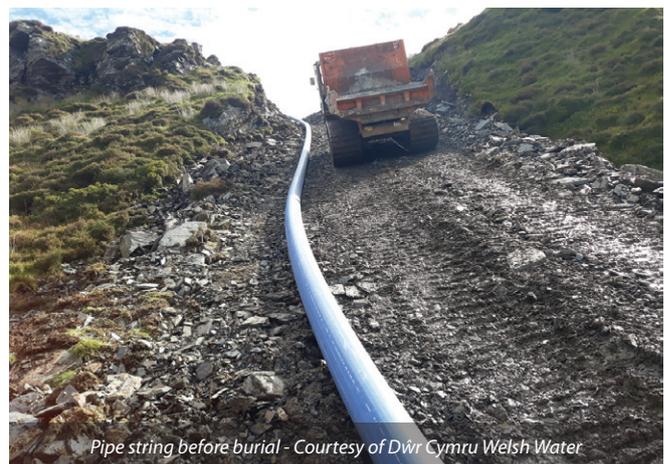
Pipe string before burial - Courtesy of Dŵr Cymru Welsh Water
