WAMM (Water & Abandoned Metal Mines) Programme

improving water quality in the metal polluted River Nent, West Allen and South Tyne

by Robert Cullledge, Hugh Potter & Nick Cox

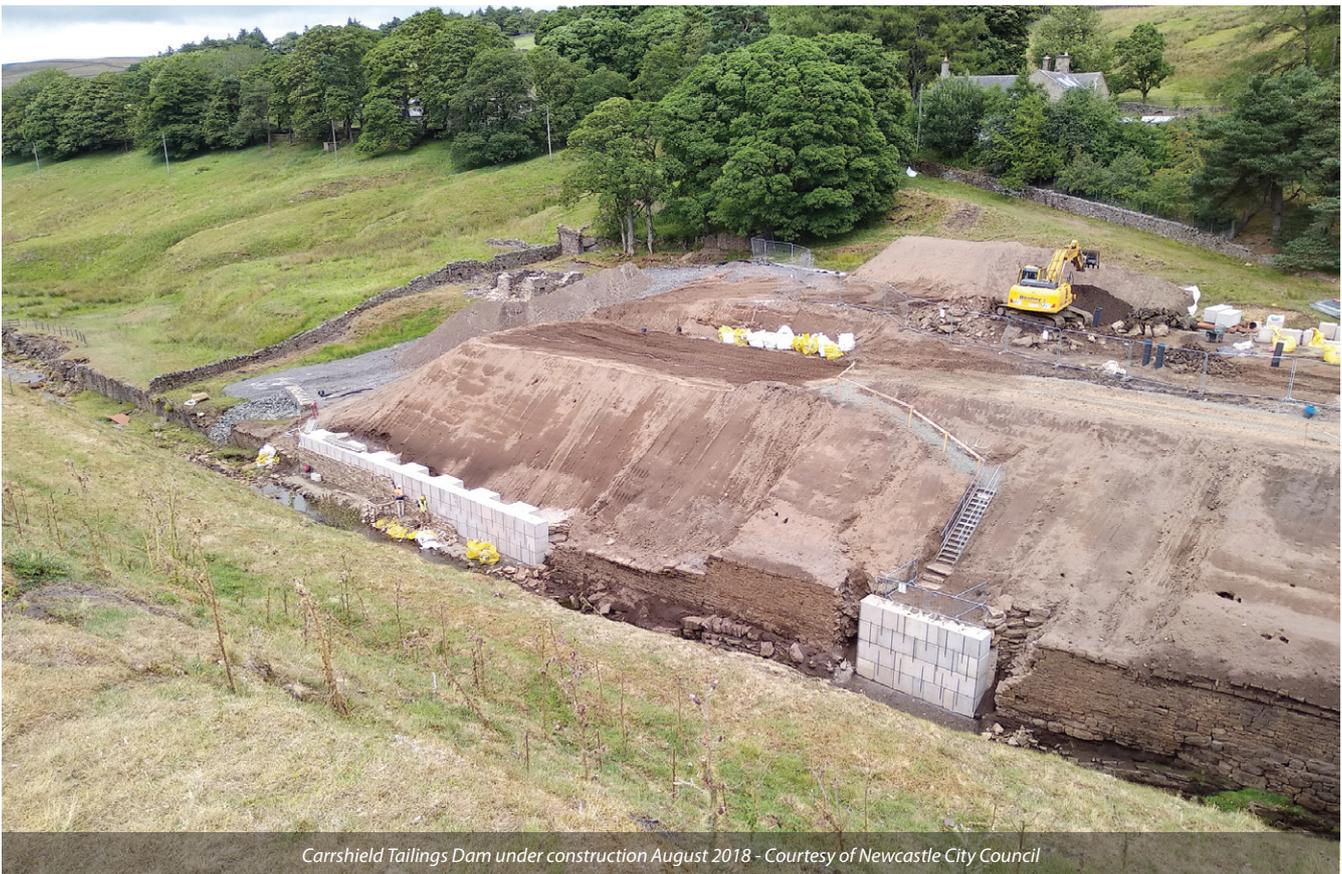
Carrshield Tailings Dam under construction August 2018 - Courtesy of Newcastle City Council

Engineering works were implemented to reduce the loading on the retaining wall and minimise water flow through the tailings and retaining wall. The engineering works consisted of a surface water interception drain to the rear of the wastes, repairs to failed sections of the retaining wall, regrading and capping the tailings.

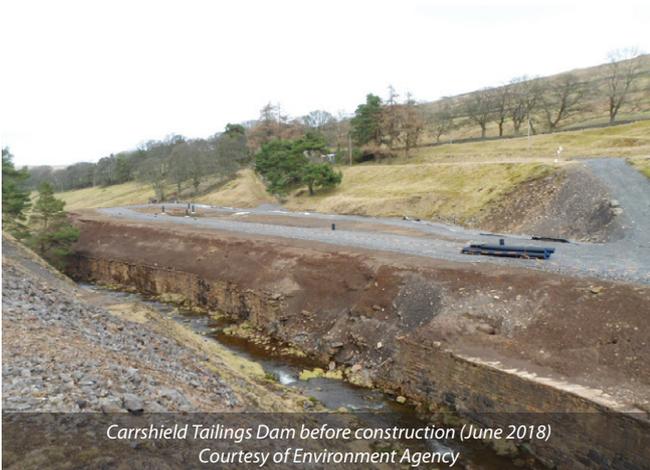
*Carrshield Tailings Dam before construction (June 2018)
Courtesy of Environment Agency*

The Carrshield Tailings Dam stores about 48,000m³ of highly metal contaminated mine wastes behind a dry stone wall constructed in the 19th Century. Up to 3 tonnes of zinc, cadmium and lead is eroded each year from these wastes which contributes to pollution

The primary cause of the failures of the retaining wall were identified as increases in pore water pressure within the tailings as a result of surface water recharge. The key remedial design principle was to prevent ingress of surface water to the wastes.

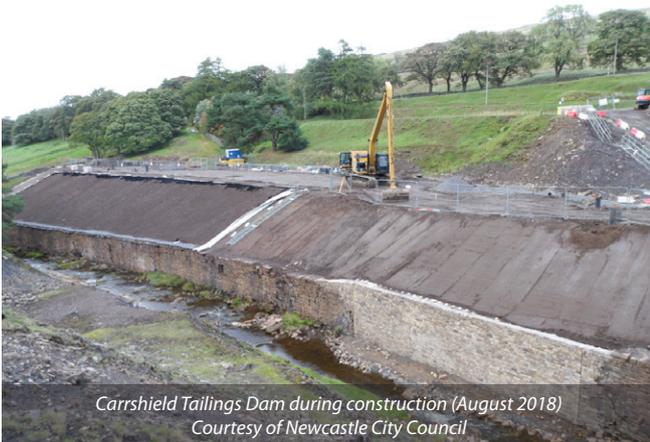
*Carrshield Tailings Dam during construction (August 2018)
Courtesy of Newcastle City Council*

Working closely with the MM geotechnical engineer the JN Bentley site team proceeded with an alternative methodology battering the excavation in sections and construction of a legato block wall using the crane from a designed position of safety. The buttress was then excavated out from behind the new wall and installed as a mass fill concrete pour in an excavation rather than using a trench box. This solution ultimately saved £90,000 costs and 8 weeks on the programme.

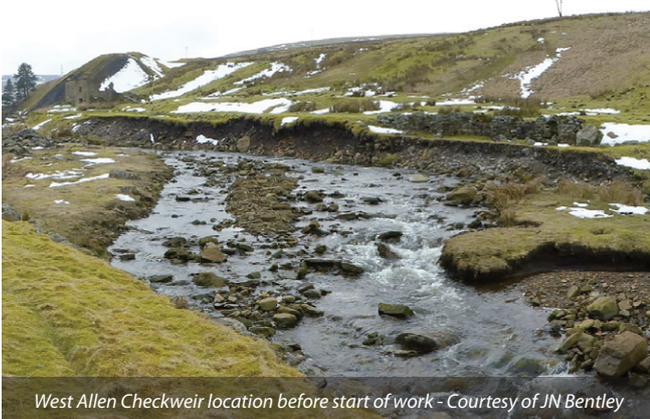
West Allen Checkweir location before start of work - Courtesy of JN Bentley

The West Allen check weir site is located immediately downstream of the Carrshield tailings dam. The project aims to capture metal contaminated sediment already in the river alongside the interventions to limit future inputs. Previous investigations have shown that most of the metals are found in the silt to sand sized fraction. The project objective is to capture about 1 tonne of zinc, cadmium and lead is each year and so limit the movement of particulate metals down the River West Allen and into the Tyne estuary.

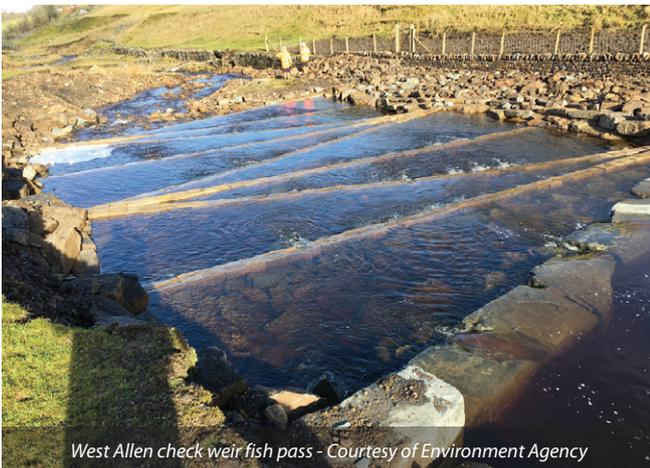
West Allen check weir fish pass - Courtesy of Environment Agency

In principle, the design consisted of a number of large rocks spanning and damming the river creating the 1m high check weir. Upstream of the check weir stone slabs were laid to the bed of the river to aid future dredging of contaminated sediments. Downstream, due to the height of the check weir and the gradient of the existing river a number of pre-barrages and rock pools were constructed such that fish passage could be maintained.

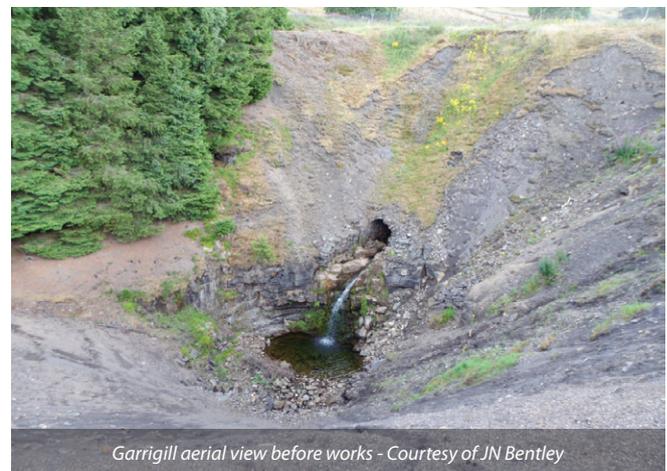
Garrigill aerial view before works - Courtesy of JN Bentley

During the 19th Century mining operations, Garrigill Burn was partially culverted and covered with mine waste. The culvert had in part collapsed allowing an estimated 3 tonnes of zinc, lead and cadmium to enter the watercourse each year and pollute at least 10km of river. Around 60,000 tonnes of wastes remain on site, containing an estimated 1,400 tonnes of metals. The old mine site is designated as a Scheduled Monument, is located in the North Pennines AONB and contains priority calaminarian plants.

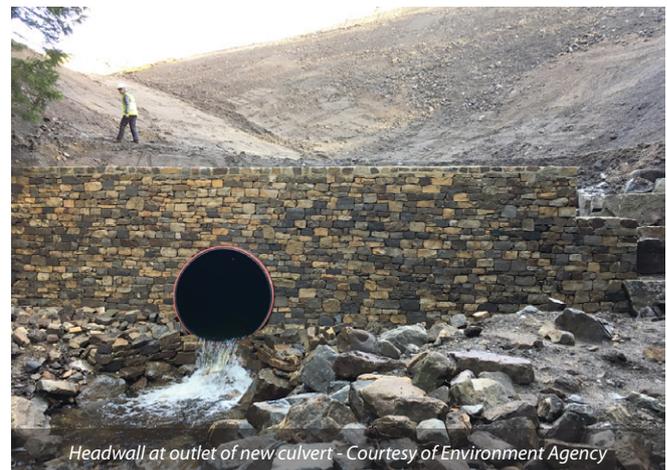
Headwall at outlet of new culvert - Courtesy of Environment Agency

Thirteen options were initially considered by designers JBA, who, after considering all aspects of heritage, buildability and cost, recommended installing a solid piped connection between the upper and lower culvert, re-profiling the spoil heap and installing a new revetment at the downstream end to mitigate future slippage and run-off during high rainfall events. A detailed 3D survey of the existing culverts, the gap between them and the respective alignment between the culverts was used to determine exact pipe lengths and angles to ensure the pipes were installed right first time.

Working with the designers, JBA, the methodology was changed to install the pipe using an 80t crawler crane, temporarily supporting and also strapping down the pipe whilst placing concrete surround to the pipe. Once the pipe was surrounded an access ramp could be formed into the void. Approximately 6,000m³ of the surrounding spoil slopes were benched and re-profiled over the new installed culvert.

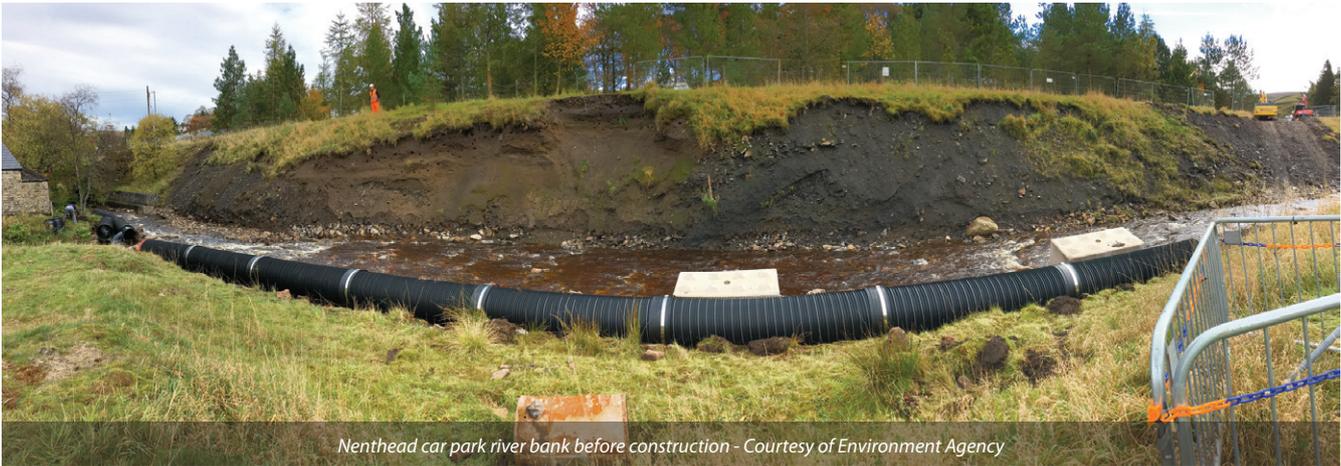
Nenthead car park river bank before construction - Courtesy of Environment Agency

The bank of the River Nent by the Nenthead public carpark comprised largely highly metal contaminated mine spoil with some disturbed natural rock. Up to 1 tonne of zinc, lead and cadmium is being eroded each year with slope failure over a

length of approximately 65m. The exposed embankment housed a population of sand martins and therefore the design and timing of construction of the scheme needed to address this.

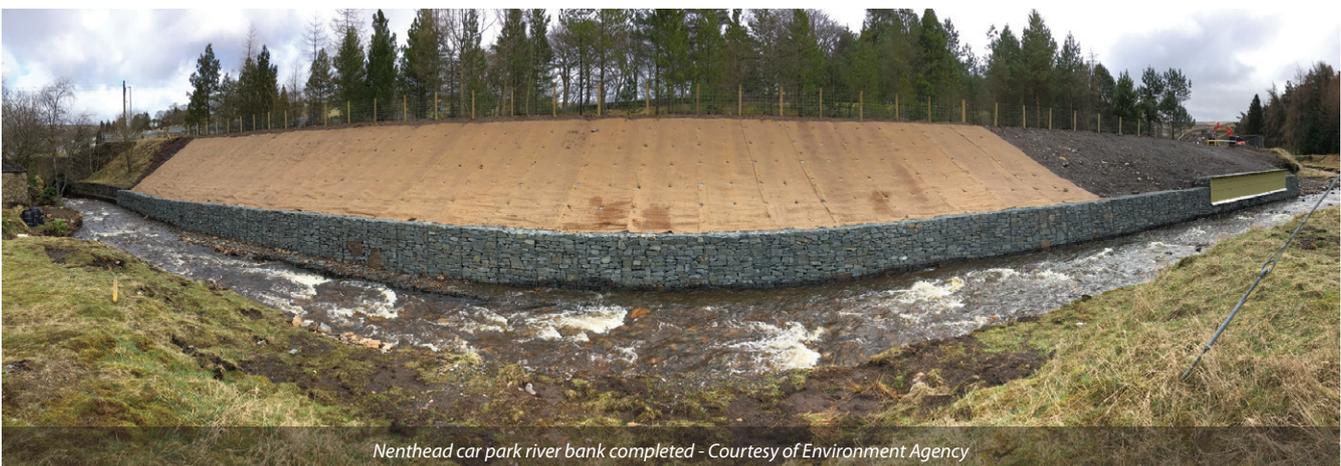
Nenthead car park river bank completed - Courtesy of Environment Agency

A reinforced earth solution was modified following the ECI and the resultant design comprised of a gabion retaining feature, regrading the embankment to a more favourable angle and covering with an erosion protection layer anchored into the resultant slopes.
