# Slimbridge Infiltration Reduction

## flood grouting trial scheme and CP308 infiltration lining

by Alexandra Finlyson

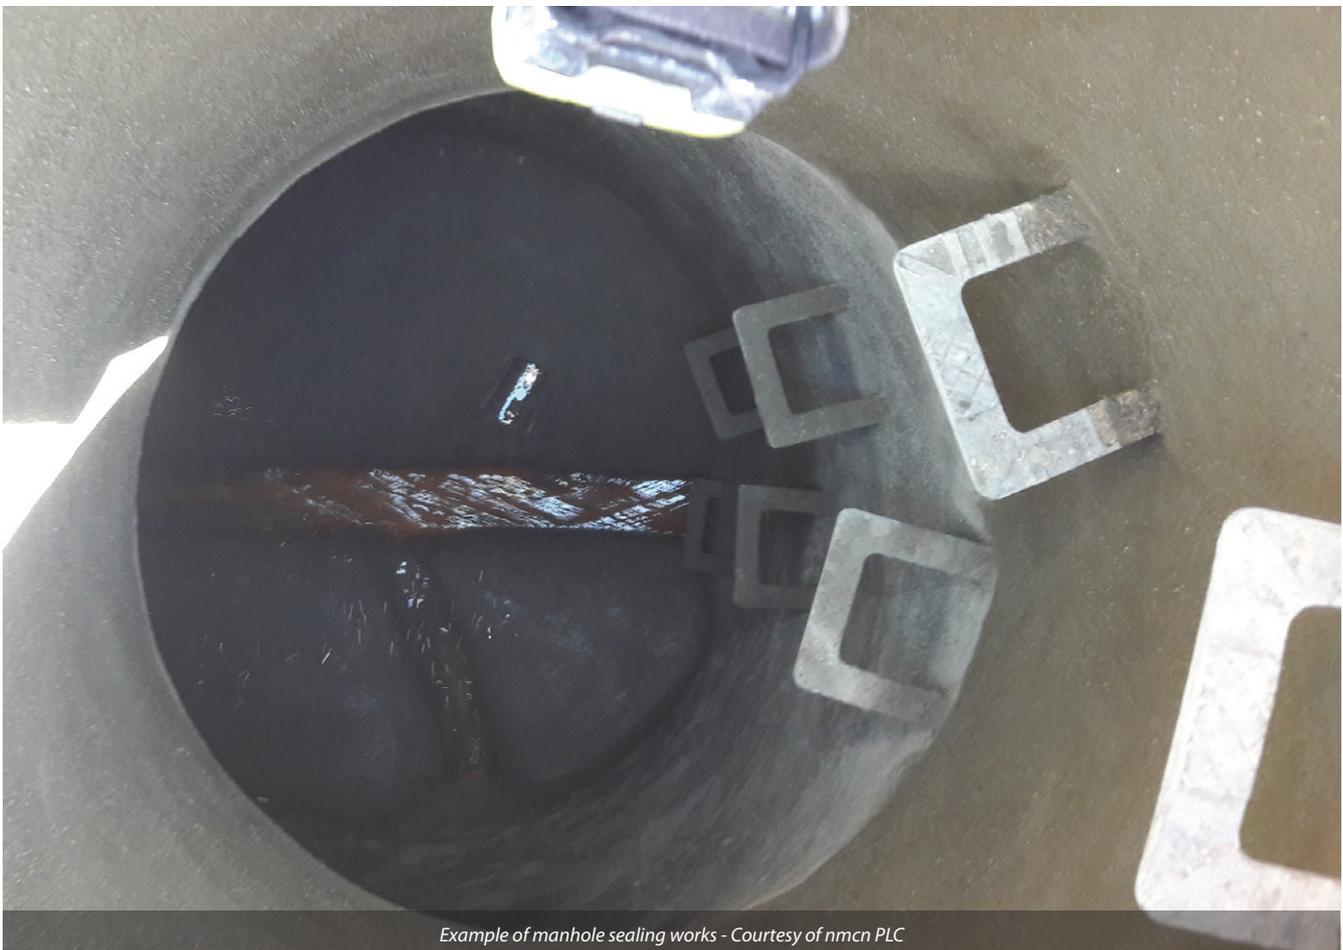
Example of manhole sealing works - Courtesy of nmcn PLC

To ensure complete sealing of the network the CIPP lining works were undertaken in conjunction with manhole spray lining and resin injection. This involves accessing the manhole chambers, and drilling multiple holes into the wall of the manhole chamber where a polyurethane-based injection foam is applied. Once this operation has been completed a secondary flexible polyurethane injection is applied to the inside walls. This seals the manhole from exfiltration and infiltration.
