Ten Acre Impounding Reservoir

efficient design and delivery of a reservoir discontinuance to enhance the natural environment, whilst providing limited future operational requirements

by Jade Toulson & Mark Colledge

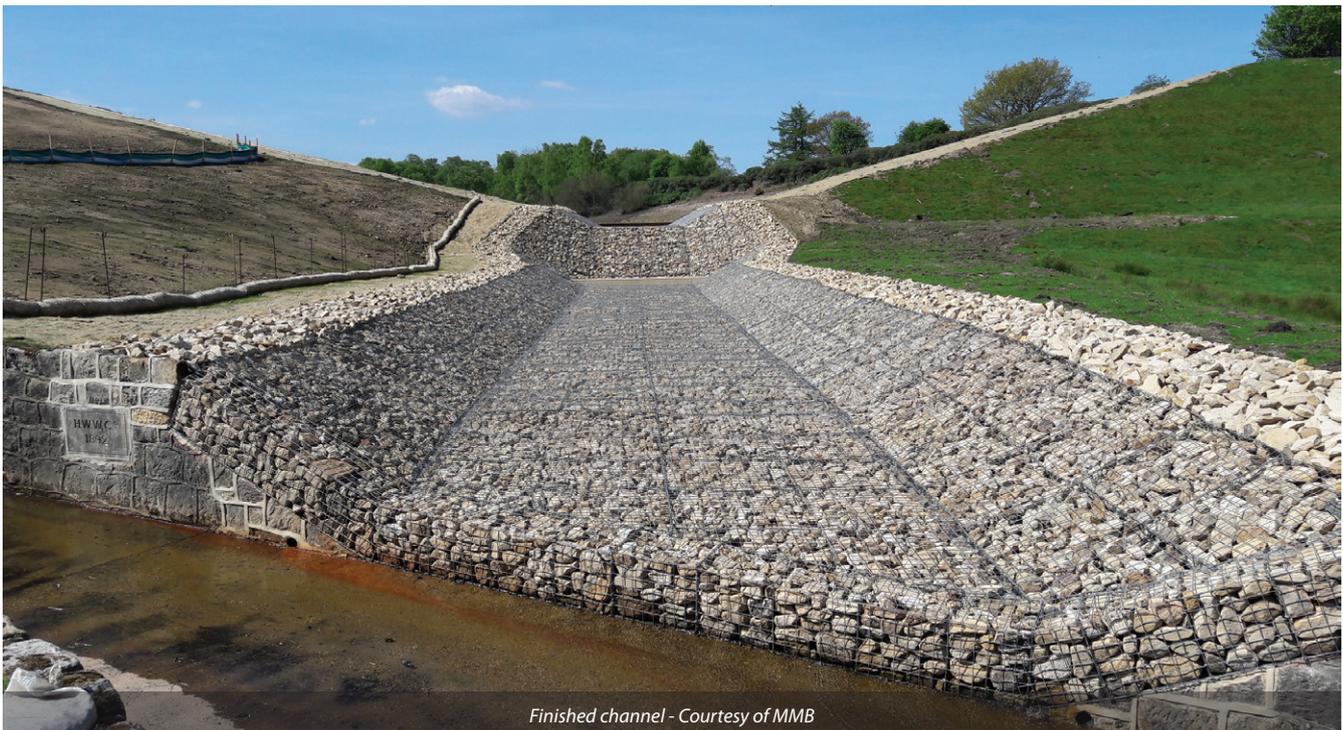
Finished channel - Courtesy of MMB

The new lower level channel was designed to minimise the amount of excavation and designed to tie into the existing spillway channel at the downstream end to reuse the existing spillway channel and minimise construction. HEC-RAS was used to produce a hydraulic model of the channel to assess the velocities and water depths across its whole length for a 1 in 150-year flood event flow. A steep section was positioned at the toe of the dam with shallower gradients upstream and downstream to allow rip rap to be used instead of gabion baskets. The first run of the model highlighted that the velocities would be too high for rip rap downstream of the steep section. A weir was then positioned 1m downstream of the toe to force the hydraulic jump to occur earlier, shortening the length of the channel with high velocities and decreasing the amount of gabions required.

The existing stone pitchings and rip rap from the upstream face of the embankment were re-used for the rip rap and gabions rather than importing stone, reducing the carbon footprint of the channel. The original headstone from the scour tunnel was also retained and incorporated into the channel termination detail, maintain some of the heritage of the site.

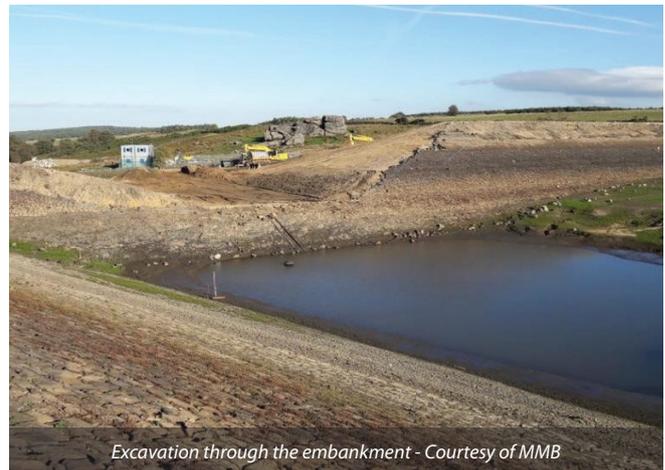
Excavation through the embankment - Courtesy of MMB

Excavation: The main excavation of the embankment and for the new channel was planned and sequenced in detail due to the small footprint of the site. It was critical excavation work could take place

whilst other plant was moving and placing the excavated material on other parts of the site. The excavation work was set out using a smart GPS station that had coordinates inputted directly from the Civil 3D model. By placing the GPS station at any point, it gave a reading of how high or low the ground level was at that exact point. This reduced the amount of setting out errors on site and reduced the duration of the excavation works.

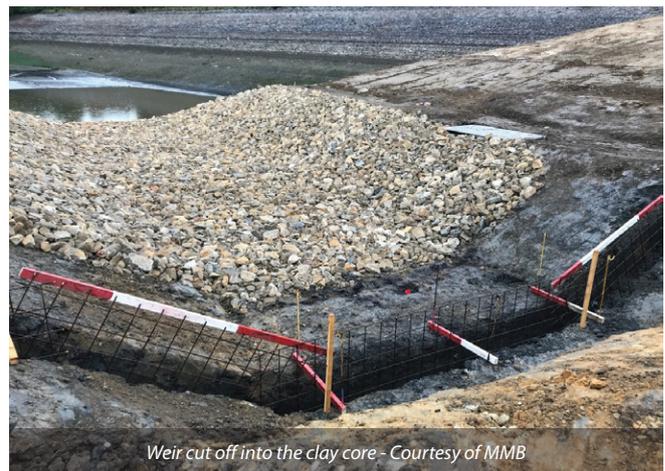
Weir cut off into the clay core - Courtesy of MMB

Weir structure and channel: The new weir structure was located and constructed in the centre of the existing clay core to provide a water tight cut off from the reservoir to the channel. The clay was over excavated before the concrete weir was cast in the trench.

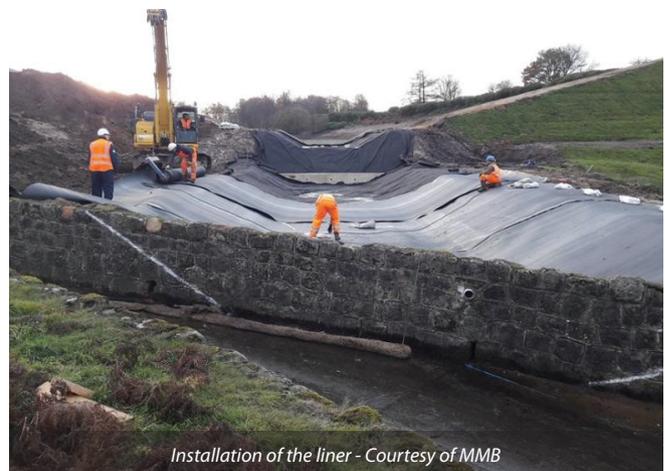
Installation of the liner - Courtesy of MMB

The channel was formed out of a combination of rip rap and gabion baskets, the downstream sections were installed on top of a waterproof liner to ensure water passed from the reservoir directly into the watercourse. The waterproof liner was installed with a soft geotextile above and below to protect the liner from being punctured by the stone and earth.

Key design and construction details included ensuring the liner terminated into a tie-in trench at the top of the channel slopes as well as tying into the existing spillway at the downstream end of the channel and the new weir structure at the top end of the channel to provide a water tight channel. Bespoke steel angles were fabricated to tie the liner into the concrete structures.

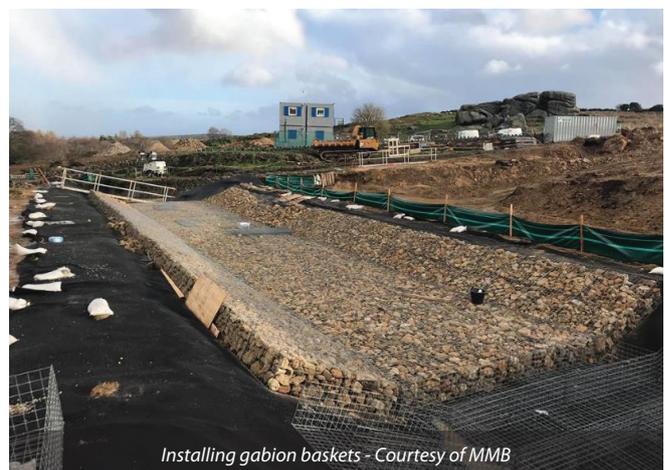
Installing gabion baskets - Courtesy of MMB

The gabions were filled mainly with stone reclaimed from the site during the excavation works. The masonry wave wall was removed as well as a number of pitching on the upstream side of the embankment. This stone was crushed on site to a suitable size and used in the gabion baskets.
