Woodhall Park River Restoration

revitalising the River Beane through Woodhall Park

by Sophie Mortimer

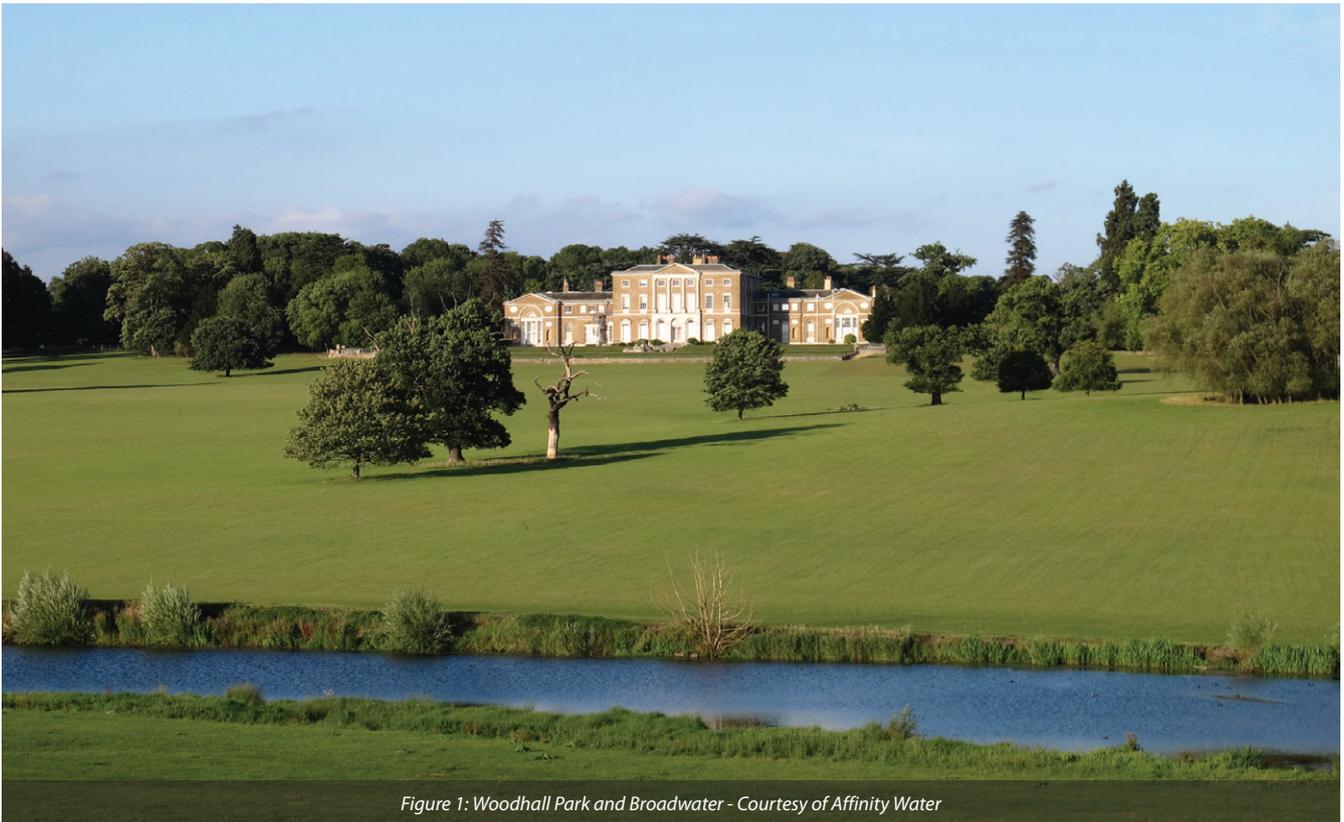
Figure 1: Woodhall Park and Broadwater - Courtesy of Affinity Water

Woodhall Park (Figure 1) located in Watton-at-Stone near Stevenage forms the heart of the Woodhall Estate and is a Grade II listed parkland. The River Beane flows through the Estate over two significant weirs; the Tumbling Bay Weir which creates an ornamental waterfall and holds back an impressive broadwater, and the Horseshoe Weir 700m downstream of Tumbling Bay Weir which was installed for ornamental purposes.

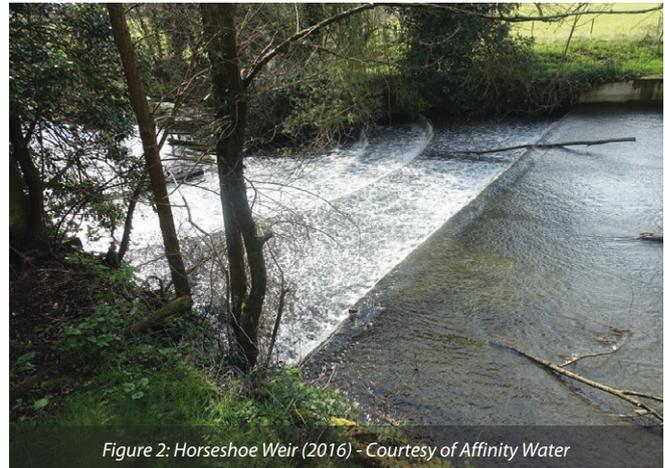
Figure 2: Horseshoe Weir (2016) - Courtesy of Affinity Water

The Horseshoe Weir (Figure 2) was acting as a barrier to fish passage and impounded flow upstream of the structure. The section of river upstream of the weir was artificially straightened and had few natural chalk stream features. The weir is ornamental and has a Grade II listing which meant it could not be removed. In order to enable fish to migrate up and downstream (which is important for breeding and mobilising downstream during drought conditions) and to create a more naturally functioning chalk stream reach, it was decided that the weir needed to be circumvented by means of a bypass channel.

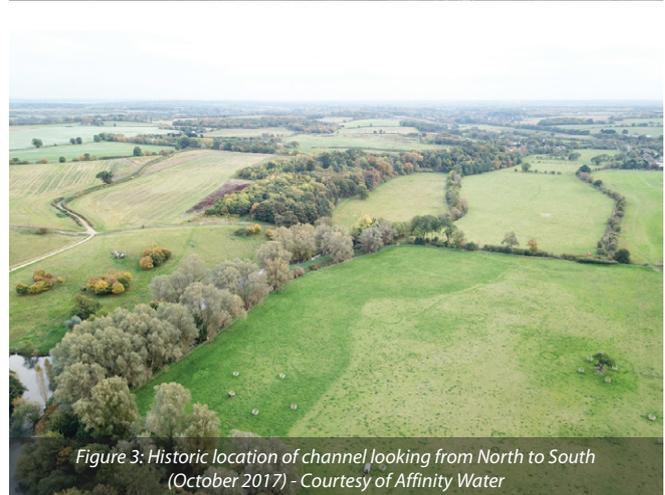
Figure 3: Historic location of channel looking from North to South (October 2017) - Courtesy of Affinity Water

Aerial photographs showed that the field to the west of the channel, which was used for grazing cattle, was likely the original path of the River Beane. This can be seen in Figure 3, where the dark green vegetation shows a naturally wetter path and therefore the most likely historic route of the River Beane. The Woodhall Estate agreed that some of the grazing field could be used to reinstate the river channel back to its more natural location. This would mean the river would be better connected to the upstream section for fish movement by bypassing the Horseshoe Weir with the additional benefit of better groundwater connectivity and more natural chalk stream features.

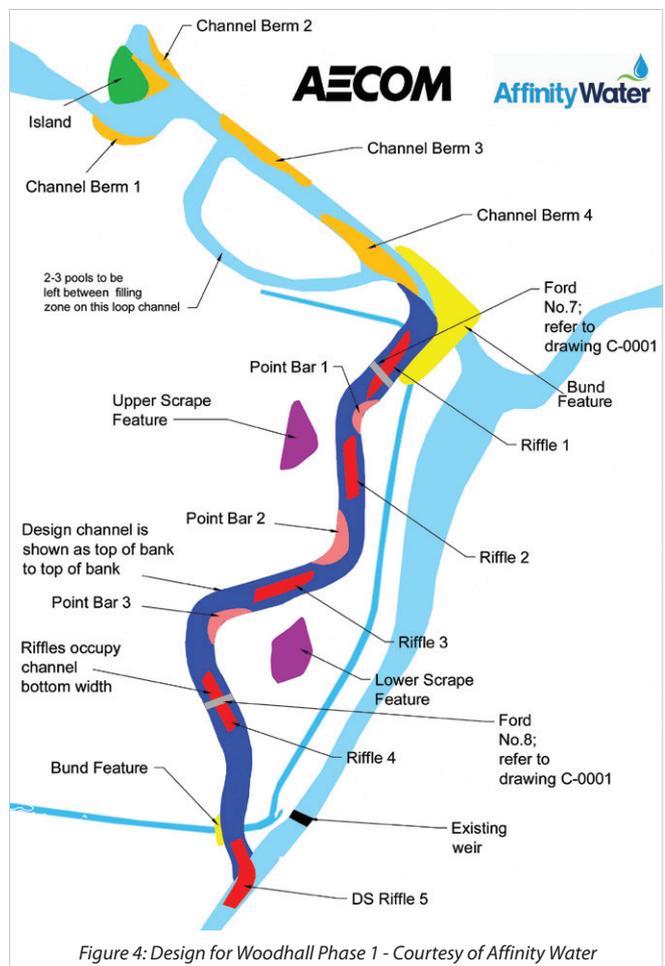
Figure 4: Design for Woodhall Phase 1 - Courtesy of Affinity Water

The design (Figure 4) was carried out by AECOM and was agreed with the Woodhall Estate, the Environment Agency (EA) and Natural England. Archaeologists were on site during excavation to ensure that nothing of historical importance was found on site, as the area is known for Roman remains. The design was run through the EA flood model to ensure that flood risk was not increased up or downstream of the project. Modelling was also carried out to calculate the correct bed elevation of the new channel, ensuring it would function hydrologically. Construction of Phase 1 was carried out by Salix River and Wetland Services, starting in October 2017 and was completed in January 2018.

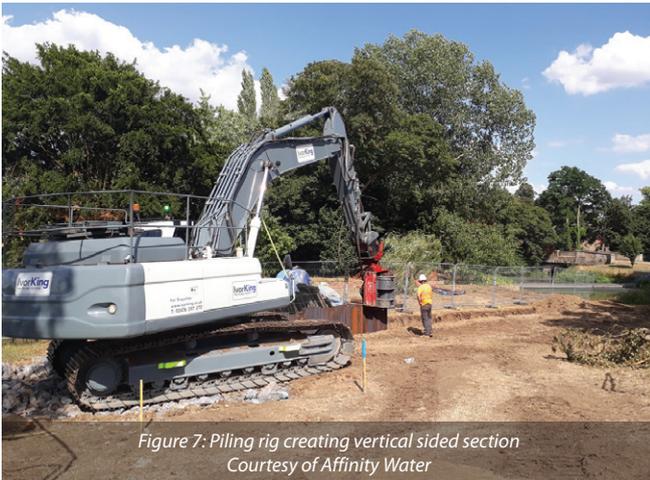
Figure 7: Piling rig creating vertical sided section
Courtesy of Affinity Water

Salix River and Wetland Services carried out the construction work. The most downstream section of the Phase 2 channel, where it re-enters the Tumbling Bay, was constructed with vertical sides using sheet piles due to the lack of space. Due to the space constraints, a clay-core compacted embankment was constructed which 'pinched' the Broadwater in, narrowing it as this point, and created the left bank of the channel.

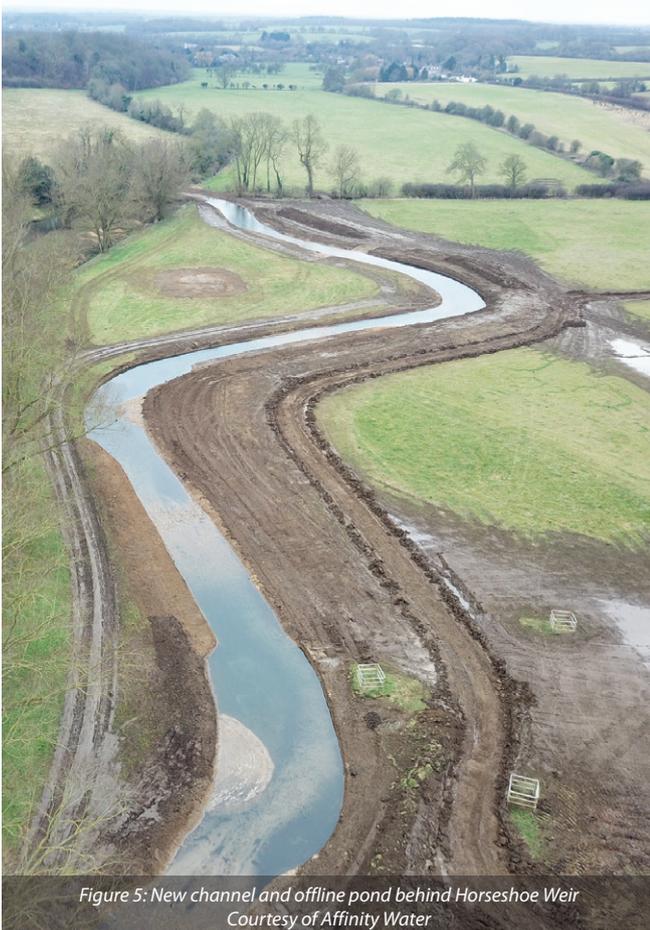
Figure 5: New channel and offline pond behind Horseshoe Weir
Courtesy of Affinity Water

The original channel has been left in situ as an offline pond behind the weir, which is fed by occasional flows from the Dane End tributary after heavy rainfall.

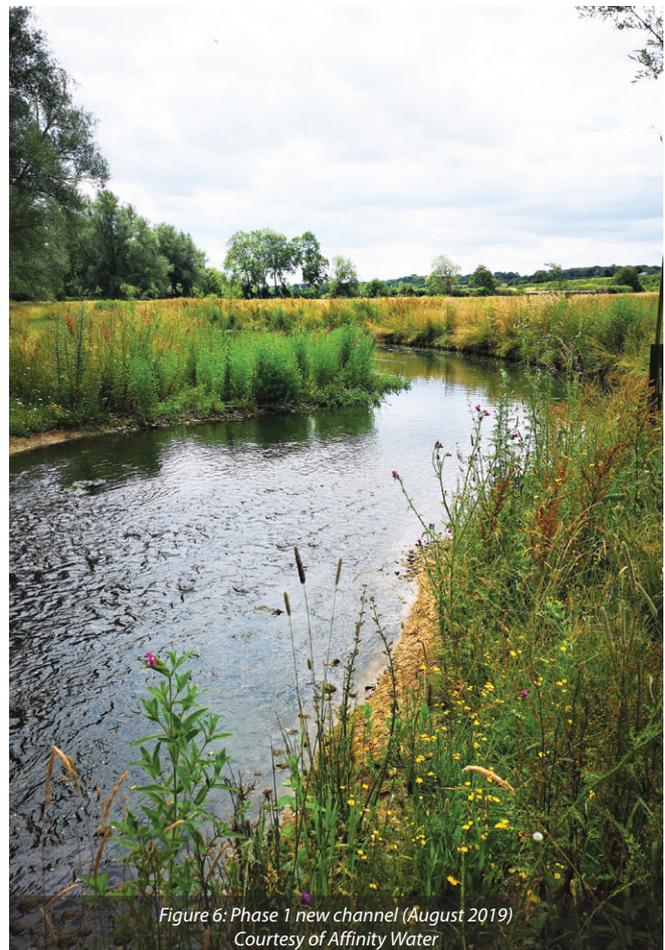
Figure 6: Phase 1 new channel (August 2019)
Courtesy of Affinity Water

The bypass channel created 400m of new chalk stream habitat following construction. Riffles, pools and berms were created in the new channel to provide a range of habitats along this stretch. Local gravels were used to create the riffle features and create natural characteristics of a chalk stream. The Woodhall Estate have planted a trees on the right-hand side of the new channel to create an area of wet woodland. Fencing has also been installed so that the rest of the field can be grazed again, without the risk of poaching.

As part of the project, a volunteer day was held with staff from Affinity Water and the Woodhall Estate as well as members of the River Beane Restoration Association, to rescue aquatic and marginal plants from the drained down broadwater before the silt was removed from it. The plants were dug up and planted in pots in the summer of 2017 and kept in the offline section of the old channel over winter. In spring 2018 they were added to the berms by Woodhall Estate staff so that the new channel could vegetate over the summer with native species. Figure 6 shows the channel in summer 2019.

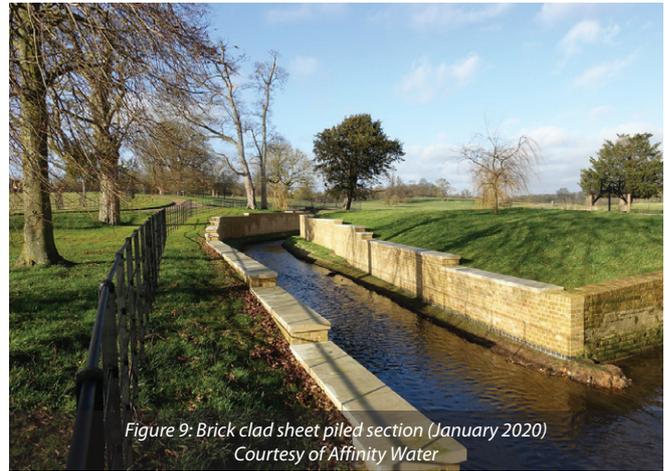
Figure 9: Brick clad sheet piled section (January 2020)
Courtesy of Affinity Water

Due to the historic nature of the weir, we had the sheet piles clad with brickwork using traditional materials and techniques to match the original weir feature (Figure 9) giving a very effective finish. The brickwork was completed by Herts Renovation, a locally based master stonemason.

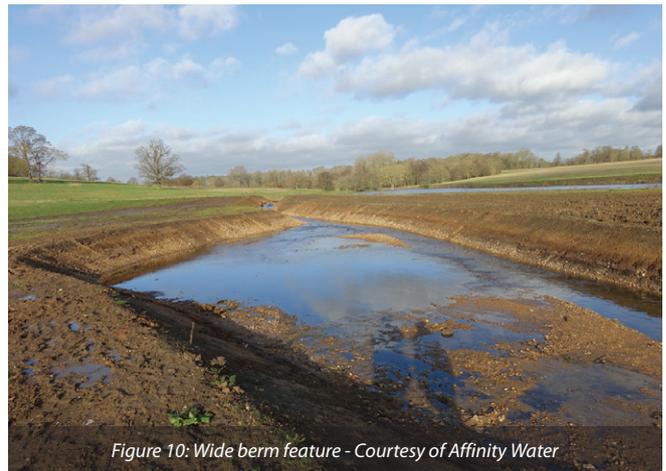
Figure 10: Wide berm feature - Courtesy of Affinity Water

On the upstream half of the new river, a bifurcate channel has been constructed as well as an online pond feature and a wide shallow berm (Figure 10). Due to the location of the sewage pipe to the west of the new river, we were unable to create a meandering channel, so these features have been added to vary flow and create a diverse range of chalk stream habitats.
