# Wrington Flood Storage Area Case Study

flood Storage clay-core embankment to protect eastern Wrington (North Somerset) from 1:50 year floods

by Nigel Horwell MA (Cantab) PGCert CEng MICE MAPM

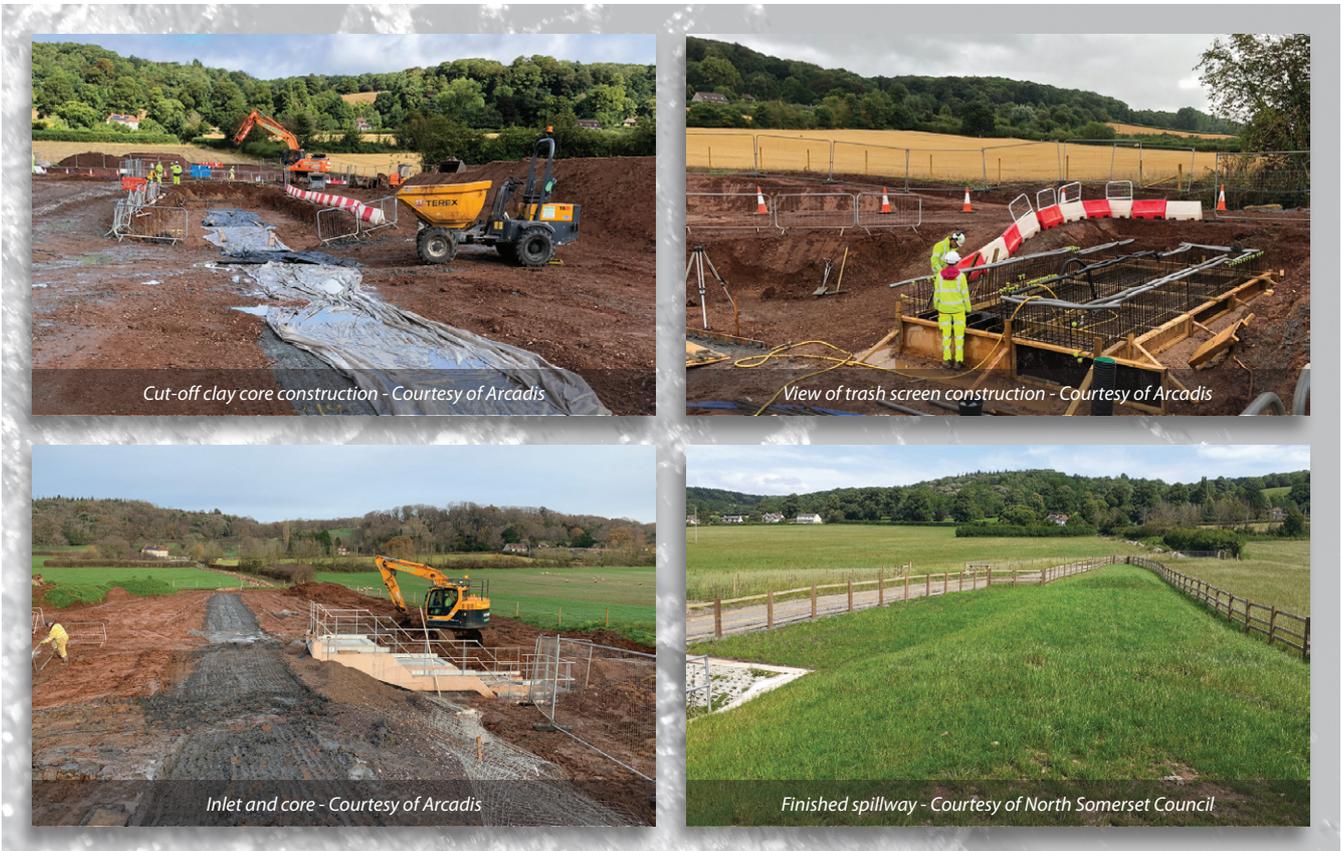
Cut-off clay core construction - Courtesy of Arcadis

The embankment has a 2m clay core which is socketed into the existing ground up to a depth of 3.6m to ensure that leakage is minimised. A compaction method was specified to avoid the need to for man-entry into a deep excavation, but Skanska eventually elected to install the core using a traditional benched excavation to get to formation level. Both faces of the embankment were designed with a slope of 1:3. The rear 'dry' face uses the excavated arisings from the clay core trench to minimise transport and carbon emissions. The face is founded on 150mm thick coarse sand drainage blanket. The front 'wet' face is formed from more granular material to resist the drawdown forces exerted by the rapid drainage of the flood storage embankment after the flood subsides. Both faces are protected with badger-proof mesh and stock-proof fencing to prevent burrowing animals from either forming a failure path through the dam or causing damage to the faces.

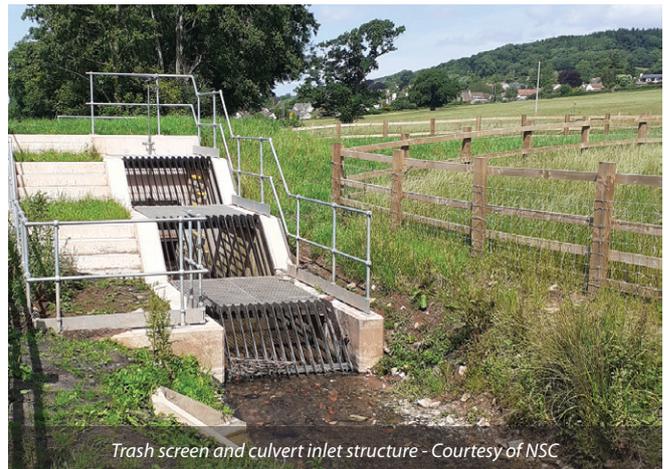
View of trash screen construction - Courtesy of Arcadis

JacksonHyder designed a flood storage embankment capable of reducing the flooding risk to 1 in 50. This includes a 3-stage trash screen and penstock capable of throttling flows to a maximum of 1.4m<sup>3</sup>/s through a 1000 x 500mm precast concrete culvert during floods with good access for maintenance. This throttling effect is important so as not to overload a culvert running through the village that was upgraded during Phase 1 of the scheme (completed by North Somerset Council).

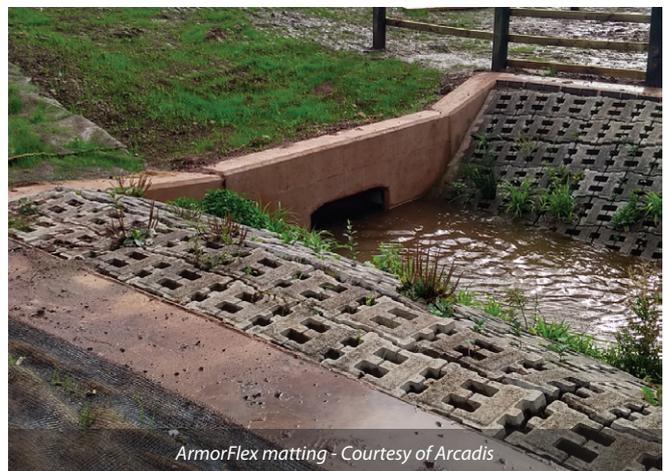
Inlet and core - Courtesy of Arcadis

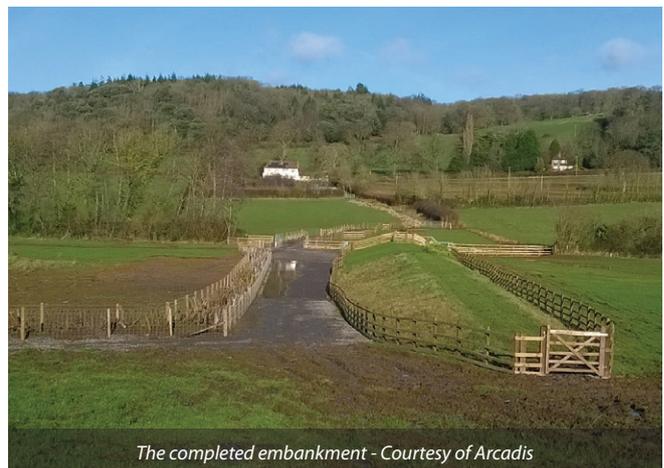
Finished spillway - Courtesy of North Somerset Council

The 160m long flood storage embankment is located some 300m upstream of Rickyard Road with a crest level set at an elevation of 27.5mAOD and include a 20m long spillway set at 27mAOD thus giving an attenuation volume of 4,600m<sup>3</sup>. The spillway will become activated for a flood event with a probability of above 2% AEP (1:50-year) and is capable of easily conveying the 0.2% (1:500-year) AEP flows.

JacksonHyder took the original concept design and modified it by changing the position of the spillway so that exceedance flows would rejoin the watercourse rather than discharge to the natural valley floor which would have created further flooding problems. The spillway was designed with a permanent turf reinforcement rather than a concrete block system for better aesthetics.
