Phillipson Street CSO

construction scheme to replace underperforming combined sewer overflow causing pollution to the River Tyne - an NWG digital delivery pilot project

by Dave Shaw

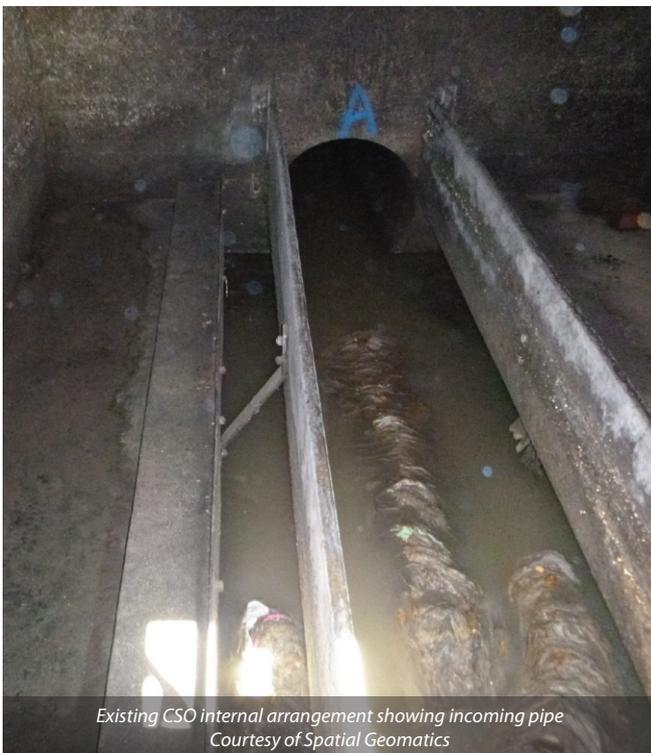
Existing CSO internal arrangement showing incoming pipe
Courtesy of Spatial Geomatics

The existing CSO at Phillipson Street was a low double-sided weir arrangement including scumboards. As mentioned above this was not the original overflow arrangement and the CSO internal configuration, continuation flow route and overflow route has been adjusted at least twice over its history based on evidence from the surrounding network.

The existing CSO was a 4.9m x 2.8m rectangular chamber with a depth to invert of 3.4m below ground level. Access was readily available via an access cover which was in reasonable condition. The chamber and cover were located on one side of a quiet residential street. Historical mapping shows that the CSO used to be located at the top of Phillipson Street, giving the CSO asset its name, however the street itself has since been demolished and replaced with more modern housing. The CSO did not include any screens, and there was no evidence that any of the previous configurations of the CSO included screens.

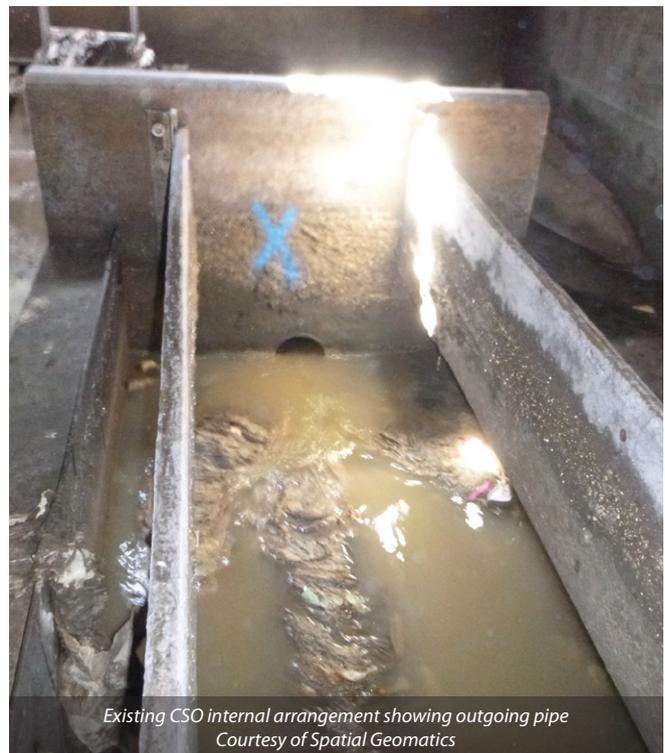
Existing CSO internal arrangement showing outgoing pipe
Courtesy of Spatial Geomatics

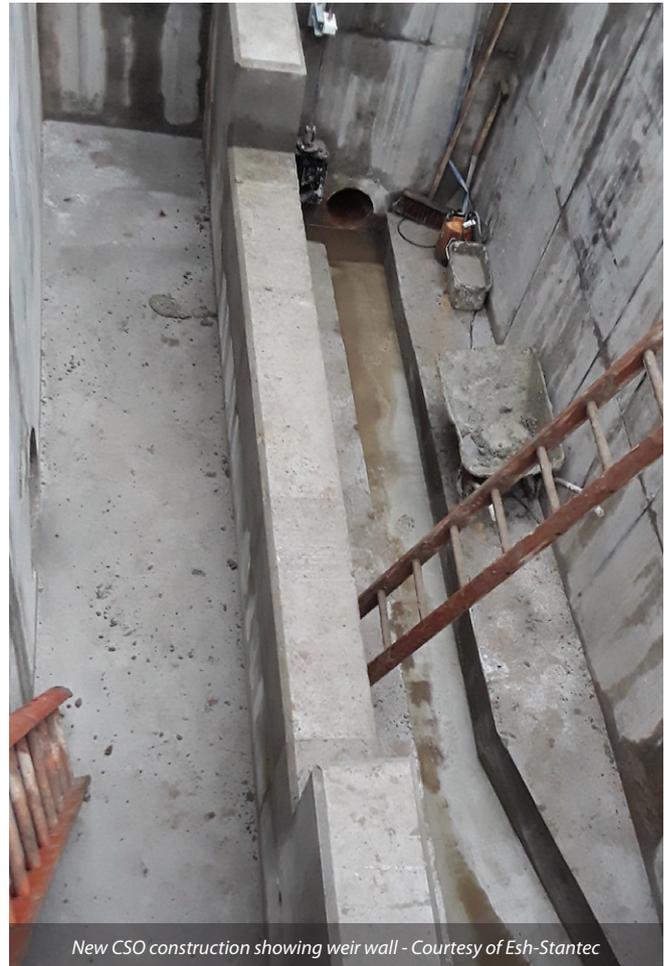
New CSO construction showing weir wall - Courtesy of Esh-Stantec

A new 6.0m x 3.3m x 4.1m deep reinforced concrete chamber was designed featuring a high sided weir and a 3.125m long mechanical self-cleansing spiral screen from Huber Technology. Pass forward flows were controlled using a laser cut steel orifice plate with a bypass penstock arrangement for water level draw down in the event of a blockage. The new CSO was carefully positioned to be within an unused corner of an existing NWG compound whilst maintaining calm 'straight-through' flow conditions to encourage minimal screen loading with solids.

The new CSO featured significantly higher weir walls than the existing setup, reducing the number and volume of spills. Hydraulic modelling identified that the downstream surface water sewer network had limited capacity which would prevent efficient CSO performance. For this reason, strategically positioned surface water sewer upsizes and upgrades were designed downstream.

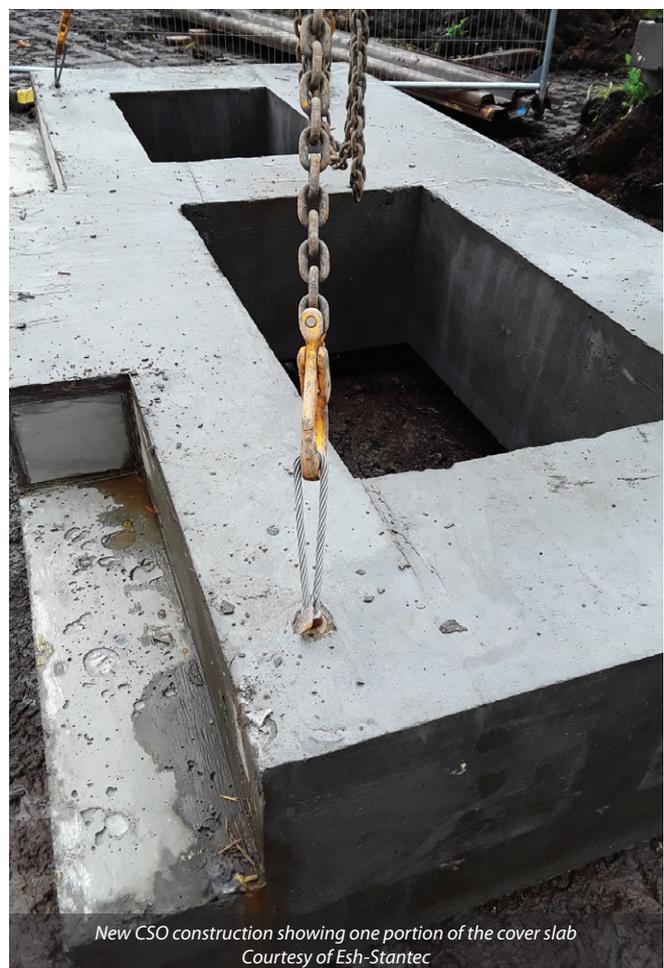
New CSO construction showing one portion of the cover slab
Courtesy of Esh-Stantec

The new CSO was successfully constructed using in situ reinforced concrete and a 3-part precast reinforced concrete cover slab including an opening for screen removal and maintenance. Flows were directed around temporary bypass pipework in order to keep the workforce safe during construction, and spill flows followed the existing CSO's overflow route.

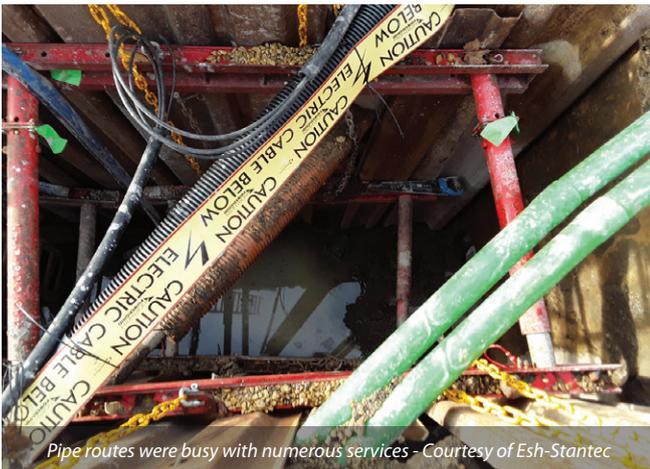
Pipe routes were busy with numerous services - Courtesy of Esh-Stantec

The surface water sewer construction struggled with the discovery of numerous uncharted services. Most of these were not identified in the underground utility survey, primarily because of the high

number of live and abandoned services in a small area making individual identification of each pipe or cable very difficult. However, each unexpected service was found during careful trial pit digging which preceded the main pipelaying construction - meaning there were no strikes with the unexpected services.

The surface water sewer upgrade designs had to be promptly adjusted to avoid the newly discovered services. However, backup options had already been considered within the design and these were then quickly adopted.

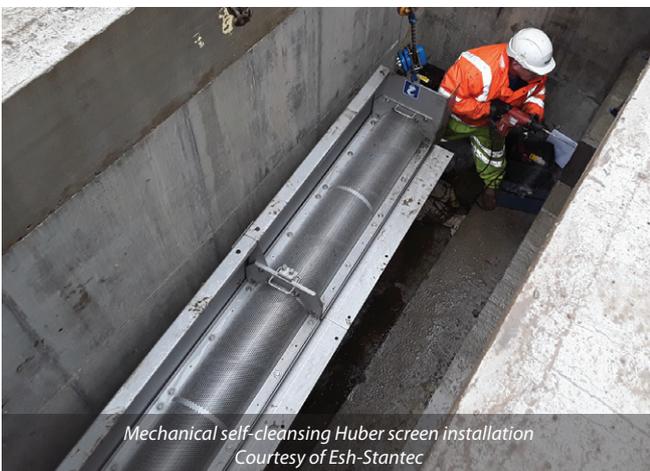
Mechanical self-cleansing Huber screen installation
Courtesy of Esh-Stantec

The mechanical screen was successfully installed, tested and commissioned in a collaborative effort by the supply chain:

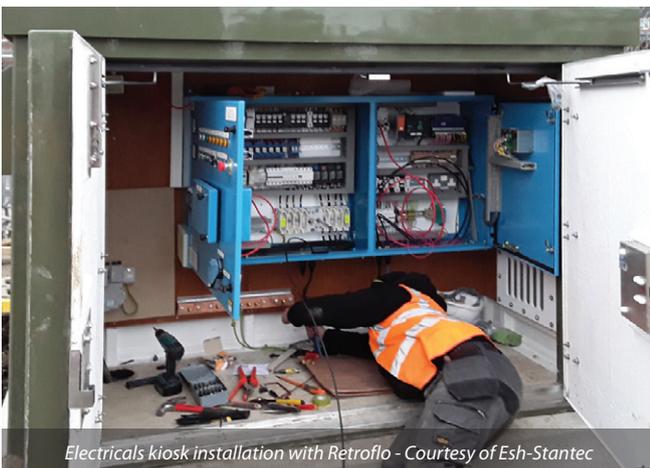
Electricals kiosk installation with Retroflo - Courtesy of Esh-Stantec

- **Esh-Stantec:** Principal designer & contractor
- **Retroflo:** Electrical, Instrumentation, Control & Automation contractor
- **Huber Technology:** Screen supplier
